**INNOVATION IN PIEZOCERAMIC BASED STRUCTURAL HEALTH
MONITORING**

A Dissertation

the Faculty of the Department of Mechanical Engineering

University of Houston

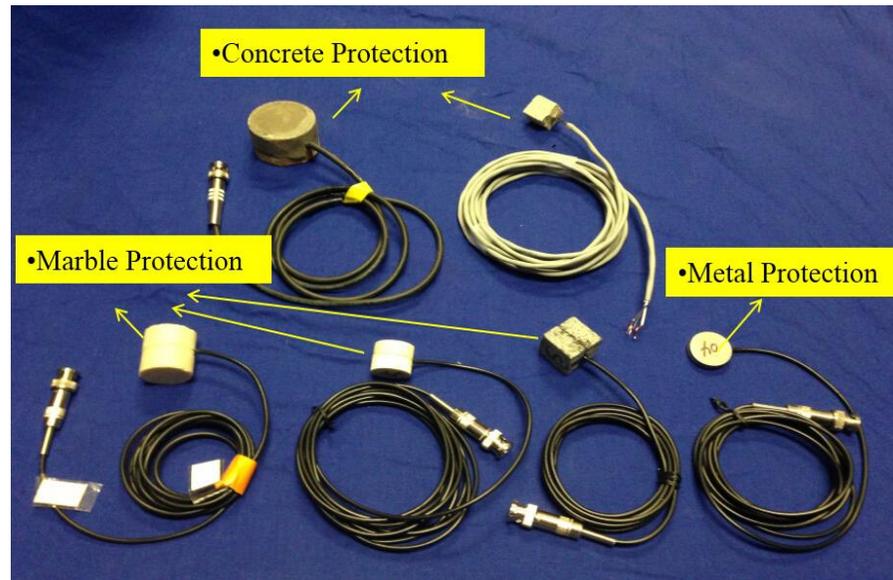
smart aggregate can be replaced by some other materials, such as metal. Figure 2-7 shows different kinds of smart aggregates using concrete, marble, and metal housing. For easy connection, a BNC connector is welded to the end of the leading wire. Please note that all piezoceramic patches receive waterproof treatment.

Figure 2-7 Smart aggregates with different protected materials

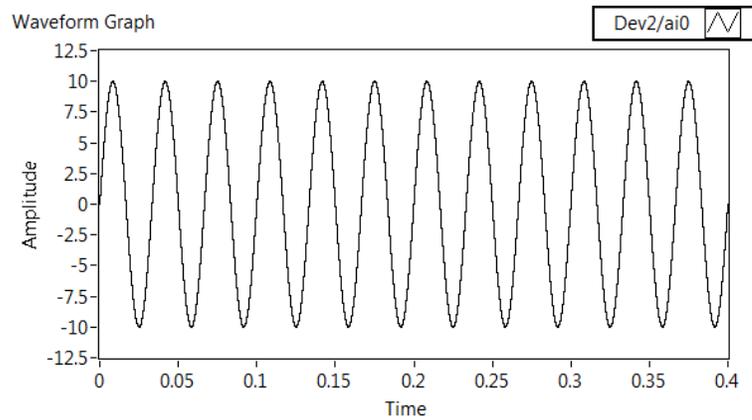
Sinusoidal signal seems to be one of the most common excitation signal used in active sensing method. One example is the constant frequency sine wave. Figure 2-8 shows a sine wave with the constant frequency of 30Hz. The advantage of the constant frequency since wave excitation is that the signal is easy to generate and analyze if the selected frequency is good enough to realize the test propose.

Figure 2-8 A sine wave with the constant frequency of 30Hz

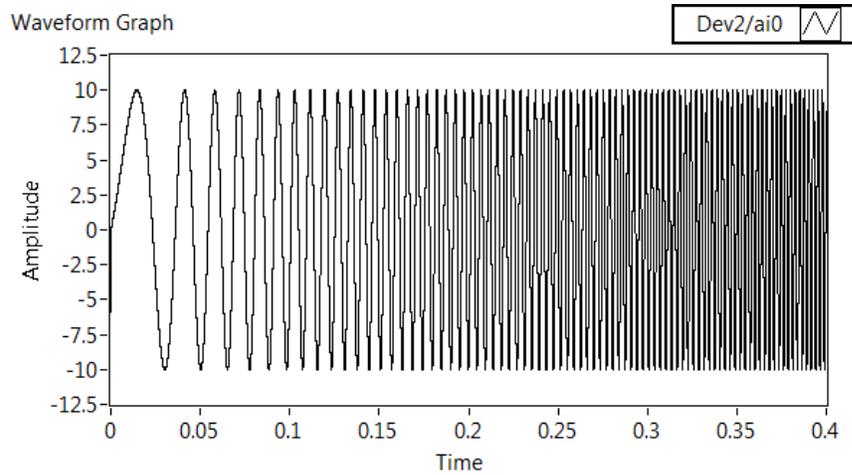
frequency is 1000Hz. The period of the signal is 1s. In order to see clearly of the frequency change, only the first 0.4s of the signal is picked up in the figure.

Figure 2-9 an example of a swept frequency signal

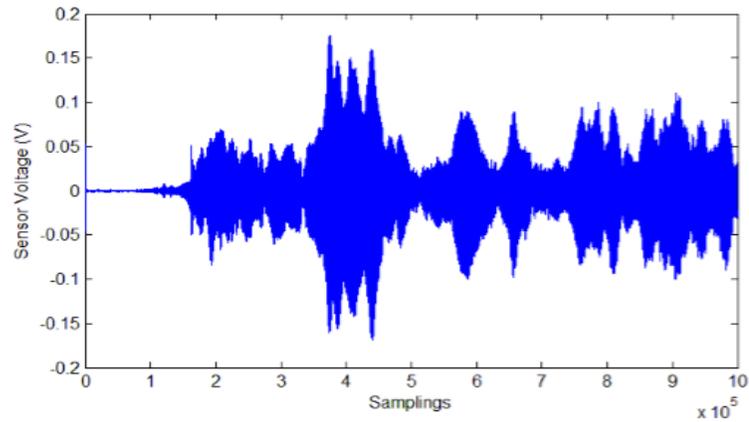
Figure 2-12 shows the received sensor signal for a period of 1s. The X-axis corresponds to the samplings and the Y-axis corresponds to the sensor voltage. Since the sampling rate of the system is 1Ms/s, the length of X-axis corresponding to time is exactly 1s which is just one period of the excitation swept frequency signal. The power spectrum of the sensor signal for one period is also calculated, as shown in Figure 2-13. It can be clearly found that the magnitude of the received sensor signal is related to the excitation frequency from the actuator.

Figure 2-12 Received sensor signal from the actuator

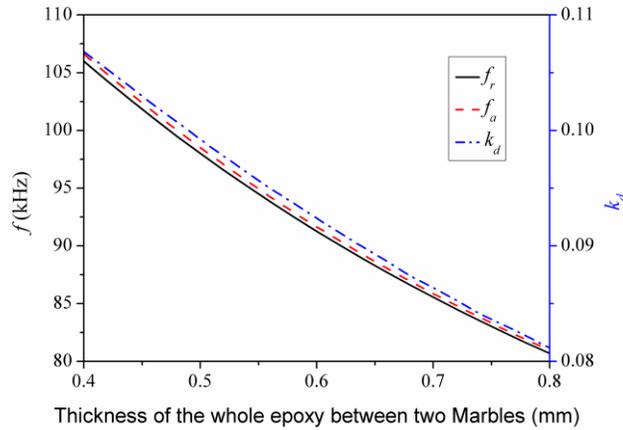
The above structural sizes and material properties are adopted in the following numerical analysis, unless otherwise stated. During the fabrication of the proposed smart aggregate, it is difficult to keep the thickness of the whole epoxy between two marbles as constant. The influence of the thickness of the whole epoxy on the dynamic characteristics of SA is evaluated by numerical analysis. The thickness of the whole epoxy ranges between 0.4 and 0.8 mm. The analytical results are plotted in Figure 3-3.

Figure 3-3 The influence of the thickness of the whole epoxy between two Marbles on the fundamental resonance and anti-resonance frequencies as well as the corresponding electromechanical coupling factor

It shows that the fundamental resonance and anti-resonance frequencies as well as the corresponding electromechanical coupling factor decrease as the thickness of the whole epoxy increases. Further, keeping the thickness of the whole copper package as constant, Figure 3-4 and Figure 3-5 present the effects of the thickness and diameter of PZT patch on the dynamic characteristics of SA. In Figure 3-4, the thickness of PZT patch ranges between 0.1 and 0.8 mm. It can be found that with the increase of the thickness of PZT patch, the fundamental resonance frequency decreases obviously than the fundamental anti-resonance frequency, which leads to the increase of the corresponding electromechanical coupling factor. The diameter of PZT patch ranges between 10 and 16 mm. Similar results obtained from Figure 3-5 can be also found.

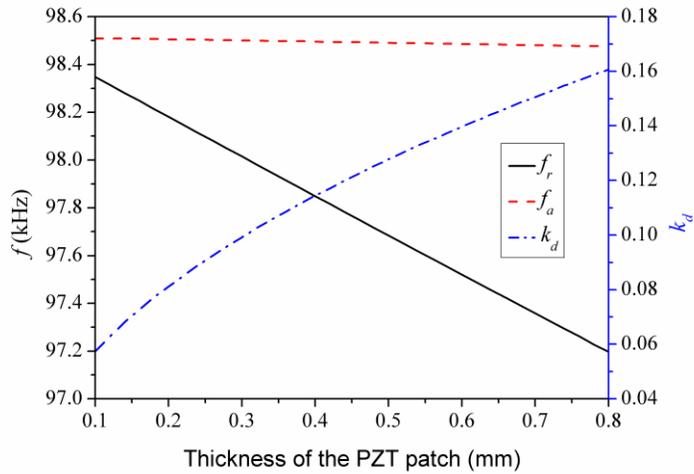
Figure 3-4 The influence of the thickness of the PZT patch on the fundamental resonance and anti-resonance frequencies as well as the corresponding electromechanical coupling factor

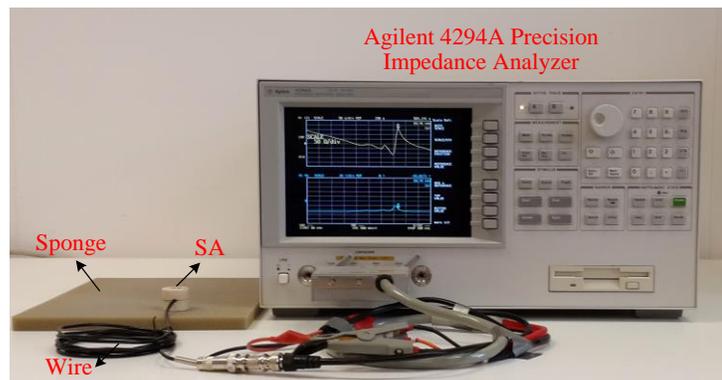
In the test, the *Agilent 4294A Precision Impedance Analyzer* scanned the smart aggregates in the frequency range from 60 KHz to 90 KHz and the impedance of each smart aggregate was recorded.

Figure 3-6 Experiment setup

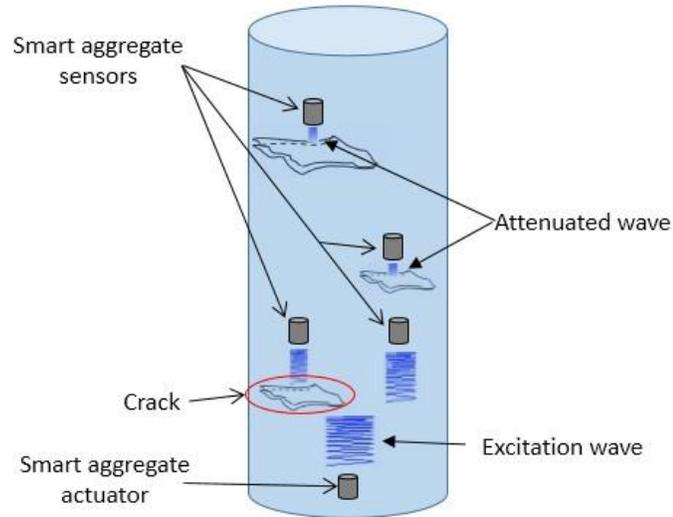
The active sensing approach using smart aggregates is a good example to illustrate the principle developed in this chapter for structural crack monitoring, as shown in Figure 4-1. A column structure with embedded smart aggregates is drawn to explain the developed structural damage detection approach. One or several smart aggregates can function as actuators to generate guided waves propagating in the structure. Other distributed smart aggregates are used as sensors to receive the waves. If a crack appears in the structure, it can act as a stress relief in the wave propagation path. The amplitude of the received signal from sensors will attenuate due to the related cracks. In addition, the severity of cracks can be characterized by the selected signal processing technique called “wavelet packet-based analysis”, as mentioned in Section 2.5. A wavelet packet-based structural damage index is capable of providing quantitatively values to describe the initial crack in the structure and its further development.

Figure 4-1 Block diagram of smart aggregate based active sensing system

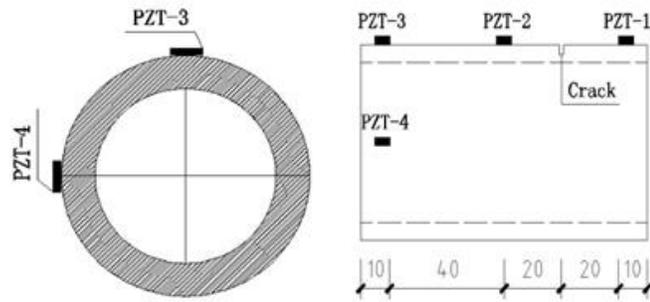
Four PZT patches were fixed on the pipeline surface using Epoxy (LOCTITE EPOXY). The locations of PZT patches are shown in Figure 4-2. It should be noted that PZT-1, PZT-2, and PZT-3 are equidistant from each other along the length of the pipe. Also seen in Figure 4-2, the location of PZT-4 is rotated 90 degrees counterclockwise from PZT-3. A third point to note is that an artificial crack was cut approximately halfway between PZT-1 and PZT-2. Figure 4-3 shows the actual specimen with the aforementioned PZT locations and the artificial crack.

Figure 4-2 location of PZT patches on the pipeline

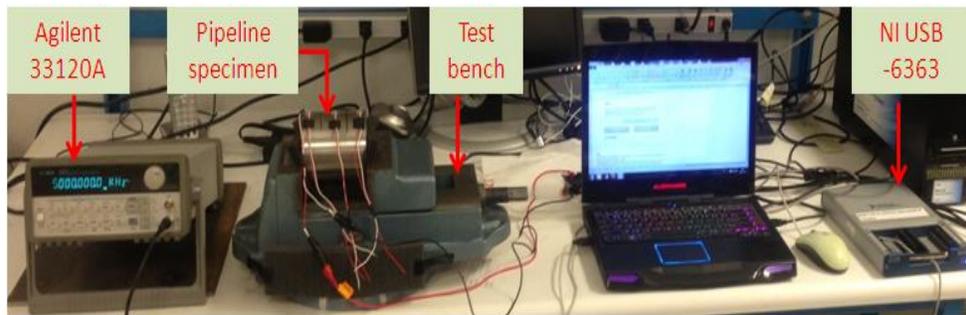
In the presented test system, the PZT actuator (PZT-1) is connected with a function generator (Agilent 33120A). The PZT sensors (PZT-2, PZT-3 and PZT 4) are connected with a data acquisition system (NI USB-6363). The sampling rate of the data acquisition system for each channel is 1Ms/S. The test bench is used to fix the pipeline sample. Please note that two pieces of artificial form were placed between both pipe edges and the test bench. Thus the stress wave cannot propagate through the test bench. The experimental setup is shown in Figure 4-4.

Figure 4-4 Experimental setup

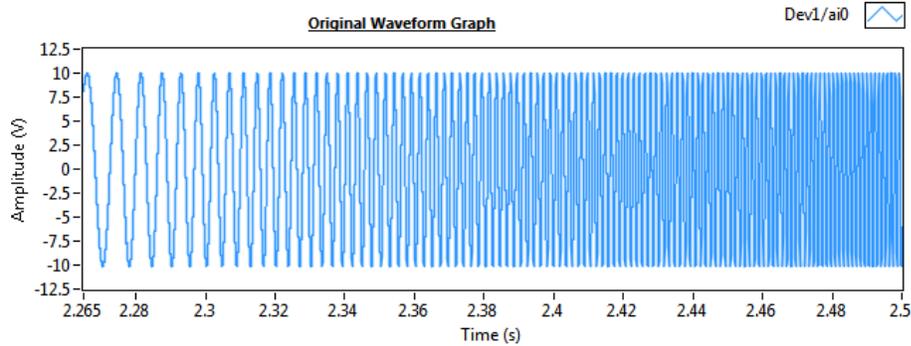
Figure 4-5 One section of the swept sine wave signal used in the experiment

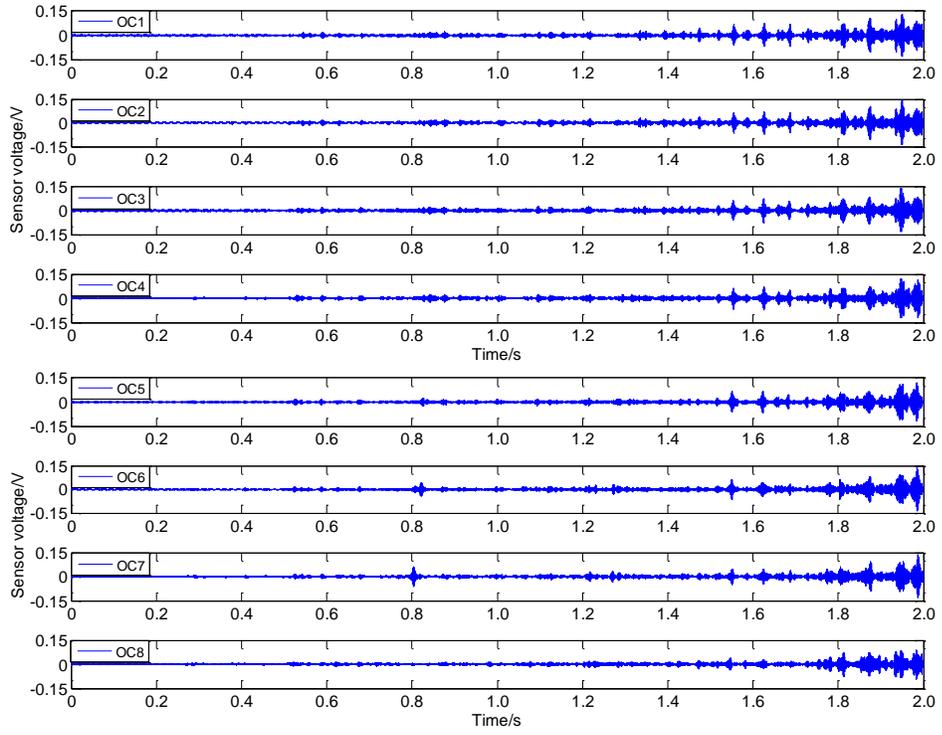
The received signals of PZT-2, PZT-3 and PZT-4 in each operating condition are shown below in Figure 4-6, Figure 4-7 , and Figure 4-8. Each signal was subject to several resonance frequencies within the range of 60 kHz to 200 kHz. Each plot reflects the sensor signal response from one period of the swept sine wave signal, which is equal to 2 seconds in the time domain. From the plots, several resonance peaks can be observed, especially towards the end of the period (i.e., after 1.8 seconds). Through the analysis of these peaks, the same general trend can be identified for each of the PZTs. This trend shows that the amplitudes of the resonance peaks decrease with an increase of the crack depth. This trend indicates that less energy is collected by the sensors with increasing crack depth. Ultimately when the crack is of a depth near 10.5 mm, the entire signal response is extremely weak, which indicates that the crack almost fully blocks the stress wave propagation from the actuator to sensors.

Figure 4-6 Signal response of PZT 2 for Each Operating Condition (OC)

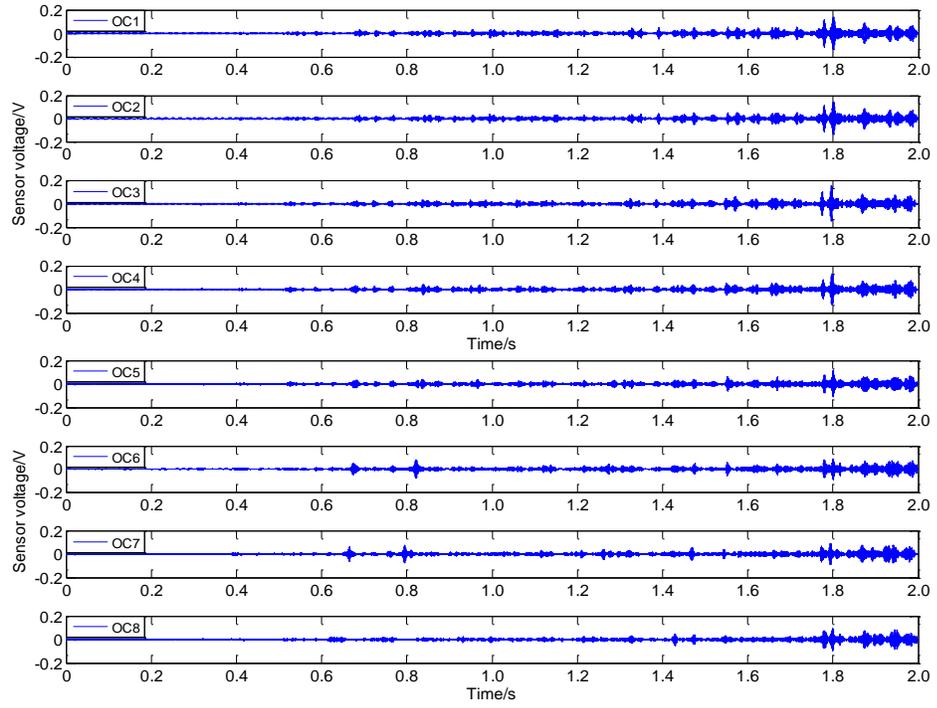
Figure 4-7 Signal response of PZT 3 for Each Operating Condition (OC)

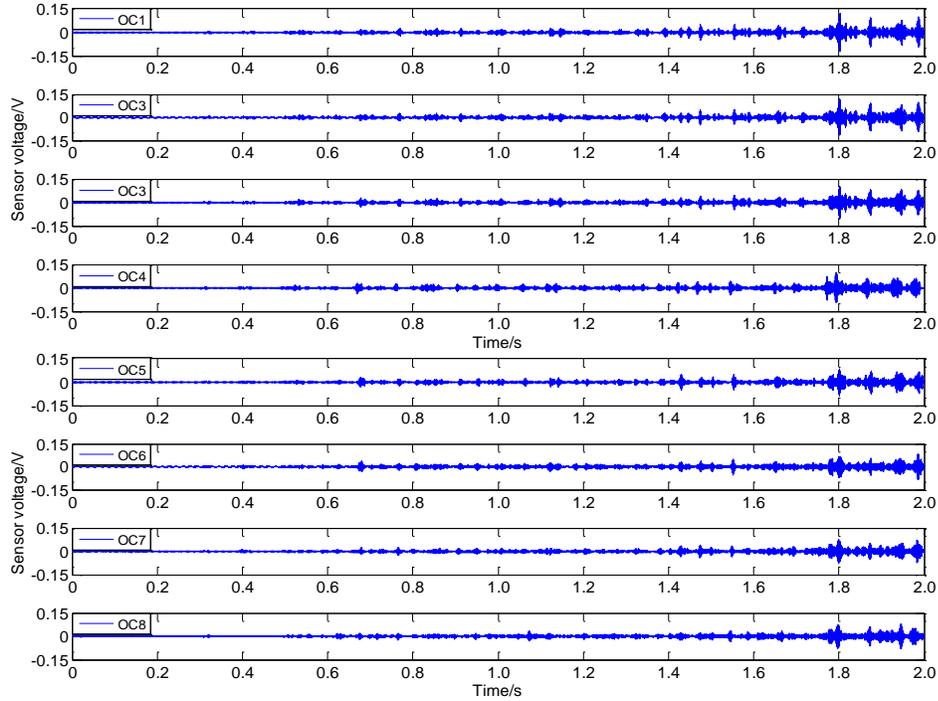
Figure 4-8 Signal response of PZT 4 for Each Operating Condition (OC)

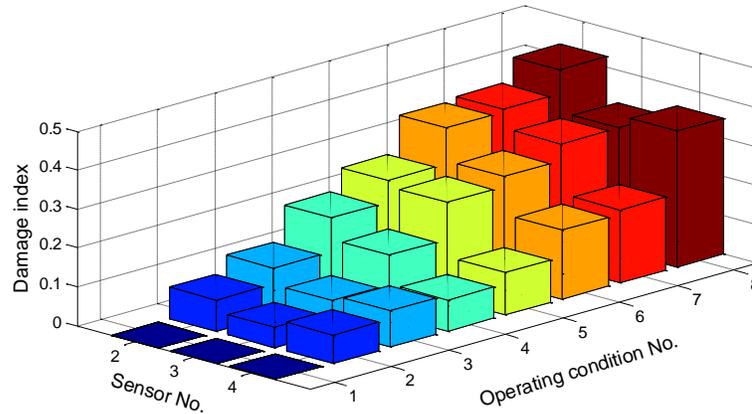
In order to quantitatively analyze the crack severity on the pipe, the wavelet packet-based crack severity index is developed, as shown in Figure 4-9. The height of the bars indicates the damage degree collected by the each corresponding sensor. Based on the principle of the crack severity index, 0 is the health status of the structure corresponding to a crack depth of 0 mm (Operating Condition No. 1). It can be seen that the heights of the bars increase for each incremental operating condition that corresponds to an increase of the crack depth. For Sensor 2, the most distinguishable changes in crack severity index are observed due to the increases in bar height up to the value of 0.4 for Operating Condition No. 8. This can be attributed to Sensor 2's close proximity to the artificial crack location on the pipe (as seen in Figure 4-3). The same trend is also observed for Sensors 3 and 4, which confirms that the crack functions as a stress relief in the wave propagation path.

Figure 4-9 Wavelet packet-based pipeline crack severity index

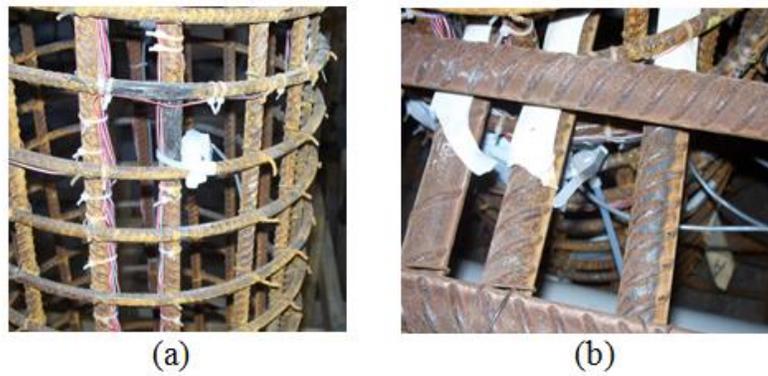
Figure 4-11 (a) A smart aggregate fixed on the rebar cage (b) A Smart aggregate was installed in the base

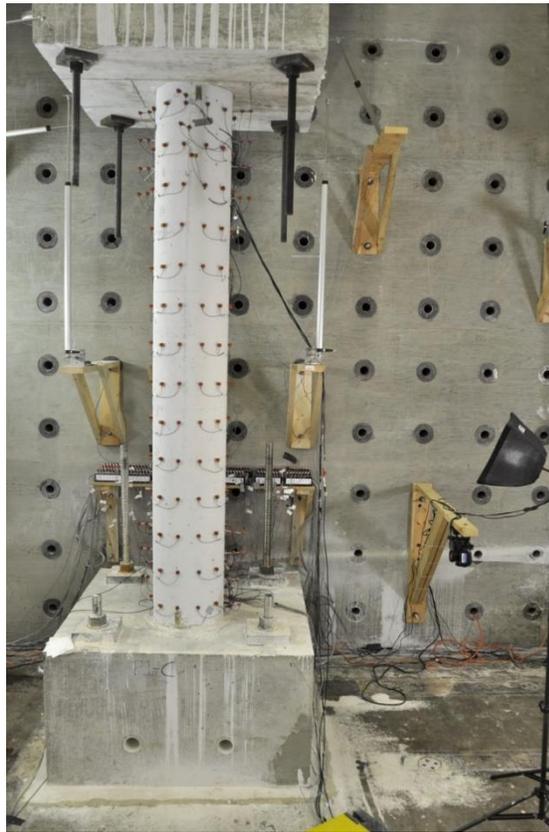
Figure 4-12 A photo of the concrete column after casing

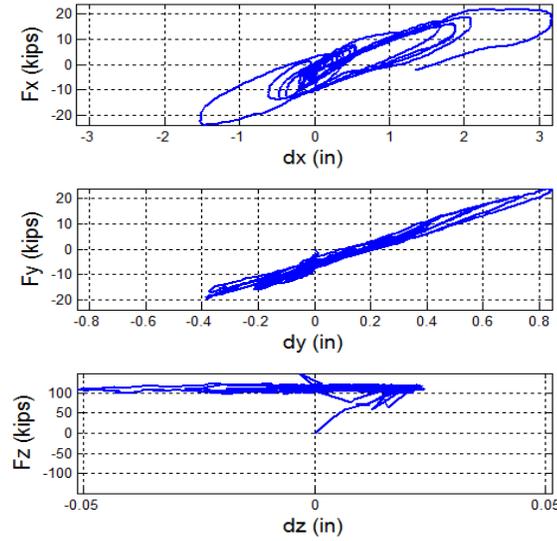
Figure 4-15 Force-displacement relationships for the concrete column

As shown in Figure 4-15, x-direction is the main axis of displacement to the concrete column. Therefore, the phenomenon of the cracks “open and close” is highly depended on the cycles of displacement in x-direction. The displacement history in x-direction at the top of concrete column was shown in Figure 4-18. During the 38-hour test, 13 cycles of displacement in x-direction is observed and marked in Figure 4-18.

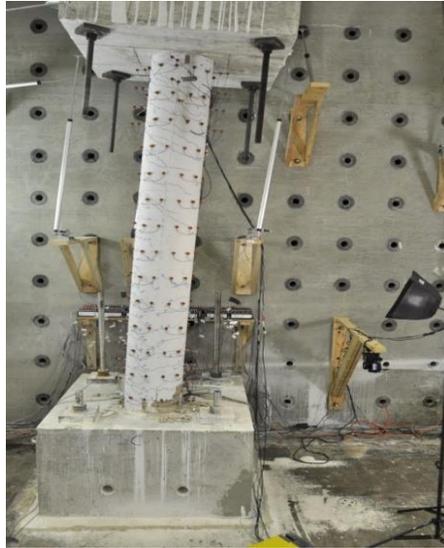
A photo of the yielded concrete column after test is shown in Figure 4-17.

Figure 4-17 A photo of the concrete column yielding after test

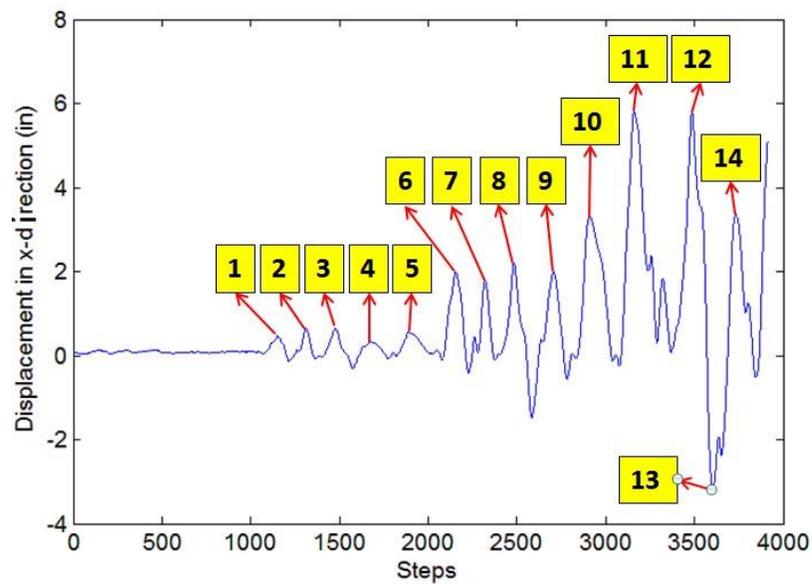
Figure 4-18 Displacement history in x-direction of the column

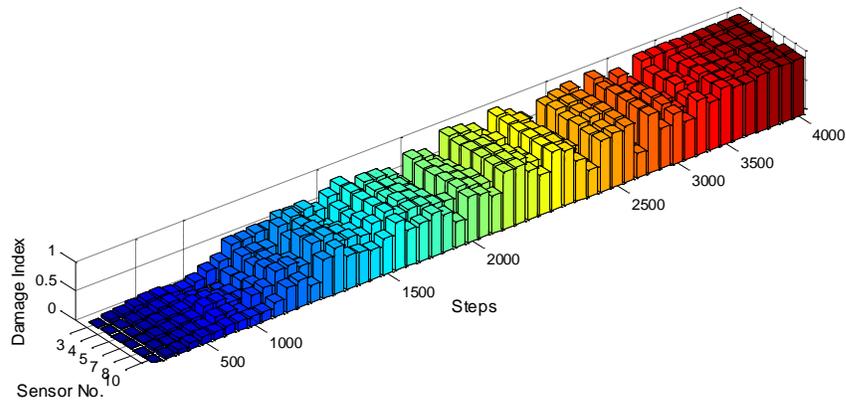
Figure 4-19 shows the wave packet-based damage index for the concrete column. From Figure 4-19, it is seen that the damage gradually increases throughout the duration of the test. It is also obvious that the damage increased greatly shortly after Step 1000, this corresponds to the first cracks in the column. In some places, the damage index decreases rather than increasing. This is due to the cyclic behavior of the test. As the column is pushed in one direction, cracks open on the side of the column that is in tension. As the column is pushed in the opposite direction, these cracks close. The lower damage index values correspond to the original cracks closing during the cyclic loading.

Figure 4-19 wave packet-based damage index for the concrete column

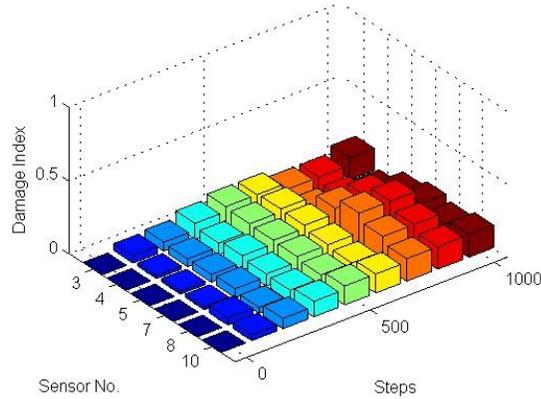
concrete column in the first 1000 steps is shown in Figure 4-20. It can be clearly seen that the values of the index for all the sensors are small. The values of the index in the first 1000 steps yield to the x-direction displacement data.

Figure 4-20 Damage index of the concrete column in first 1000 steps

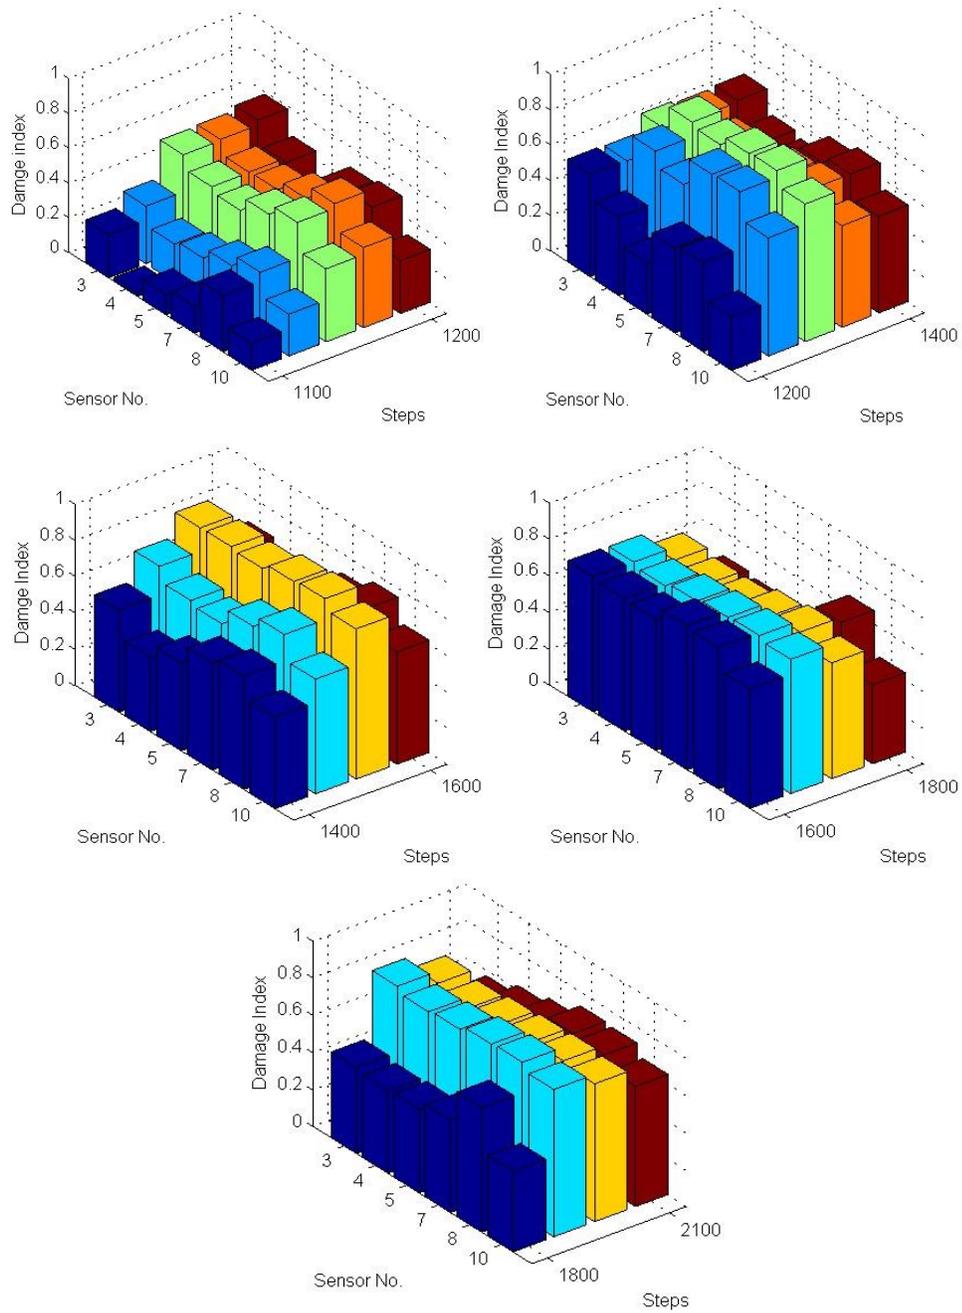
The separate damage indices from cycle 1 to cycle 5 corresponding to step 1100 to step 2100 are shown below in Figure 4-21. Each damage values have the same trend which is increasing in the first half and decreasing in the second half. The increasing and decreasing phenomenon of each damage index confirms the cyclic behavior of the test. As the column is pushed in one direction, the cracks open which correspond to the increasing of the damage index values. As the column is pushed back, the cracks close which correspond to the decreasing of the damage index. Please note that, the motion of the concrete column in first 5 cycles is smaller than the other cycles. The maximum value of the damage index is around 0.8.

Figure 4-21 Damage indices of the concrete column from step 1000 to step 2100

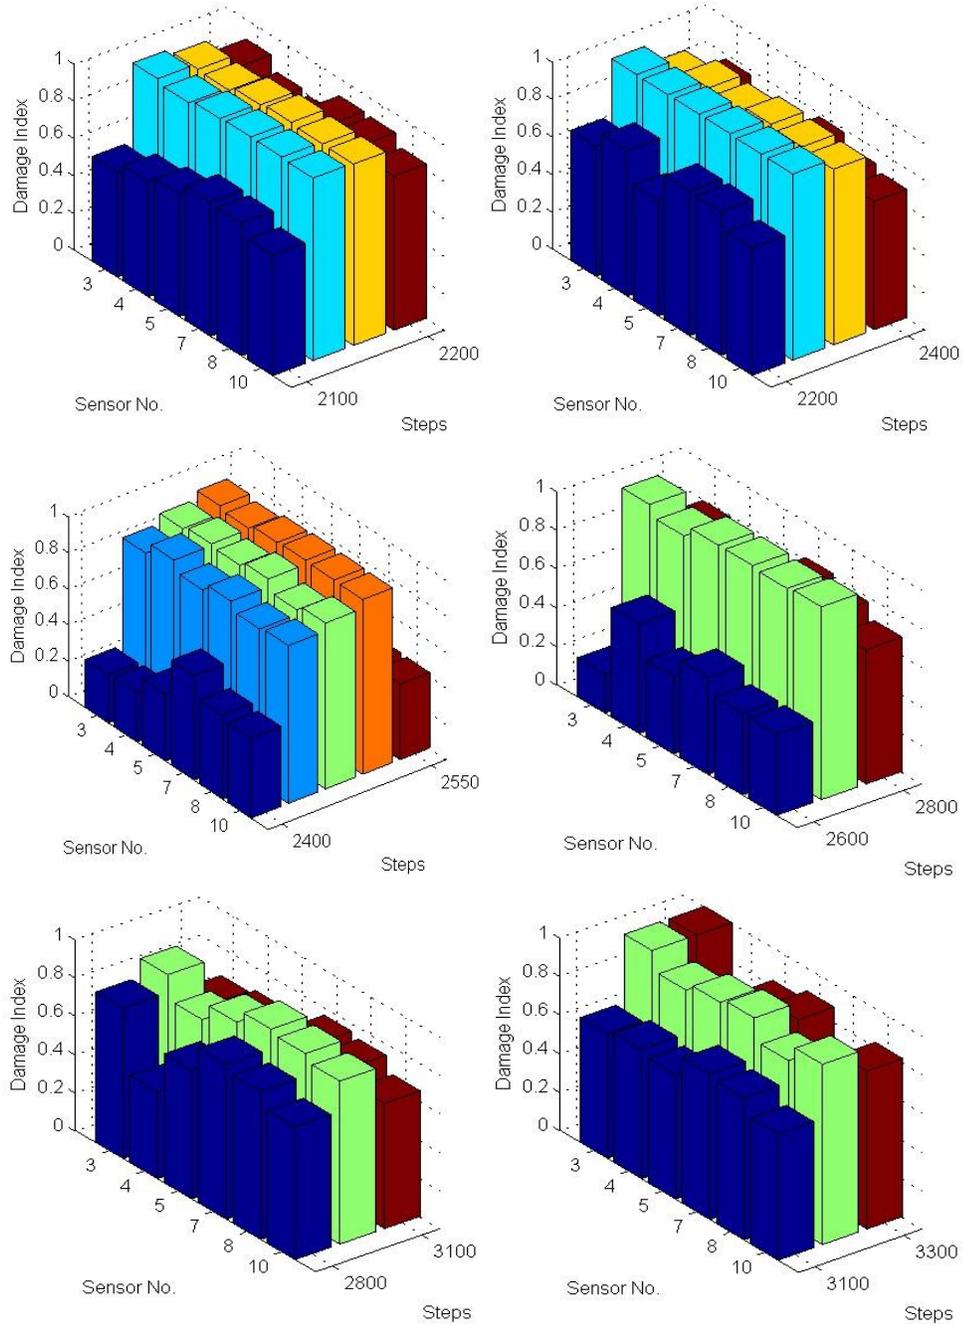
cracks close. In this period, x-displacement of the concrete column is much larger than those from cycle 1 to cycle 5. Since the concrete column structure has been failed, the maximum value of the damage index is approaching to 1.

Figure 4-22 Damage indices of the concrete column from step 2100 to step 3300

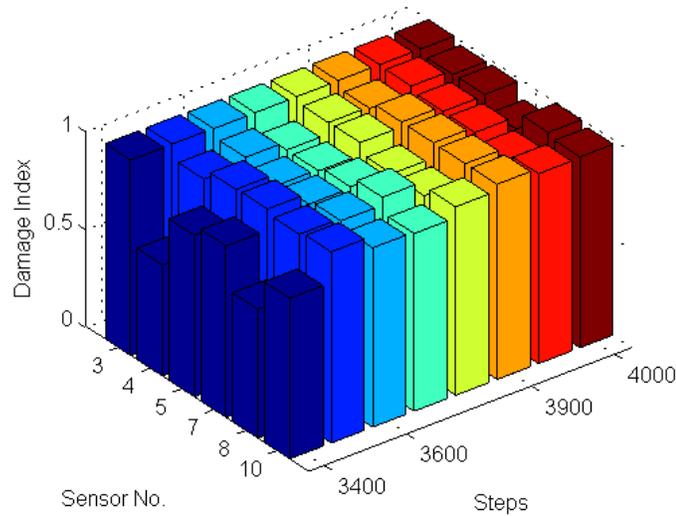
The separate damage index from cycle 12 to cycle 14 corresponding to step 3500 to step 4000 is shown in Figure 4-23. Compared to the previous damage indices, the values of the damage index is not presenting an increasing and decreasing phenomenon. It can be concluded that the cracks in this period are in large degree which dramatically attenuates the stress wave energy propagation from the actuator to the sensors. The sensors can receive very little energy which leads to the values of the damage index stable at 1 even when the concrete column is pushed.

Figure 4-23 Damage index of the concrete column from step 3400 to step 4000

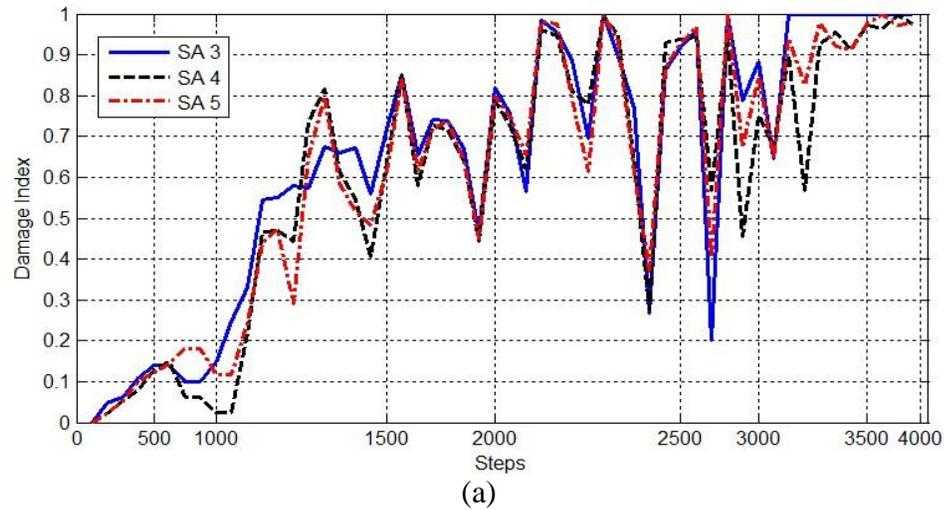
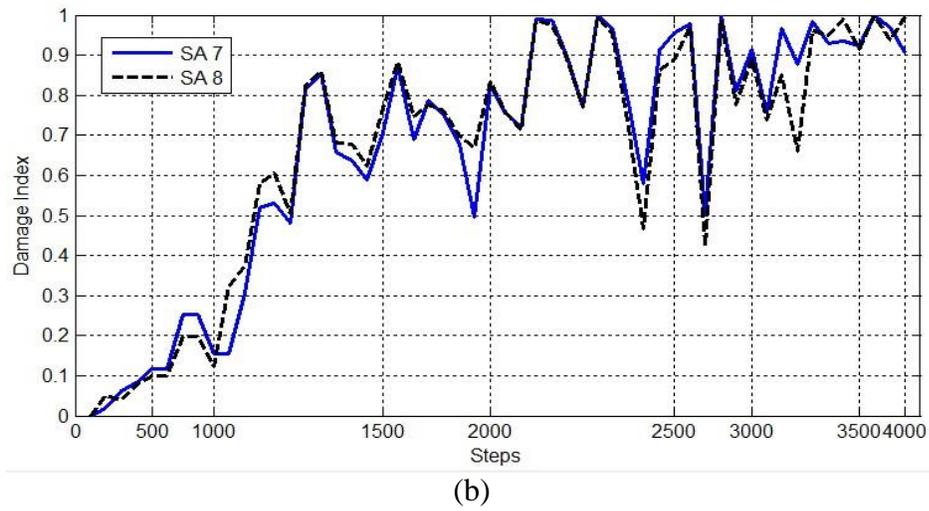
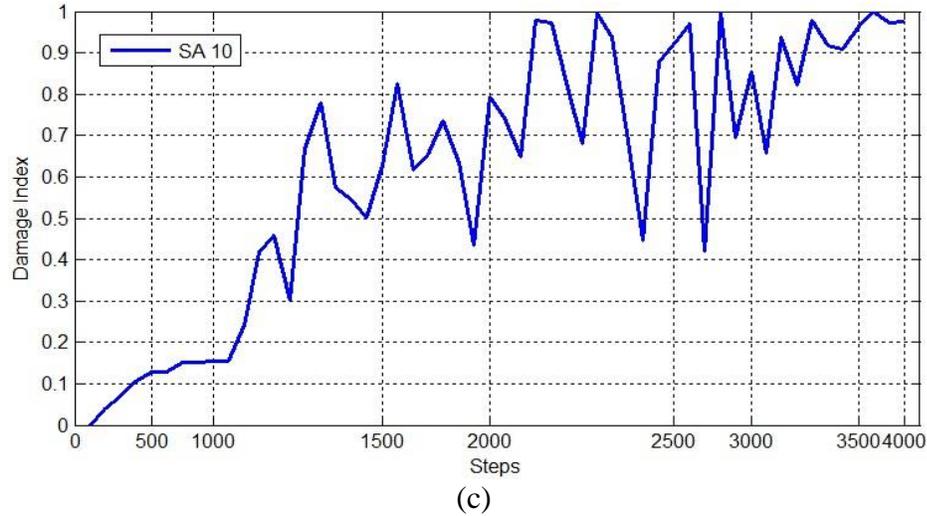
Therefore, the phenomenon of the cyclic value for each sensor can be observed from all the damage indices. The values of the damage index from different locations are closing to each other which mean that the major crack happened on the bottom of the concrete column is successfully detected by all the operating sensors.

Figure 4-24 Damage indices of the concrete column from different locations (a) Bottom sensors, (b) Middle sensors, (c) Top sensors

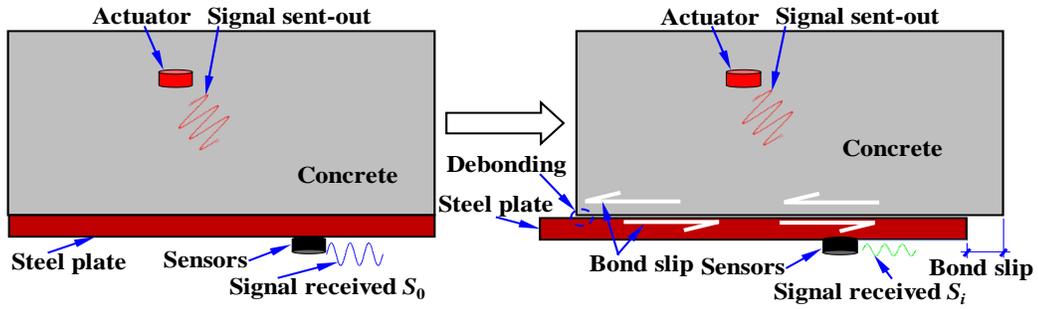
Figure 5-2 presents the principle of the bond slip detection between concrete and steel plate using smart aggregate based active sensing system. As shown in the figure, one smart aggregate embedded in the concrete (mark with red) is utilized as an actuator. A swept sine wave with desired parameters is generated by the actuator. Other smart aggregates are attached on the surface of the steel plate. When no bond slip happens, the sensor signal is recorded as a baseline. When bond slip happens, the compactness between concrete and steel plate will decrease. Due to the properties of stress wave propagation [126], the stress wave energy will attenuates related to the severity of the bond slip condition. The wavelet packet-based damage index can be utilized as an indicator to identify the beginning and the degree of the bond slip. In addition, if several predetermined distributed smart aggregates are attached on the steel plate, the proposed method has the potential determine the location of where bond slip happens.

(a) Health state before bond slip

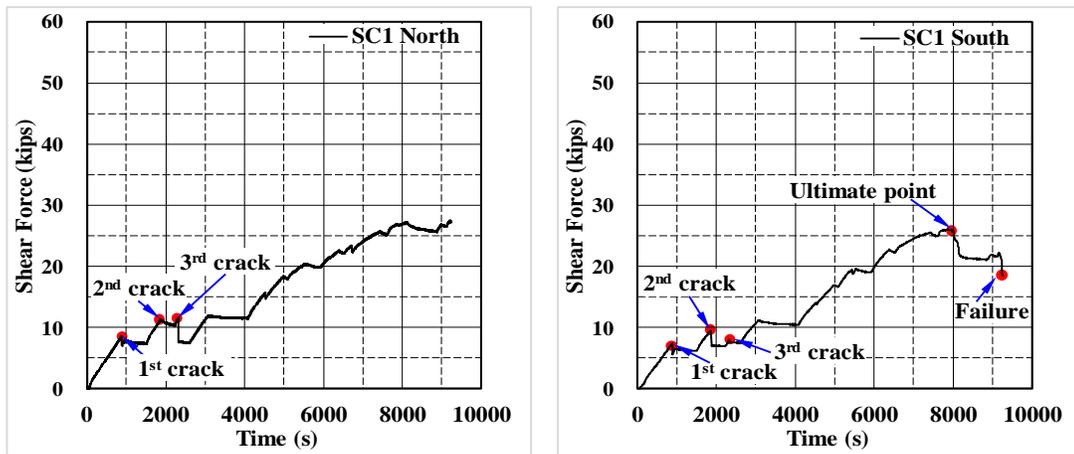
In both experiments, shear force for each beam at each side was measured. The curves of shear force vs. time for each test are shown in Figure 5-3 and Figure 5-4. According to the measured curves of shear force vs. time and visual check during loading, the statistic of crack damage and visible bond slips are shown in Table 5-1.

(a) SC1 north

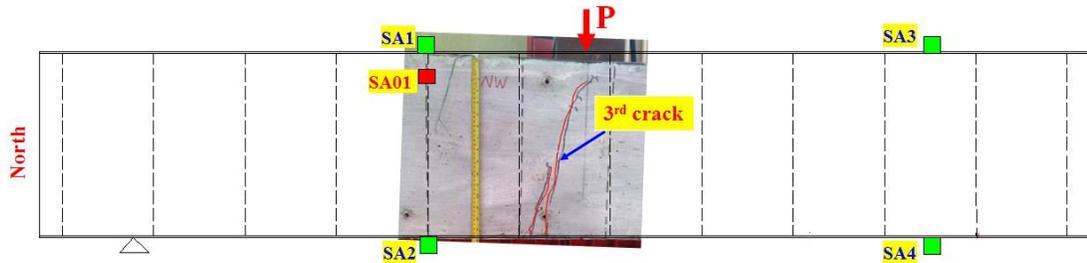
The loading test of SC1 lasted around 9000s. During the test, several cracks and bond slips were observed. Three major cracks occurred at the location shown in Figure 5-5 and Figure 5-6.

Figure 5-5 Details of crack on north side of SC1 after loading

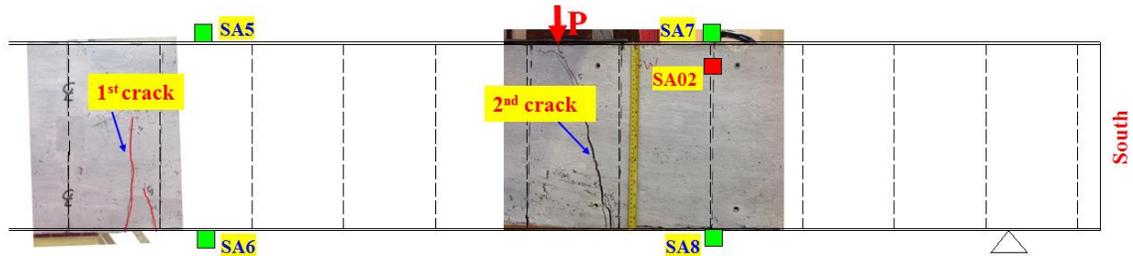
Figure 5-6 Details of cracks on south side of SC1 after loading

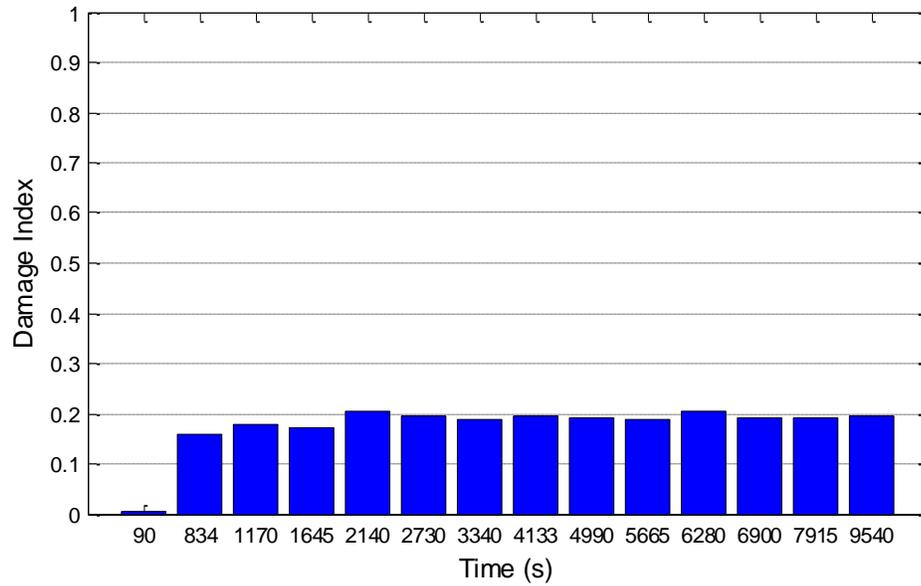
Since all major cracks occurred from the bottom of the beam, then developed to the top of the beam, no cracks happened between the path from the actuator SA01 to the sensor SA1. In addition, the bond slips between the steel plates and concrete all appeared between the bottom plate and concrete. Therefore, no cracks and bond slips happened in the stress wave path between the actuator SA01 to the sensor SA1. The damage index of SA1 is shown in Figure 5-7. It can be clearly found that, throughout the test, the values of damage index for SA1 are all small which means very little structural damage exists between SA01 and SA1.

Figure 5-7 Damage index of SA1 on north side of SC1

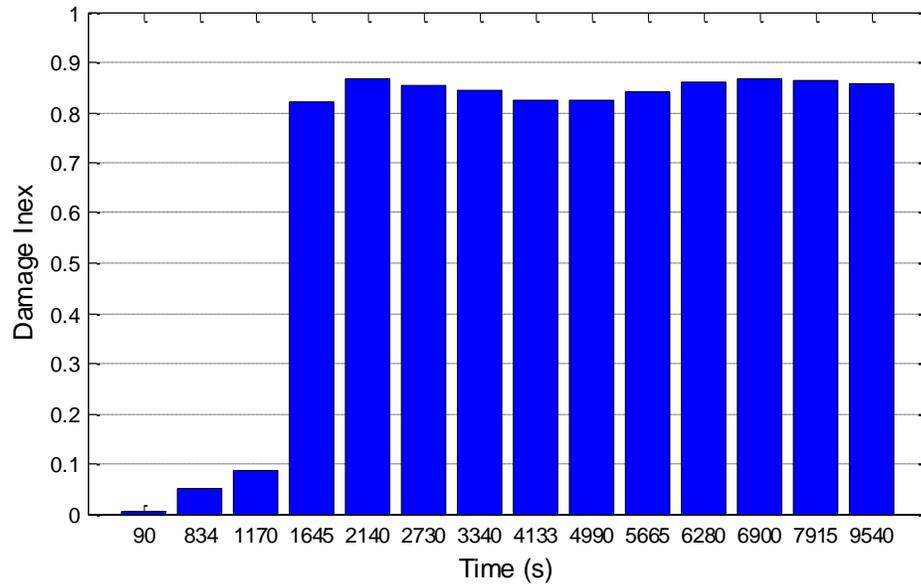
From 0s to 1170s, the values shown in the damage index are very small which means the SC1 is in a health state. Then, a great value change from 1170s to 1645s can be observed from the damage index of SA2, as shown in Figure 5-8. According to Figure 5-5, no cracks existed on the path between SA01 and SA2. Then, the received stress wave of SA2 was not affected by any cracks. A bond slip event was supposed to happen on the bottom of the steel plate on north side. After the measurement point at 1645s, the value of the damage index of SA2 slightly increases till to the end of the test. Therefore, a major bond slip on the north side occurred from 1170s to 1645s can be determined by the experimental results.

Figure 5-8 Damage index of SA2 on north side of SC1

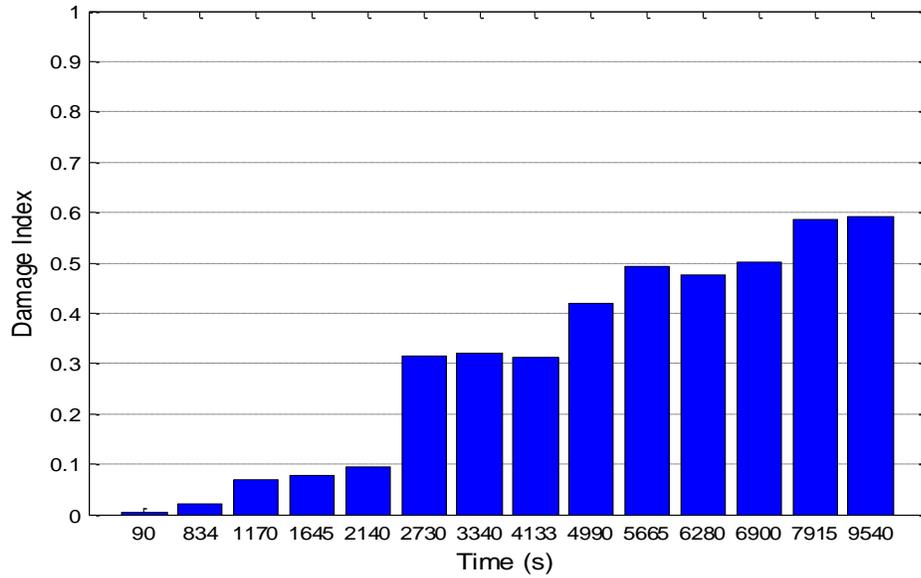
From the visual check, the 3rd crack on north side of SC1 occurred at 2320s. The 3rd crack is on the stress wave path between SA01 and SA3. The damage index of SA3 shown as Figure 5-9 successfully detects the event. From the damage index, the value of damage index at 2140s is 0.2, but jumps to 0.3 from the next measurement at 2730s. This period is exactly the moment that the 3rd crack happened. The 3rd crack opened from the bottom of the steel plate and then extended upwards to the top of the steel plate. The damage index of SA2 also successfully monitored that development of the 3rd crack from 2730s to the end of the test. The increasing value of the damage index indicates the severity of the 3rd crack. When the test was almost finished, the value of the damage index is approaching to 0.5 which is almost two times then the value when the 3rd crack was appeared.

Figure 5-9 Damage index of SA3 on north side of SC1

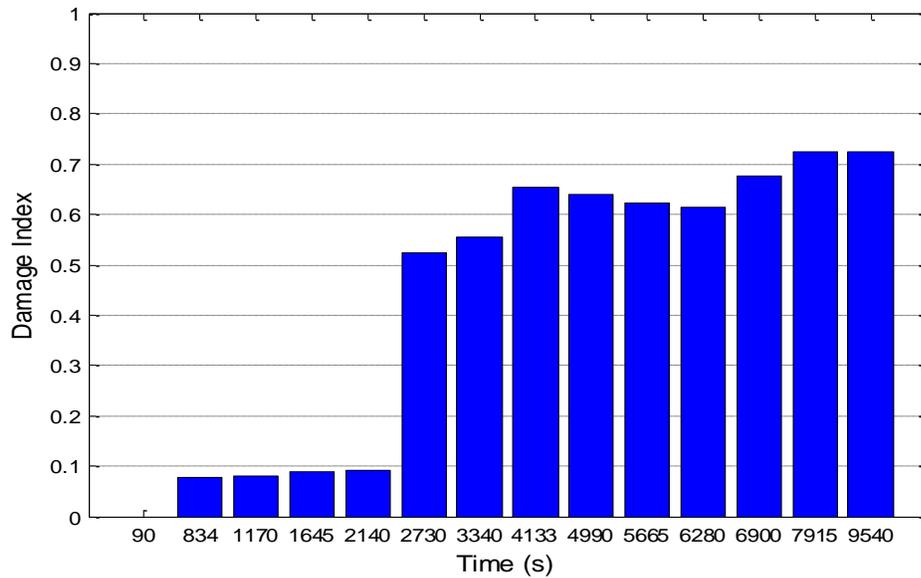
The same result of the 3rd crack detection can be found in damage index of SA4, as shown in Figure 5-10. An obvious increase of the damage index value is presented at point 2140s and 2730s. Different from SA3, the early 3rd crack mainly crossed the stress wave path between SA01 and SA4 which means more stress wave energy was attenuated between SA01 and SA4 than SA01 and SA3. The value of damage index for SA4 at 2730s is 0.5 which is much greater than 0.3 presented from SA3. In addition, since the subsequent development of the 3rd crack departed the stress wave path between SA01 and SA4, the damage index of SA4 cannot monitor the crack development. The rest values of damage index for SA4 increase only from 0.5 to 0.7. The reason of the increasing values of the damage index after 2730s is maybe from the increasing width of the crack as the loading progressing.

Figure 5-10 Damage index of SA4 on north side of SC1

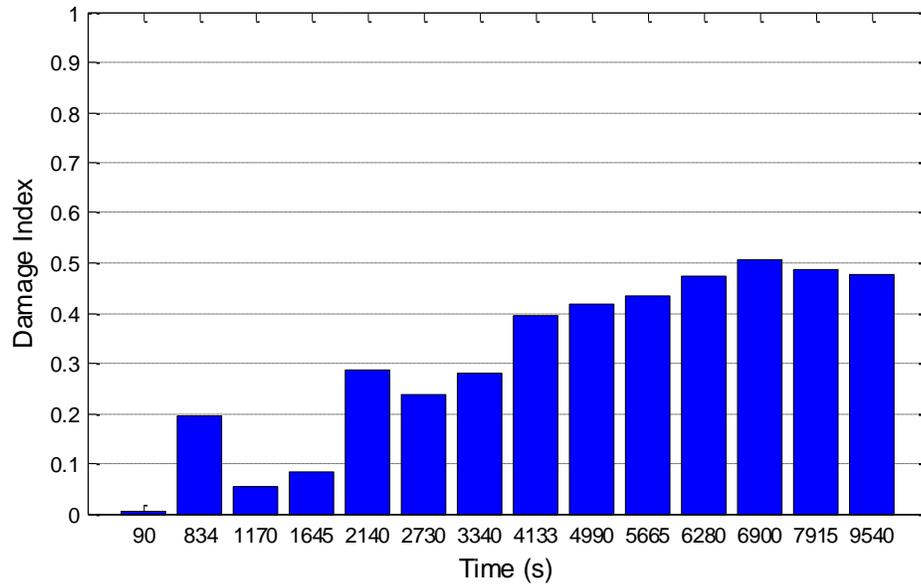
Figure 5-11 Damage index of SA5 on south side of SC1

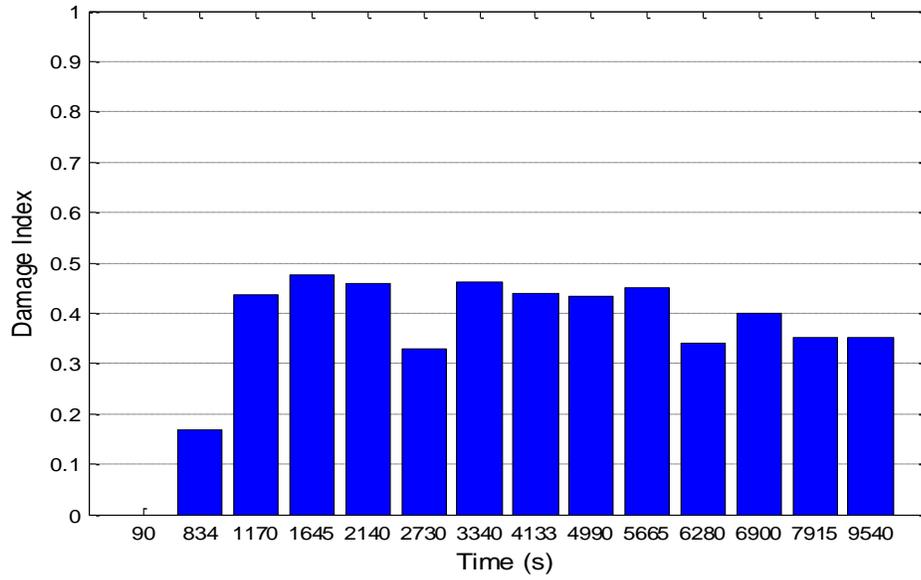
Figure 5-12 Damage index of SA6 on south side of SC1

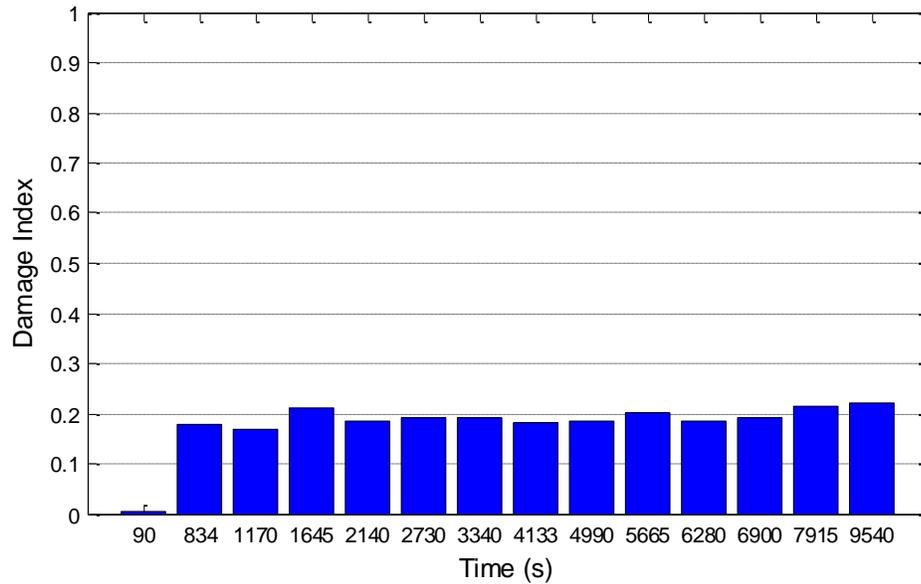
Figure 5-13 Damage index of SA7 on south side of SC1
