**INNOVATION IN PIEZOCERAMIC BASED STRUCTURAL HEALTH
MONITORING**

A Dissertation

the Faculty of the Department of Mechanical Engineering

University of Houston

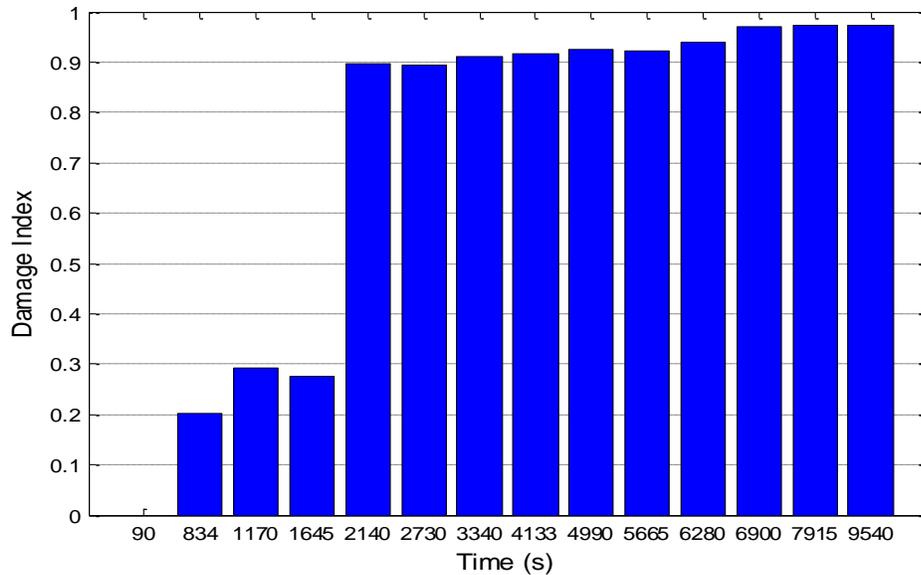
Figure 5-14 Damage index of SA8 on south side of SC1

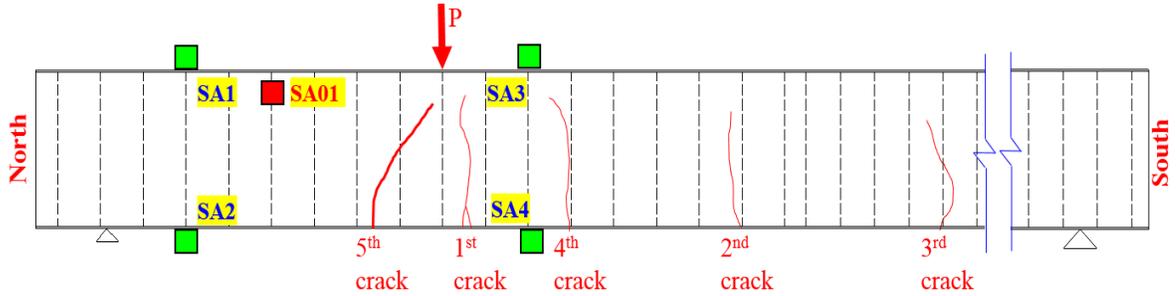
Figure 5-15 Details of crack on north side of SC4 after loading

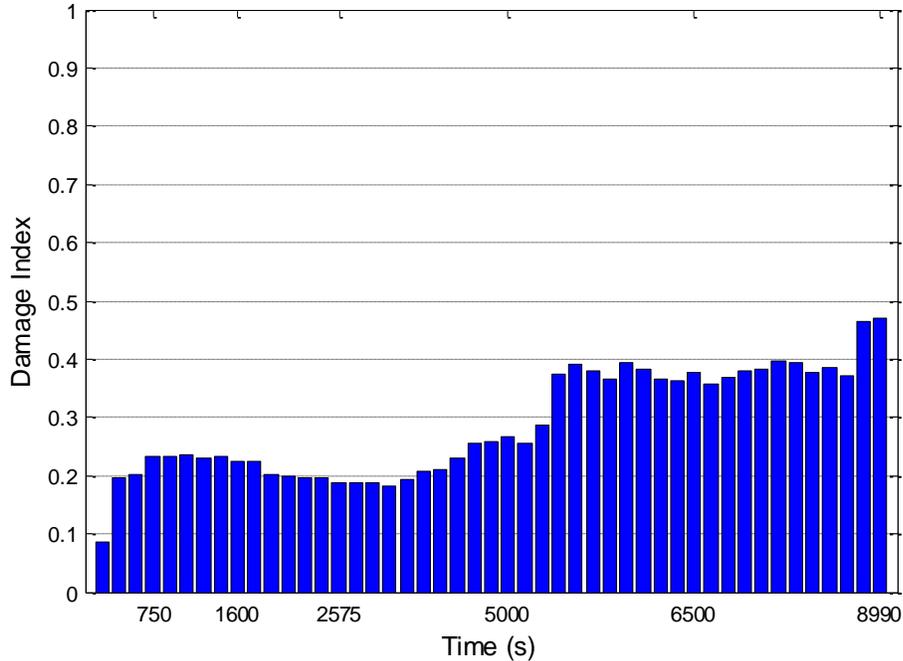
Figure 5-16 Damage index of SA1 on north side of SC4

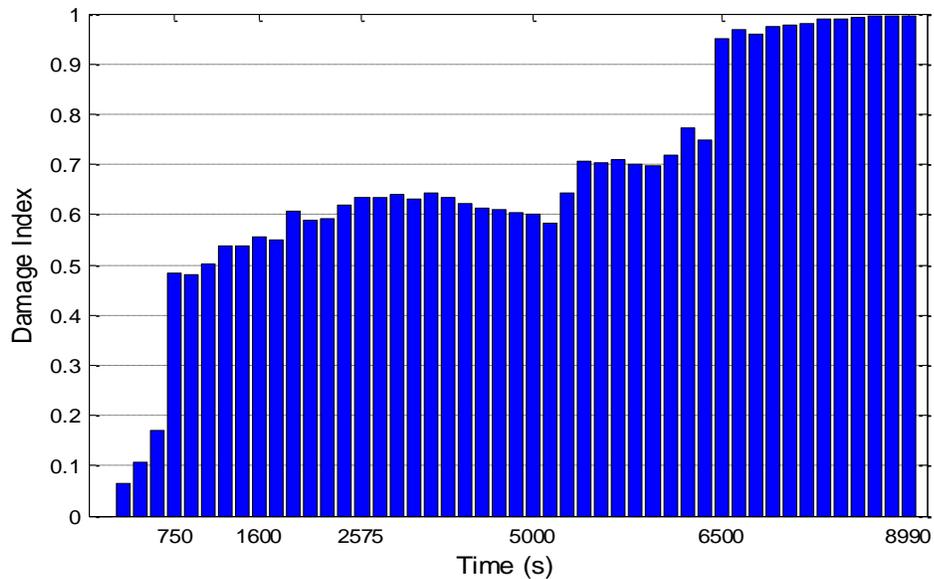
Figure 5-17 Damage index of SA2 on north side of SC4

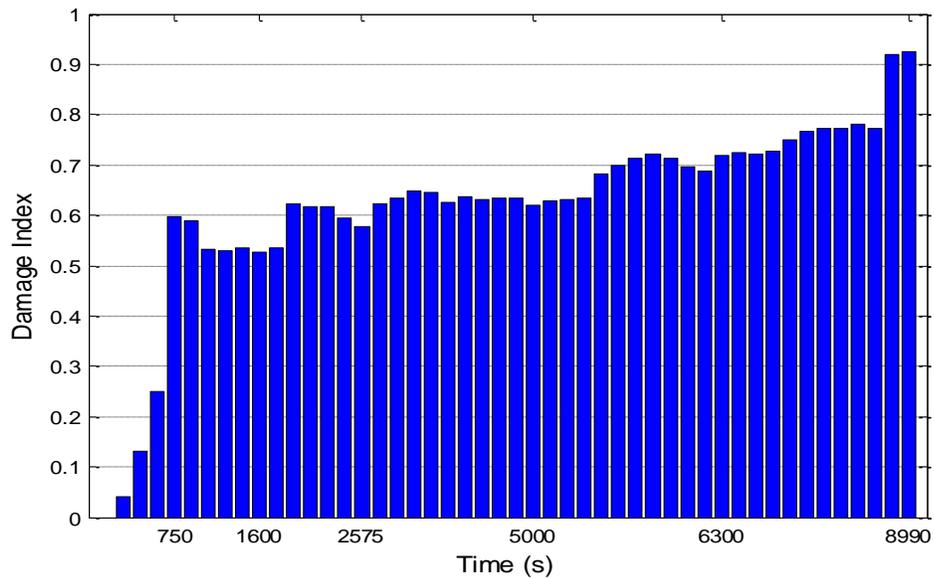
Figure 5-18 Damage index of SA3 on north side of SC4

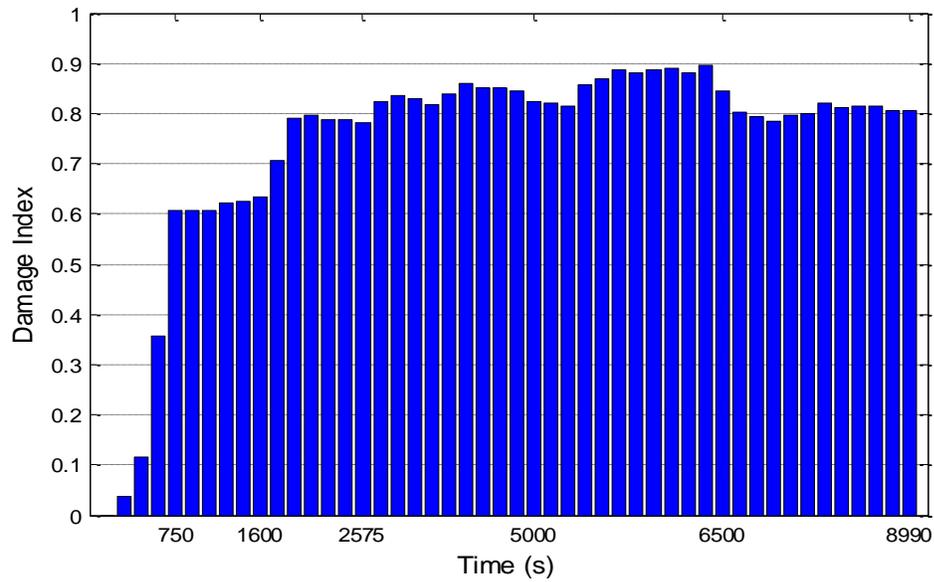
Figure 5-19 Damage index of SA4 on north side of SC4

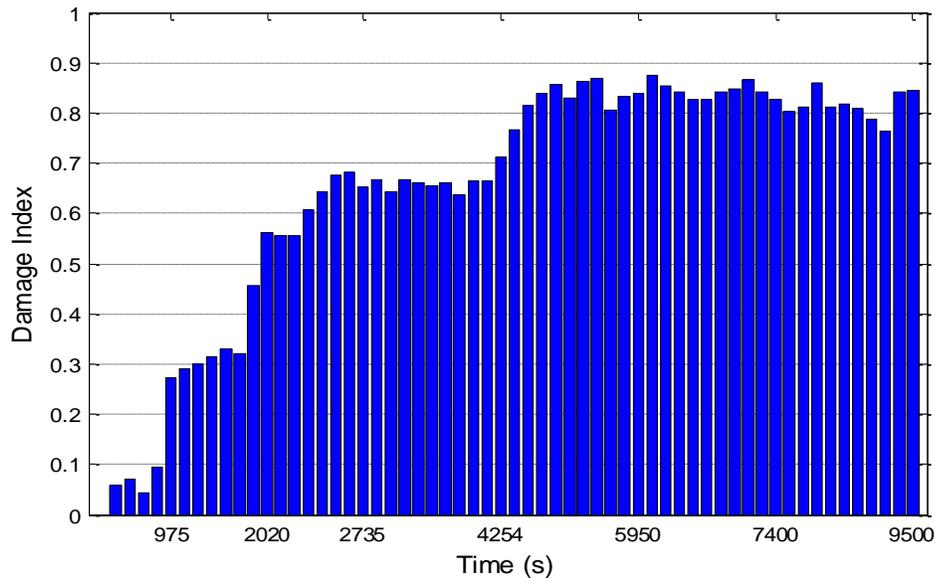
Figure 5-21 Damage index of SA5 on south side of SC4

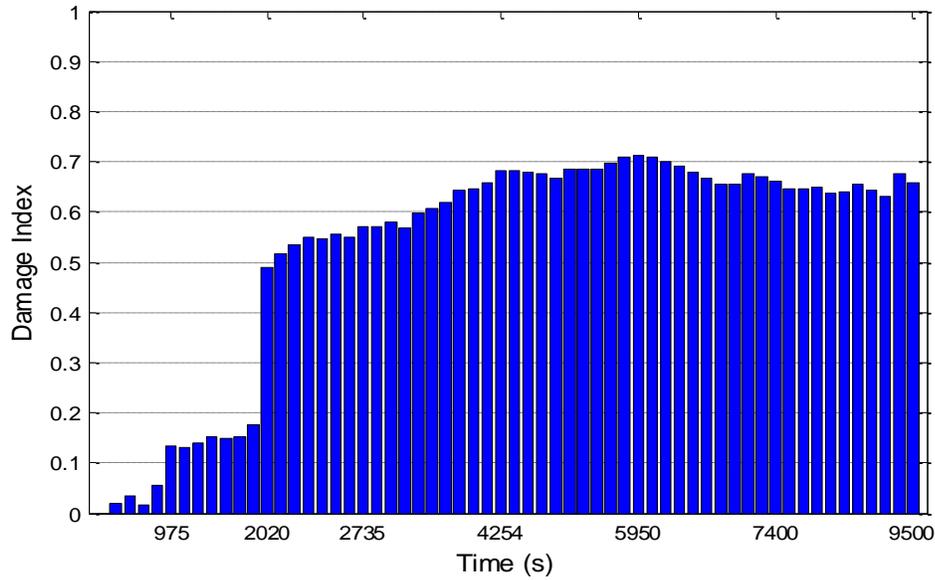
Figure 5-22 Damage index of SA6 on south side of SC4

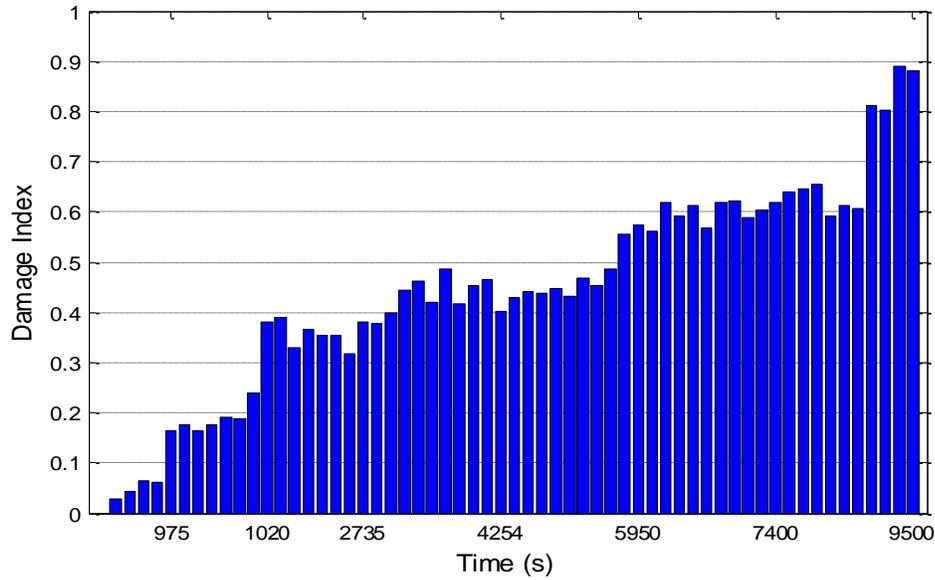
Figure 5-23 Damage index of SA8 on south side of SC4

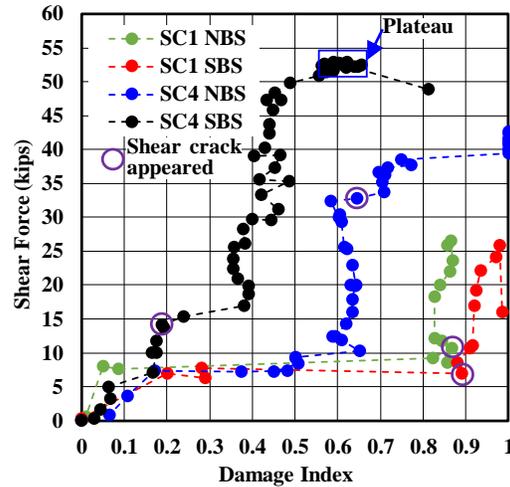
Fig. 1 Figure 5-24 Shear force vs. damage index of SC1 and SC4

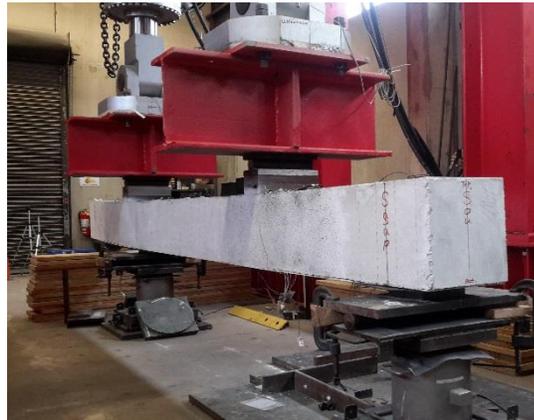
Figure 5-32 The loading actuators and the casted concrete beam of SC1

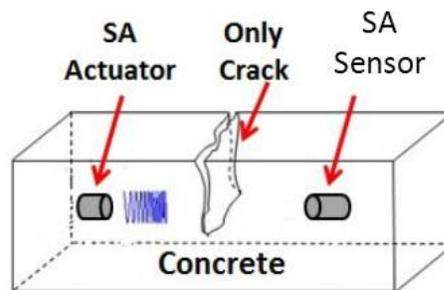
Figure 6-1 Schematic diagram of stress wave propagation through a concrete crack

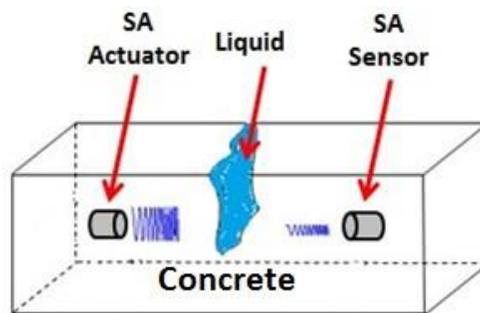
Figure 6-2 Diagram of stress wave propagation through a water filled concrete crack

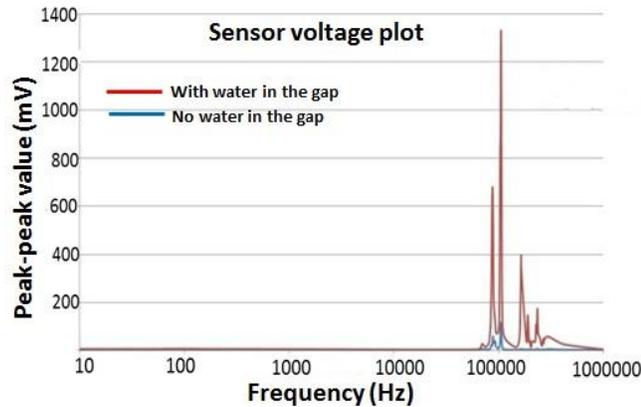
50 kHz-200 kHz. This test verified that the amplitudes of the sensor voltage were closely related to the crack and water between SAs.

Figure 6-4 Sensor voltage plot in two cases

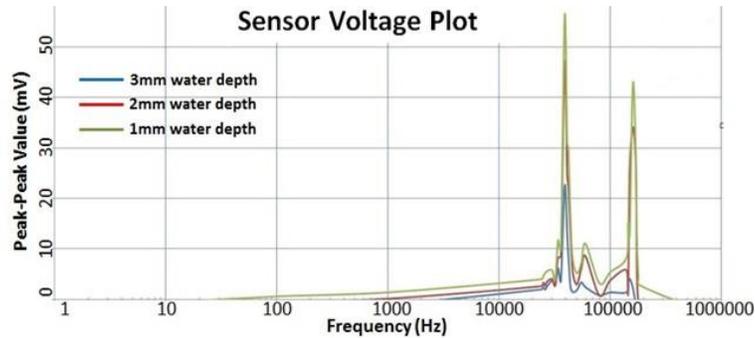
Figure 6-6 Sensor voltage plot in three cases

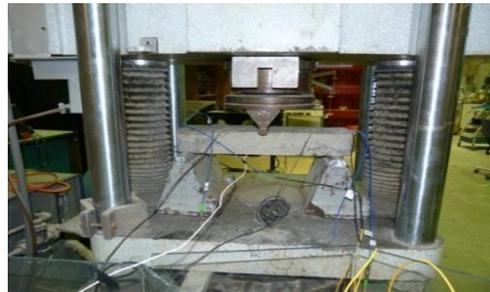
Figure 6-9 Experimental Setup of the loading process

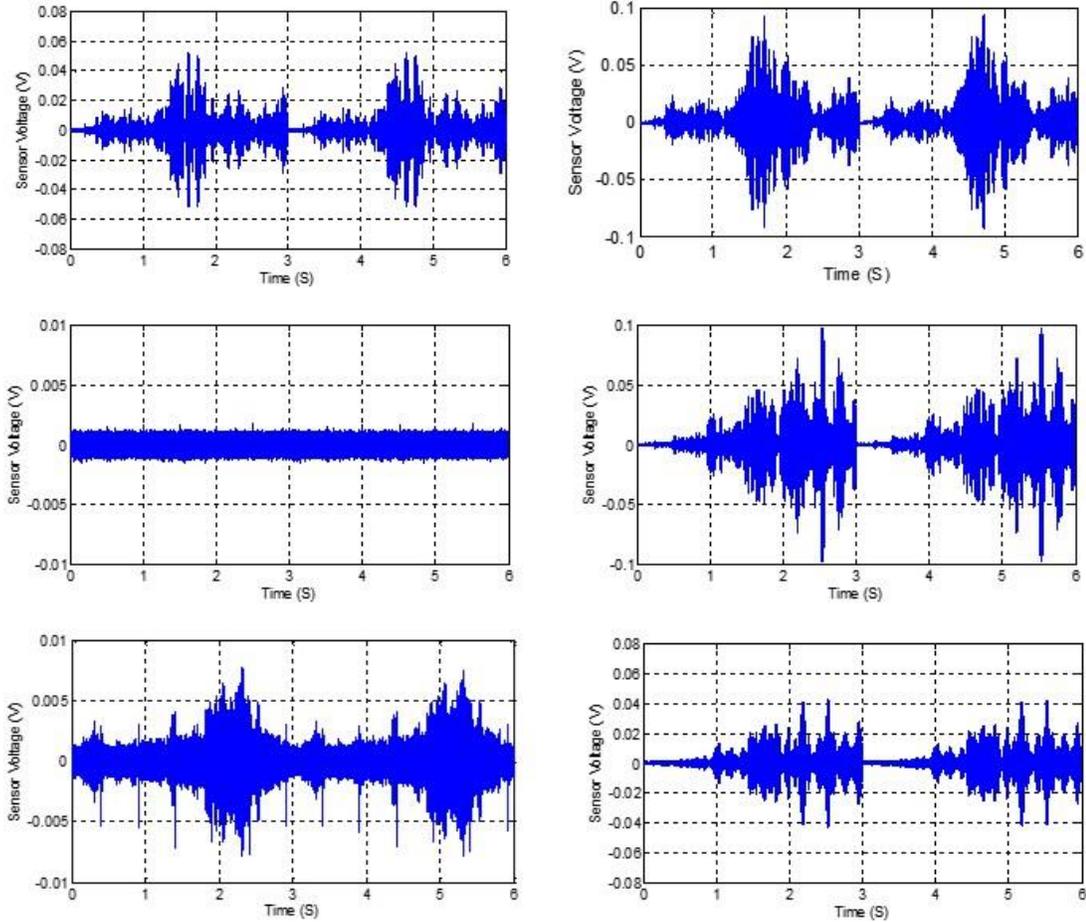
Figure 6-13 Sensor voltage graphic: (a): SA 1, no crack and no water; (b): SA 2, no crack and no water; (c): SA 1, with crack but no water; (d): SA 2, with crack but no water; (e): SA 1, with water in crack; (f): SA 2, with water in crack

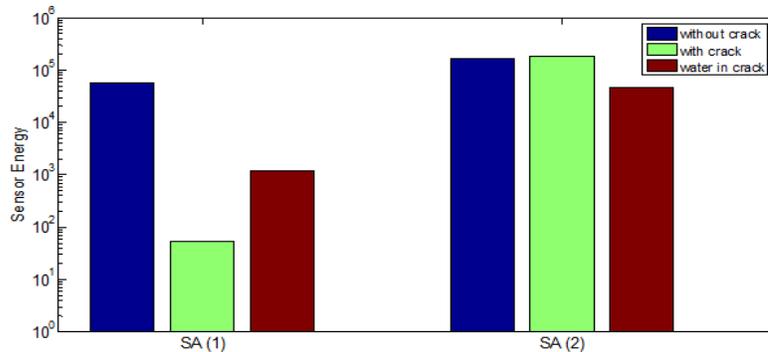
Figure 6-14 Sensor energy performance of SA (1) and SA (2) in three cases

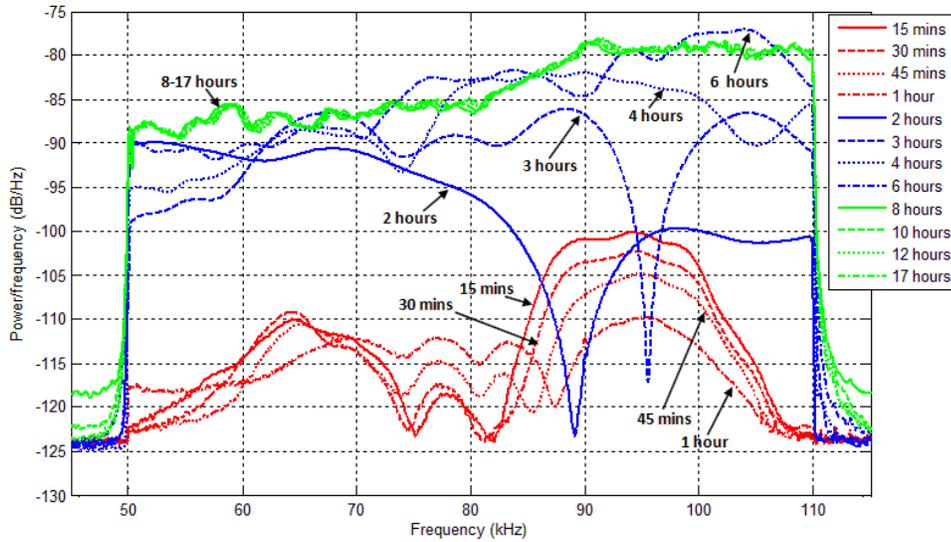
Figure 7-9 Frequency domain signal response during the concrete hydration

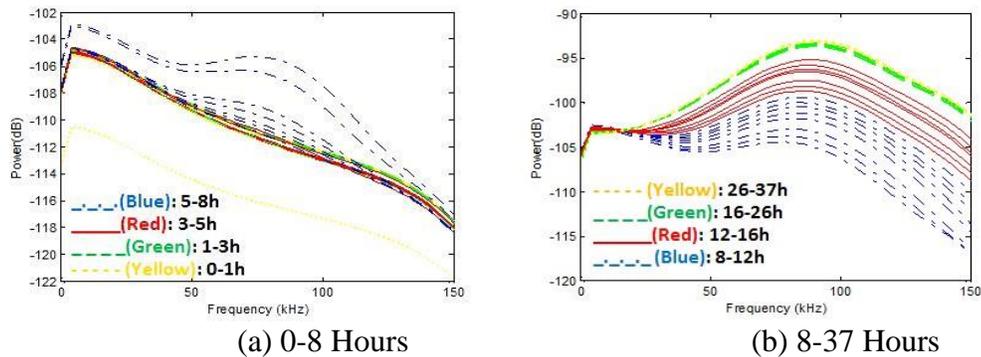
Figure 7-15 Power Spectrum Density of CMSA Sensor Signal during the entire concrete hydration process

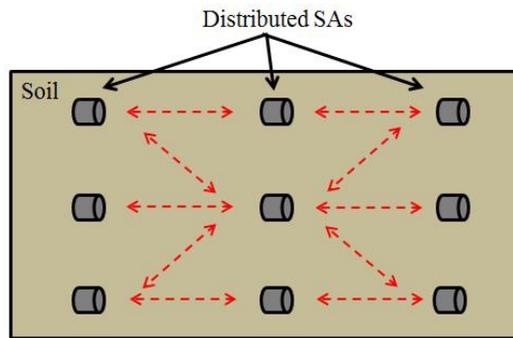
Figure 8-2 A proposed active sensing system with multiple smart aggregates for soil freeze-thaw monitoring

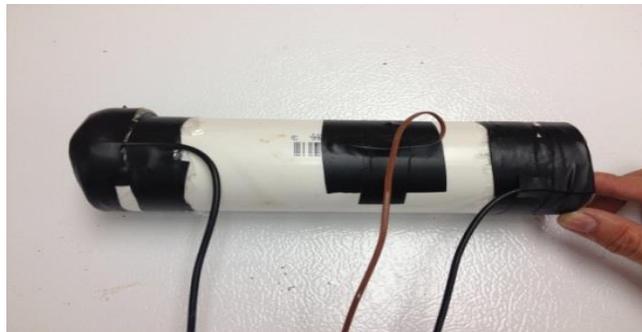
Figure 8-3 A photo of the test soil specimen with transducers

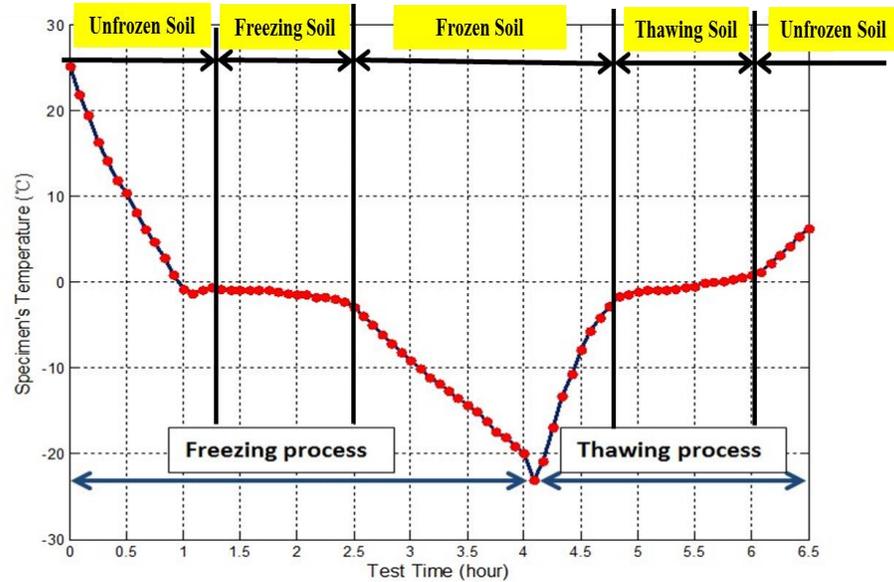
Figure 8-6 Specimen temperature monitoring during the freezing-thawing cycle

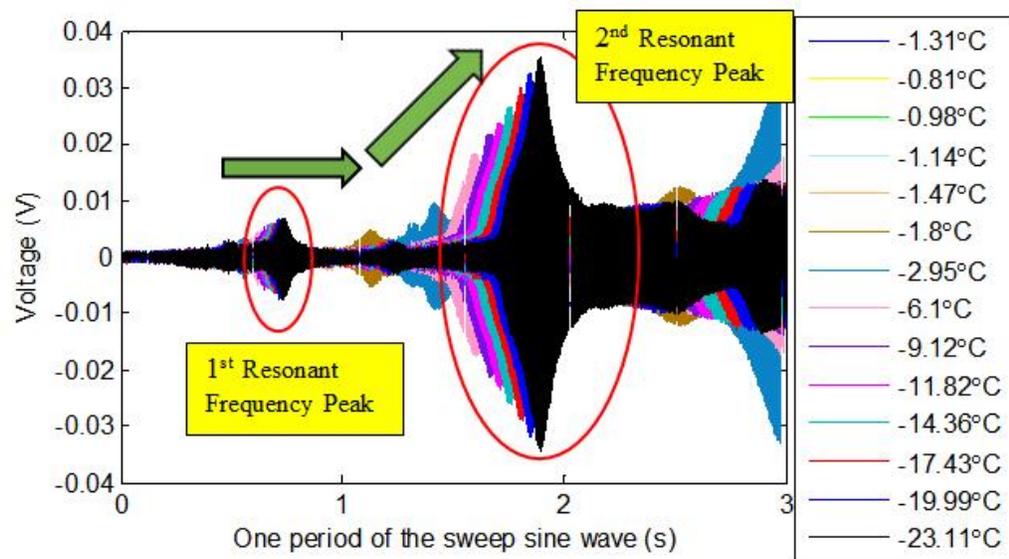
Figure 8-7 Signal recorded by the SA sensor during the freezing process

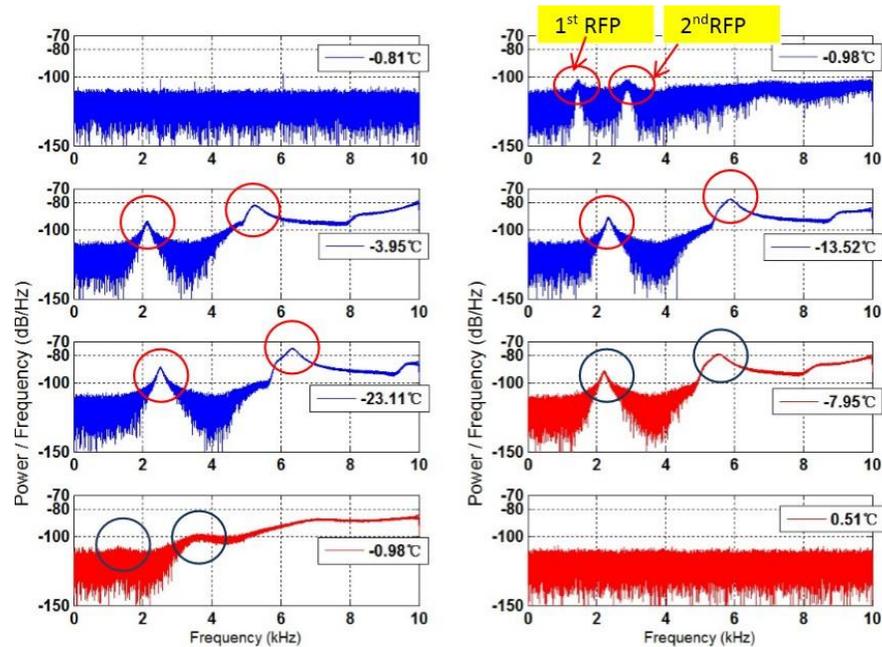
Figure 8-8 Power Spectrum Density at different soil temperature during the freeze-thaw cycle

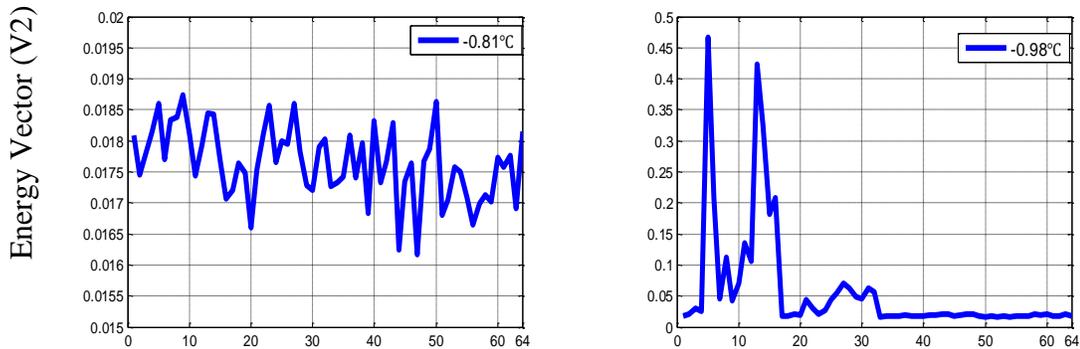
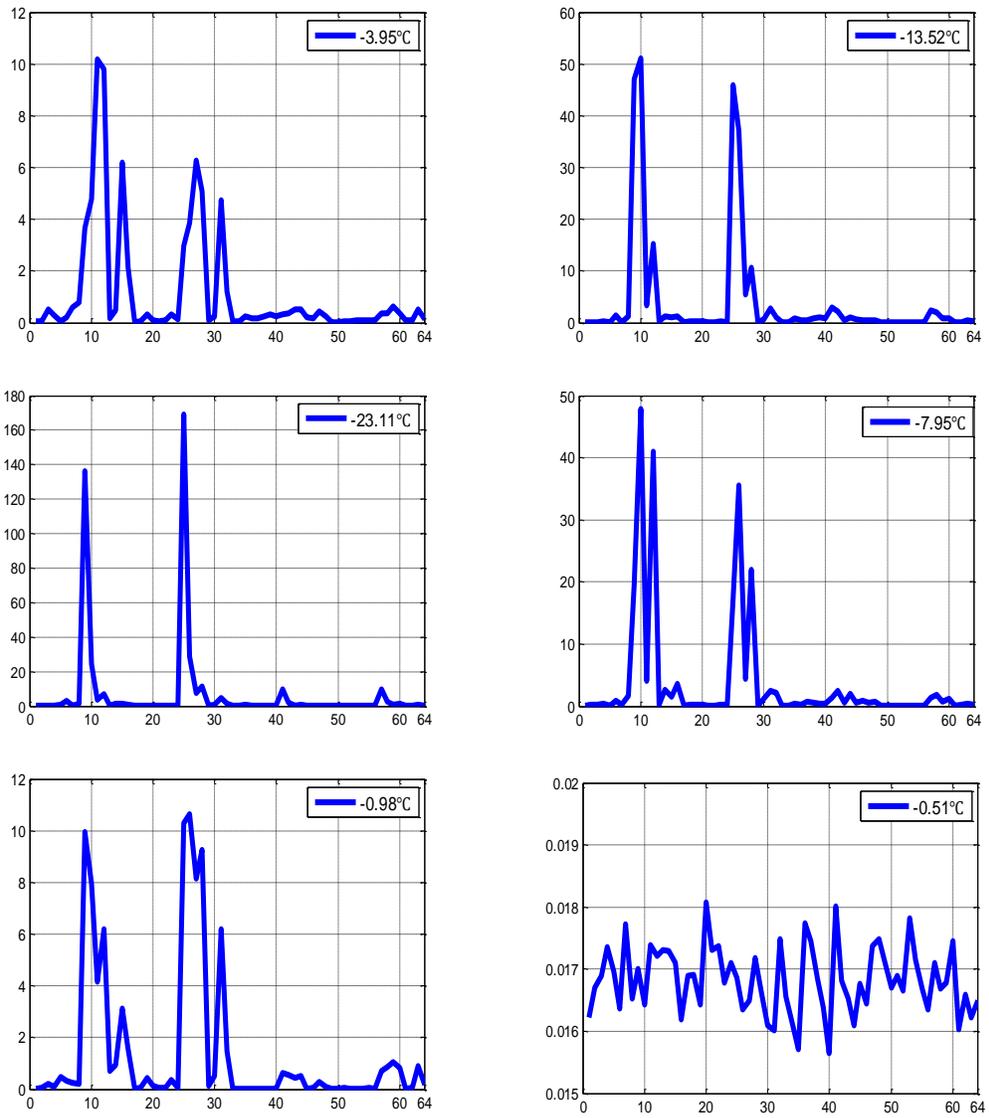
Figure 8-9 Energy vector plot in different freezing and thawing degrees

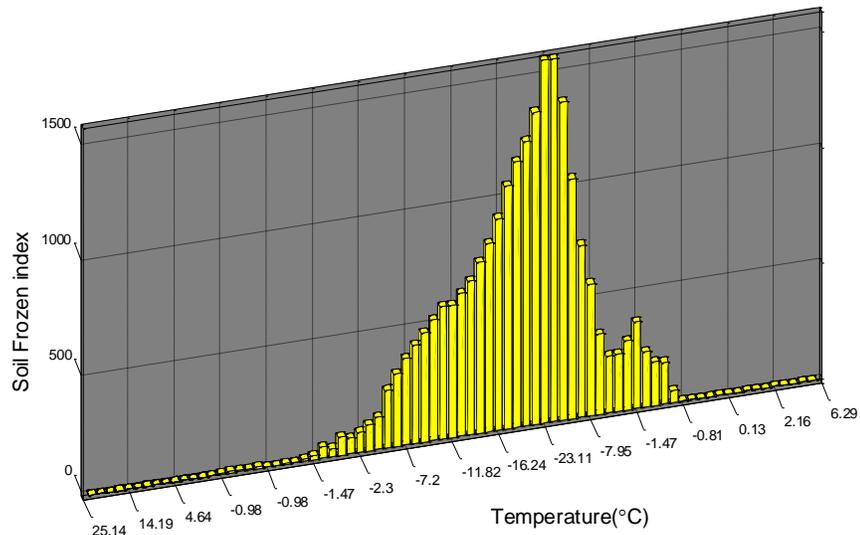
Figure 8-12 Wavelet packet-based soil frozen index

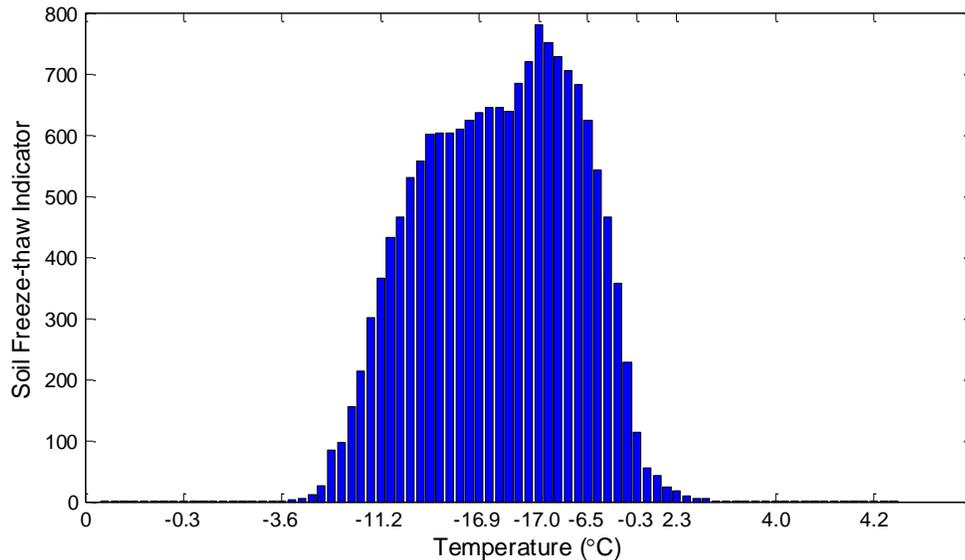
Figure 8-16 Wavelet packet based soil freeze-thaw status indicator

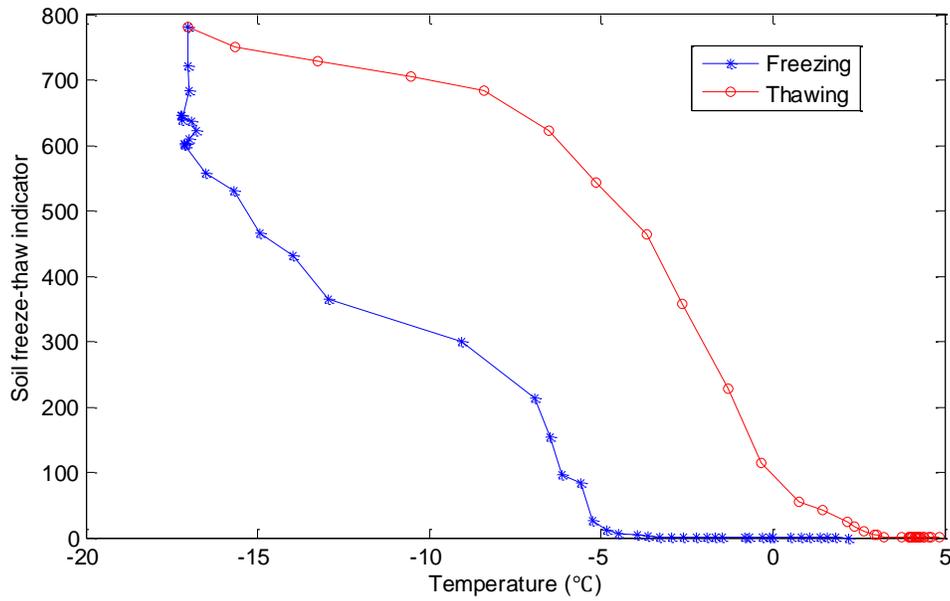
Figure 8-17 The hysteresis loop of freeze-thaw status indicator vs. temperature
