Analyzing the Effects of Hurricane Harvey on Dune Morphology and Coastline Loss  
Using Terrestrial Laser Scanning: A Case Study at Bryan Beach, Texas

A thesis submitted to the Department of Earth and Atmospheric Sciences  
College of Natural Science and Mathematics  
in partial fulfillment of the requirements for the degree of

University of Houston

May 2020

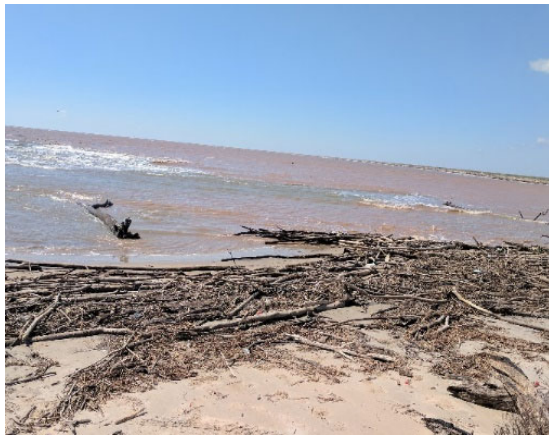
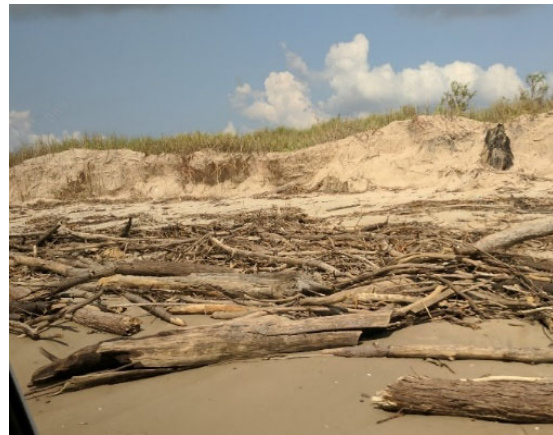
*Figure 3: Pictures of Bryan Beach Taken on September 9, 2017. A red tide was visible in the delta, indicating algal growth from sediments deposited in the subaqueous delta.*

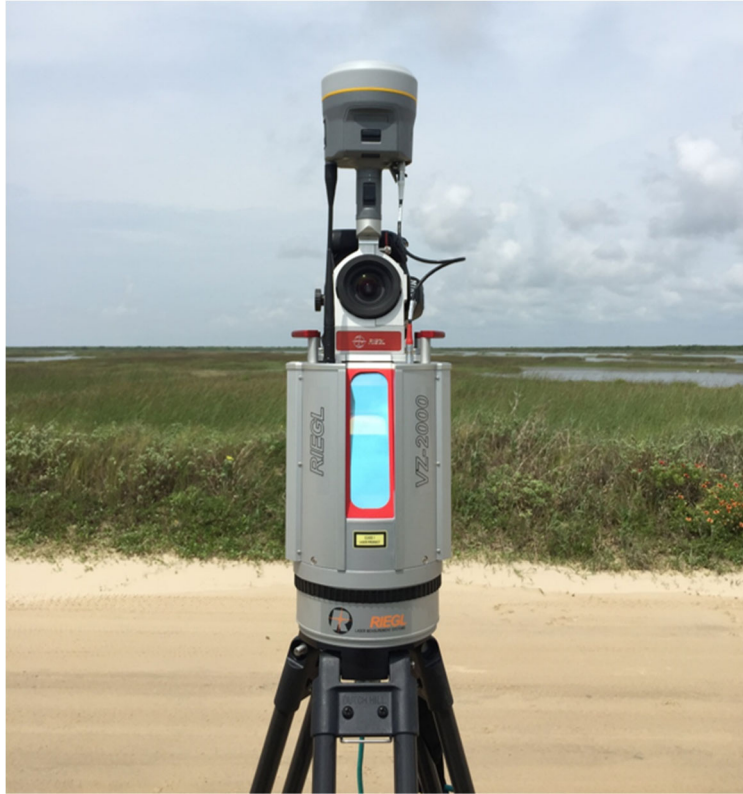
*Figure 6: TLS and GPS Integrated Setup. A Trimble R10 RTK GPS was mounted atop a Riegl VZ 2000 Terrestrial Laser Scanner (TLS). The GPS measures the scanner's own position (SOP) in UTM Zone 15N referenced to the NAD 83 Ellipsoid.*

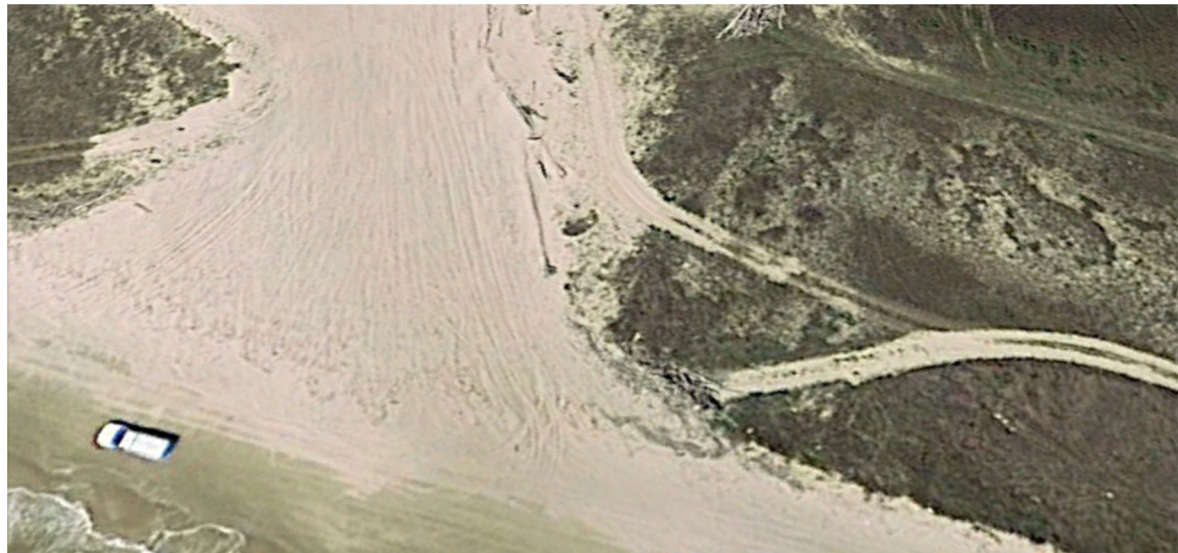
*Figure 7: (a) Dune Blowout at Bryan Beach Located Approximately 0.6 km Northeast from the Brazos River Delta. (b) Cloud-to-cloud (C2C) Image of Dune Blowout. (c) Showing erosion between May 09, 2017, and September 9, 2017. The erosion at the dune base indicates that dune scarping occurred during Hurricane Harvey in this area.*

As discussed above, the continuity of beach dunes has a significant effect on their long-term survival. Large breaches in the dunes can have a deteriorating effect on dunes by exposing more surface areas to erosive forces. Figure **7** shows a C2C distance measurement taken of Site A between May 2017 and September 2017. The figure clearly shows that the dune base and dune gap experienced the most erosion from Hurricane Harvey.

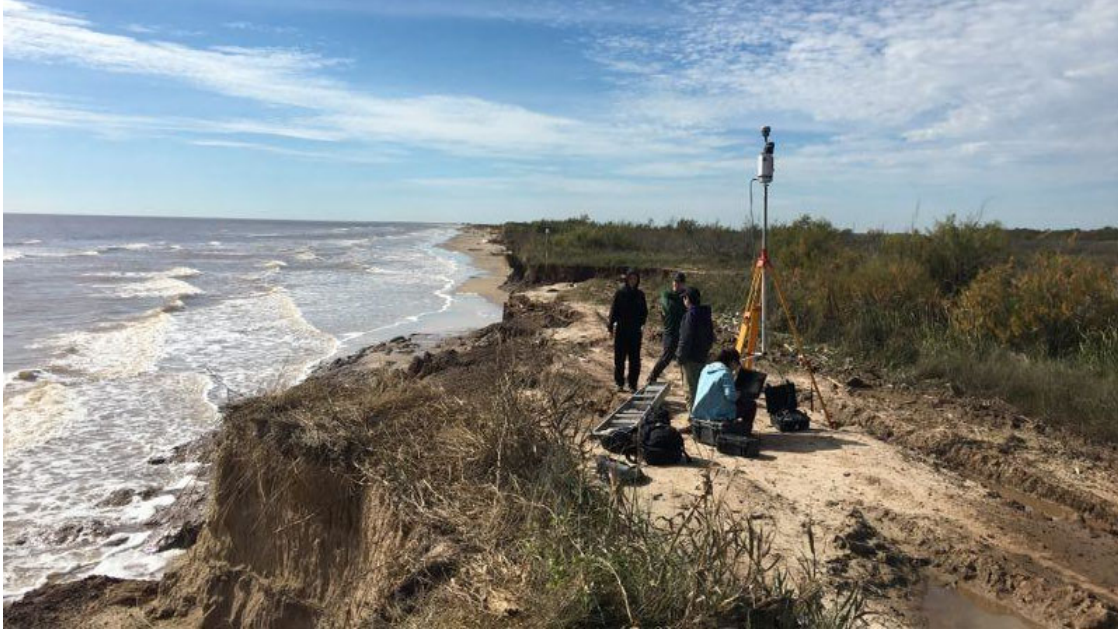
*Figure 11: TLS Tripod Setup at Bryan Beach Near Freeport, Texas. The Riegl VZ 2000 TLS is elevated several meters atop a tripod to ensure a clear line of sight over the beach dune crest.*

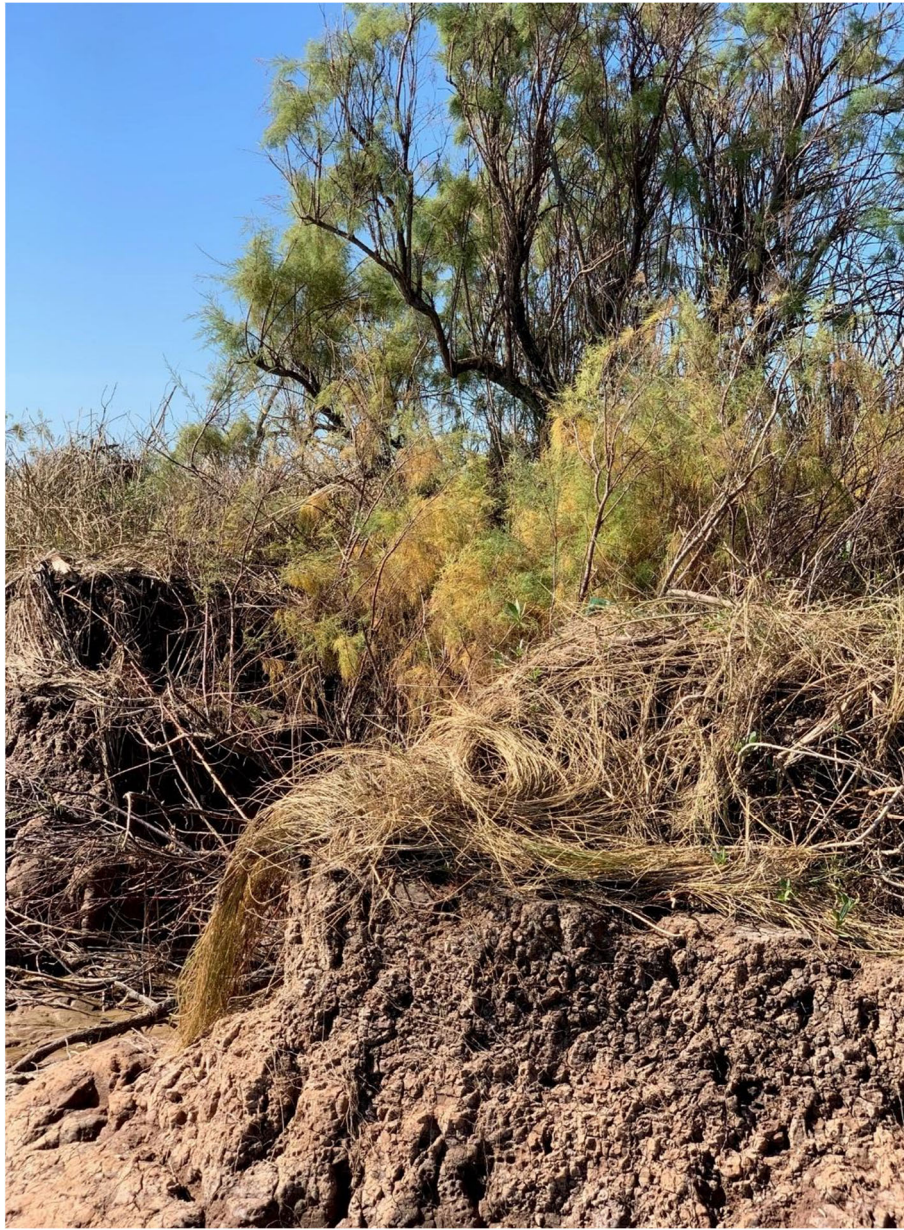
*Figure 14: Pine trees Planted during the 2014–2016 Beach Replenishment. Pine trees were artificially planted during the last replenishment program. The pine trees have reinforced the dunes but are also acting similarly to a seawall. The tree roots do not allow dune retreat to compensate for sea-level rise. Photo taken December 12,*

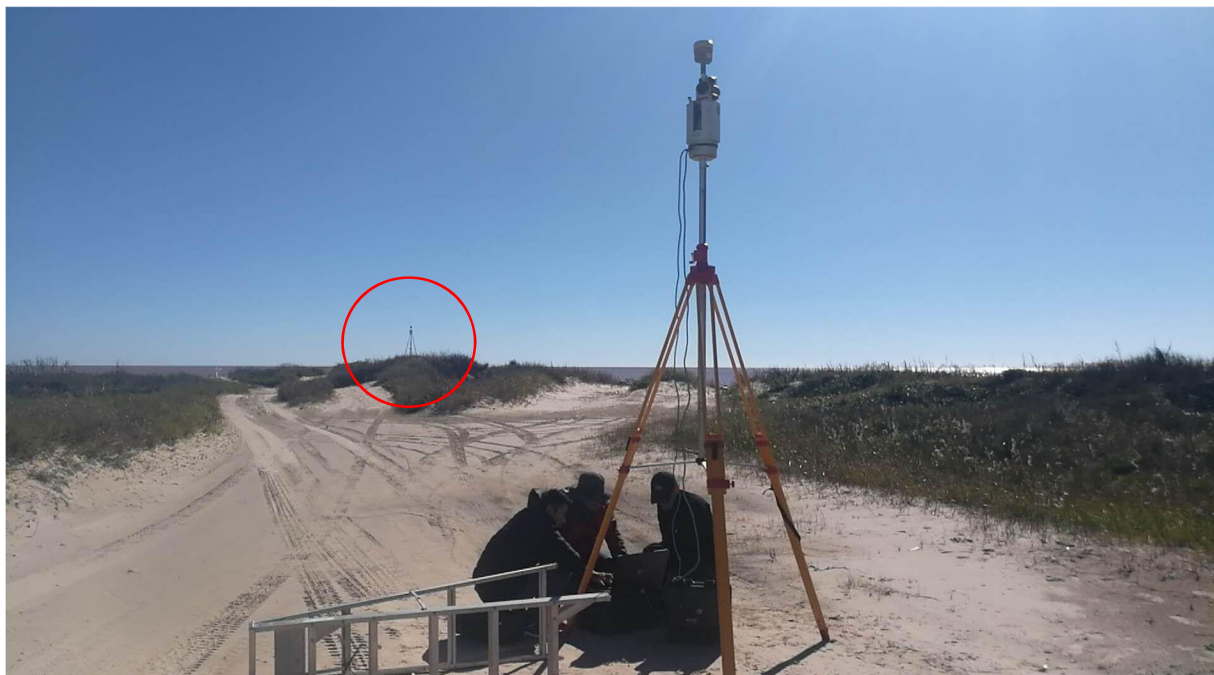
*Figure 15: Terrestrial Laser Scanner (TLS) Setup with Reflector. The TLS is set up atop a tripod and a reflector (circled) is placed at a distance. The TLS measures the reflector location, and the recorded coordinate is used as a tiepoint to combine each scan using the scanner's own position (SOP).*

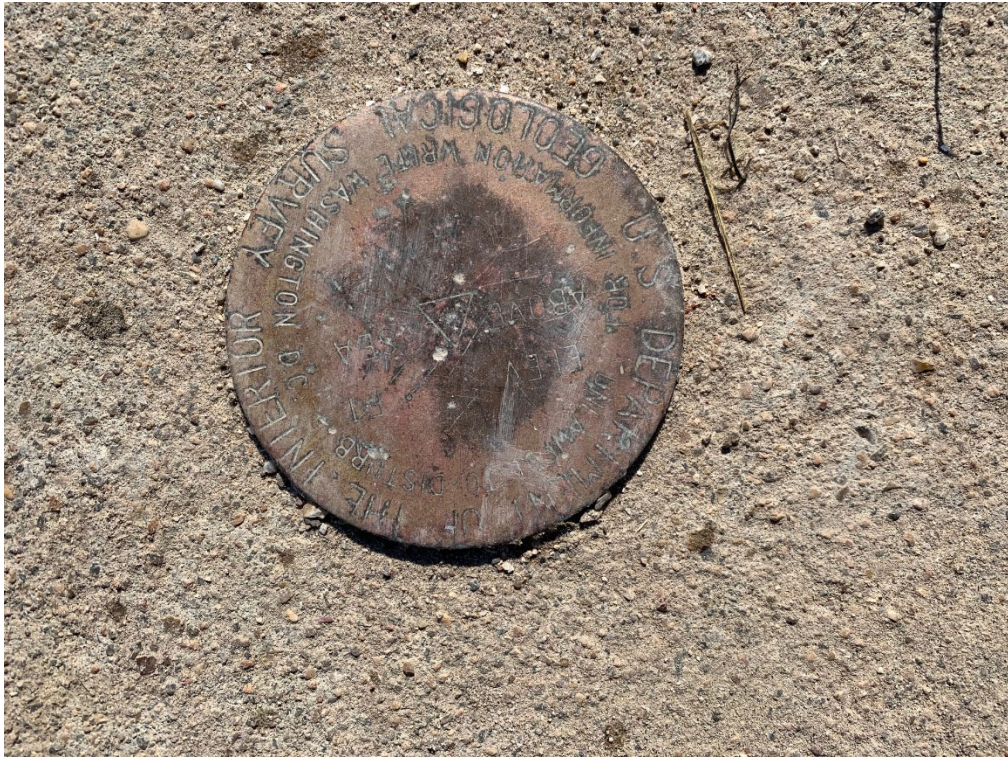
*Figure 20: National Geodetic Survey Marker at Bryan Beach, Texas. Location was measured over several hours with a Trimble R9 GPS.*

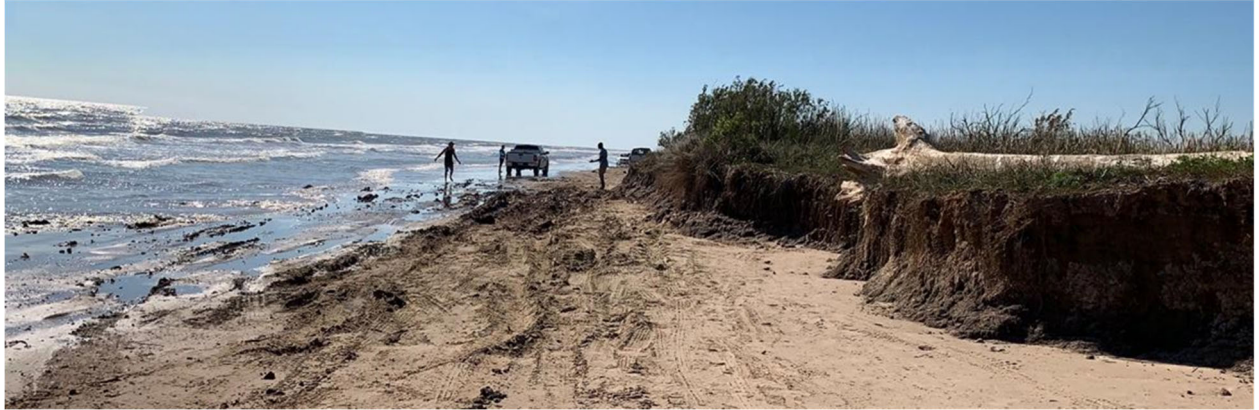
*Figure 24: Site A during High Tide. During high tide, the swash zone reaches the dune toe of the reinforced dune, indicated by the red arrow. The loss of sand exposes the underlying clay. Vehicles often become trapped in the mud, and removing the vehicle further damages the beach front. Picture taken December 14, 2019.*

During high tide, water covers almost the entirety of the beachfront past point A. Beach swash now directly hits up against the vertical dunes, causing a collision regime (Morton and Mckenna, 1999). A collision regime can be detrimental to a dune system and may cause dune scarping. Moreover, when the high tide covers the beachfront, it erodes sand and exposes the underlying clay, causing vehicles to become stuck, which in turn results in further damage to the beachfront from the vehicles (Figure **23**). Figure **25a** shows a photo of Site A taken on May 16, 2014. The dune line here is relatively continuous, as opposed to the dune line captured by March 3, 2018 photos (Figure **24b**, **24c**). Looking at the beach further in the past, when Hurricane Ike affected the Texas Coast in 2008, we can see that a large section of the dune was pushed back. We observe that the ridgeline, however, appeared to move very little, if at all, suggesting that this region is more resilient against wave forces (Figure **25**).

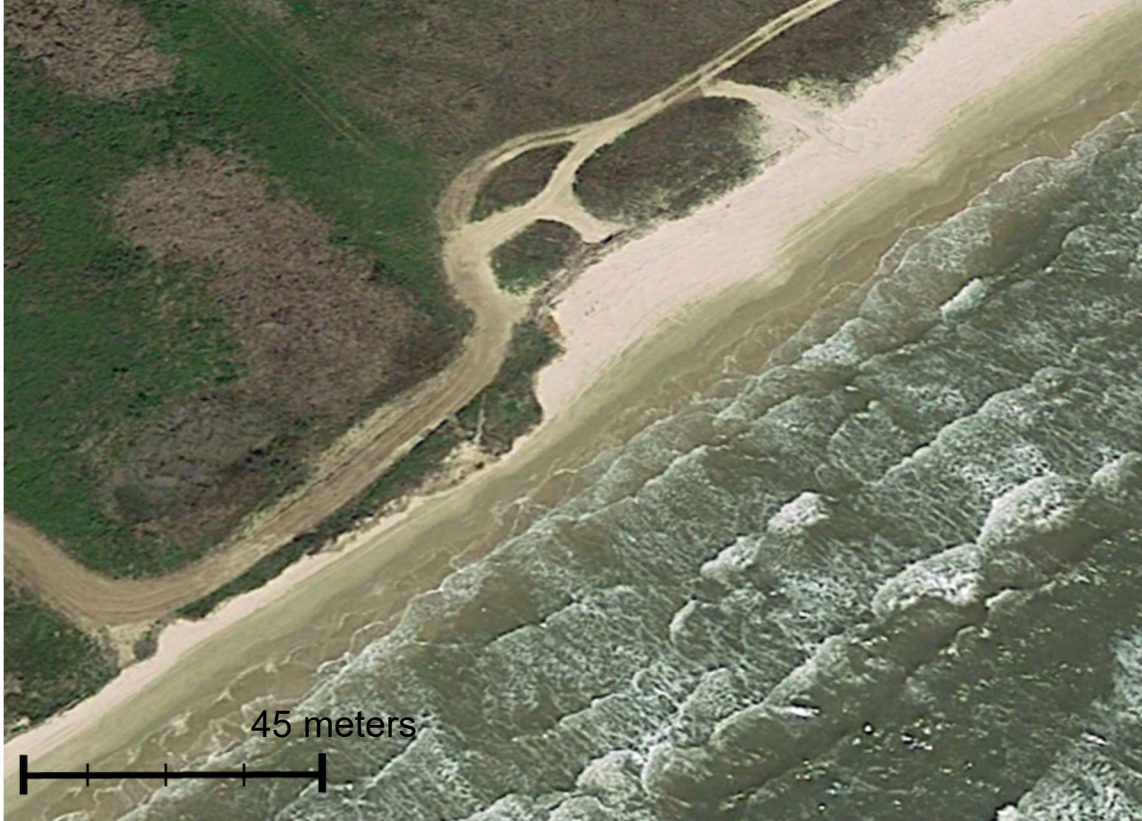
*Figure 26: Site A, Aerial View, March 23, 2018. Site A is characterized by artificially planted pine trees that were planted during a beach replenishment program between November 12, 2014, and March 14, 2016 (Texas General Land Office, 2015). The trees act similarly to a sea wall, preventing landward migration of the dune in response to coastline loss, which results in narrowing of the beachfront. Imagery from Google Earth Pro.*

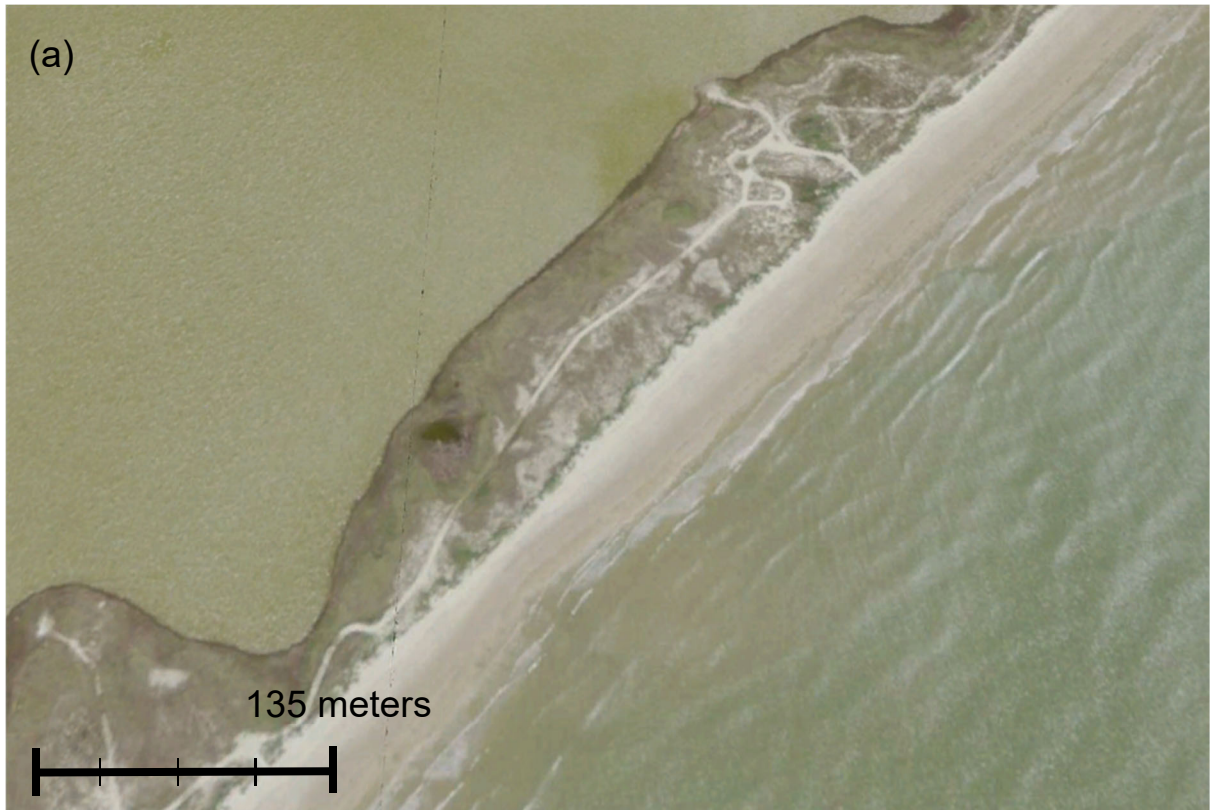
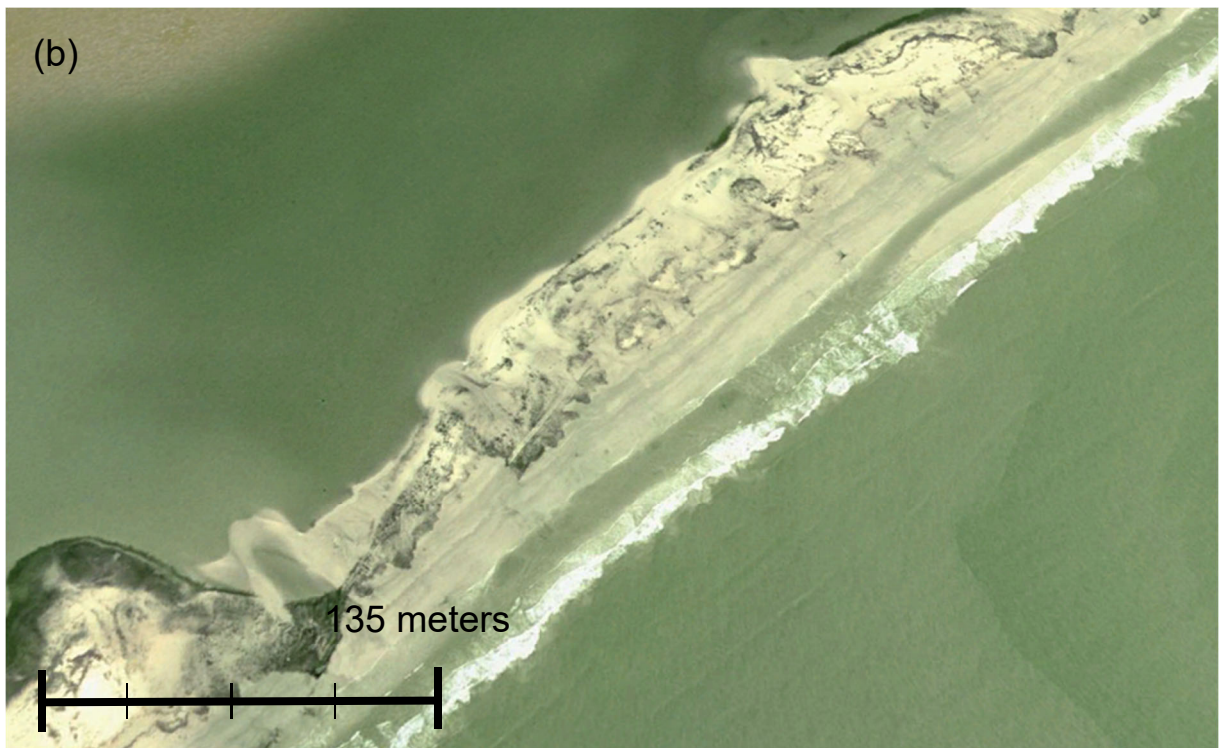
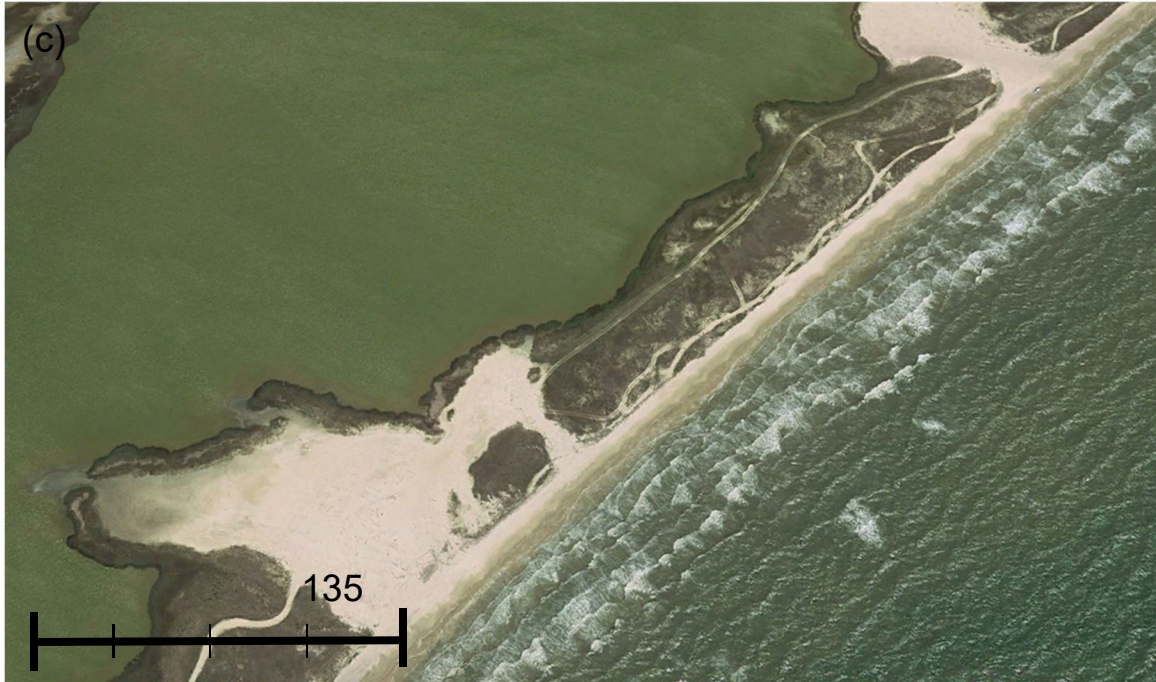
*Figure 28: Site B, Aerial Photographs, Chronological Series. (a) Site B on September 4, 2008. (b) Site B on September 14, 2008. (c) Site B on March 22, 2018. Hurricane Ike made landfall at Galveston, Texas, near Freeport on September 13, 2008, and caused dune damage that was exacerbated by coastline loss and dune erosion. Breached dunes are more vulnerable to the effects of tidal forces and wind erosion.*

Ike was a powerful category 4 hurricane, and this area appears to have recovered little by February 16, 2010. As discussed in Morton and McKenna (2014), long-term beach recovery can take up to 10 years, so it is likely that the damage observed is partly left over from Hurricane Ike's impact and that the area was still in the process of recovering in February 2014. Our team's TLS LIDAR records began in 2014; hence, we must rely on photos to assess any damage that was caused by Hurricane Ike. Moving forward to 2016, the dune line at Site A appears to have separated further, because the dune blowout continues to increase in size.

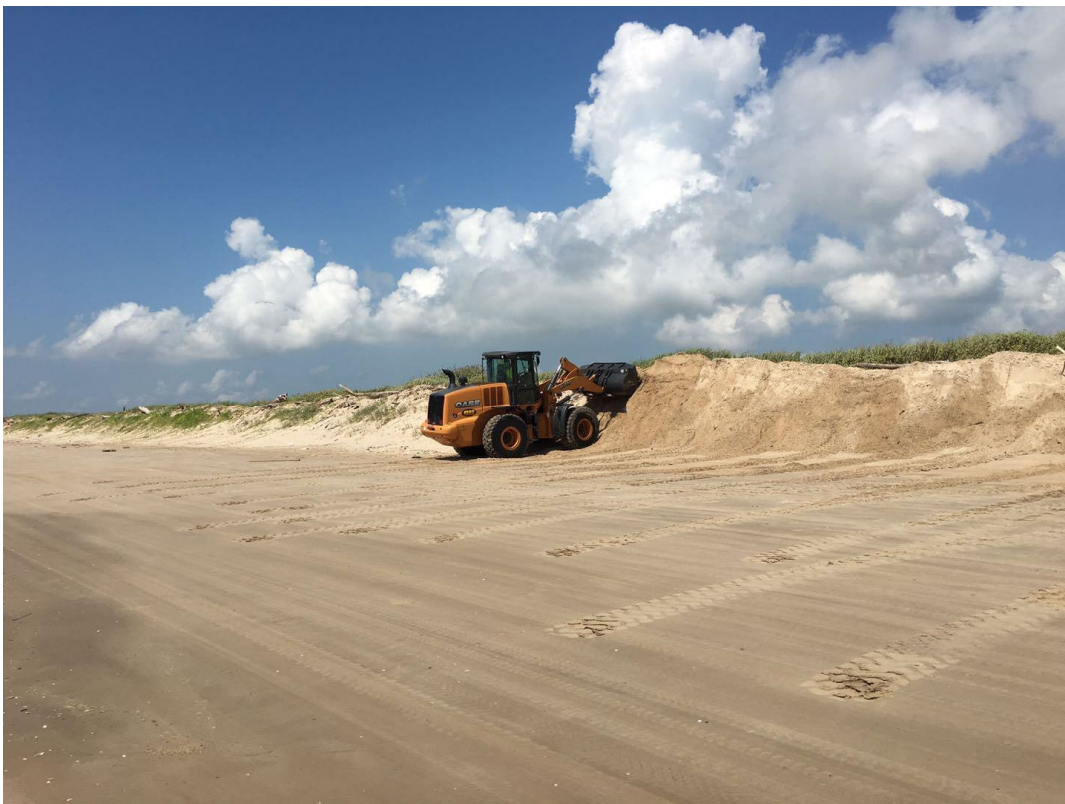
*Figure 51: Bulldozing at Bryan Beach Near Freeport, Texas. The bulldozing widens the beachfront..*

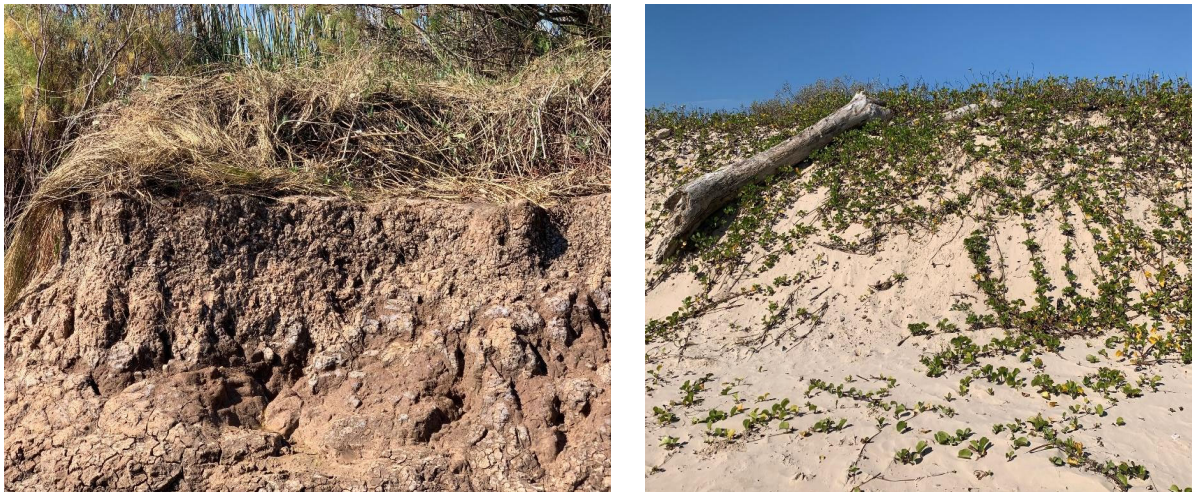
*Figure 53: Contrast between Site A Dunes and Dunes Close to the Beach Entrance Near the Quintana Jet*

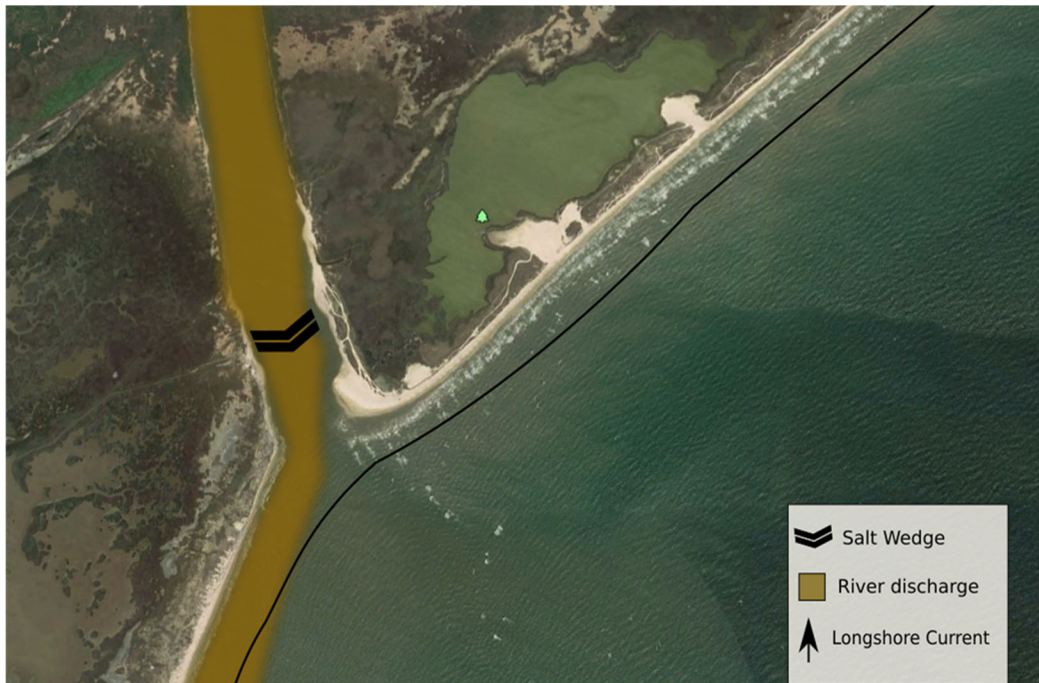
*Figure 56: Diagram Illustrating Salt-wedge Formation in the Brazos River Delta. Low river discharge causes a salt wedge to form at the Brazos Delta. The slowdown of sediment at the density boundary of the wedge allows the longshore drift to dominate and deposit sediment on the left flank of the delta (imagery from Google Earth Pro).*
