DETECTION AND QUANTIFICATION OF STEEL AND COMPOSITE  
CORROSION WITH SMART CEMENT AND POLYMER  
COATING MATERIALS

A Dissertation

University of Houston

December 2016

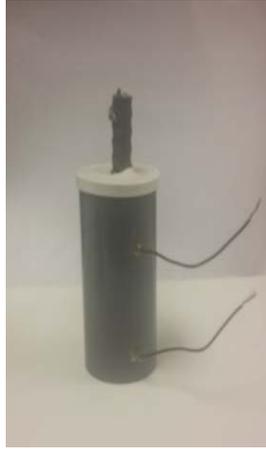
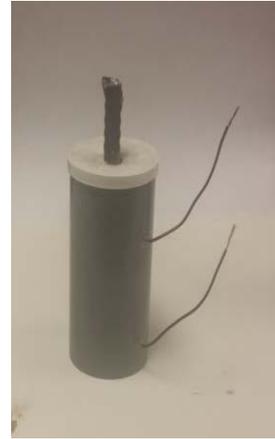
Figure 3.3 Cement composite specimens

a. Corroded bar embedded

b. Non-corroded bar embedded

Non-corroded and corroded steel bars were steel bars were prepared for laboratory tests to characterize electrical properties of the interface between the steel bar and the cement paste. The specimens were instrumented with 2 silver-paint wires connected to the cement paste and typical non-corroded and corroded cement composites are as shown in Figure 3.3.

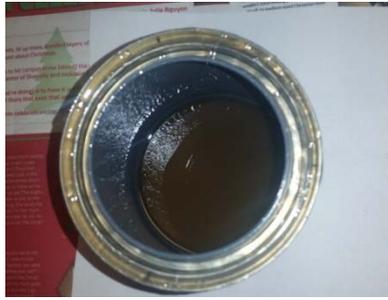
Figure 3.4 Materials used for polyester specimens

a. Polyester

Polyester specimens were prepared from composition of polyester coating, methyl ethyl ketone peroxide (MEKPO), and naphthenate as shown in Figure 3.4. The specimens had cylindrical shape with diameter of 1.5 inches and height of 4 inches. For a single specimen preparation 97.8 g of polyester, 2% (in weight of polyester) MEKPO and 0.2% (in weight of polyester) naphthenate were used. Methyl ethyl ketone peroxide (MEKPO) was used as hardener and naphthenate was used as catalyst

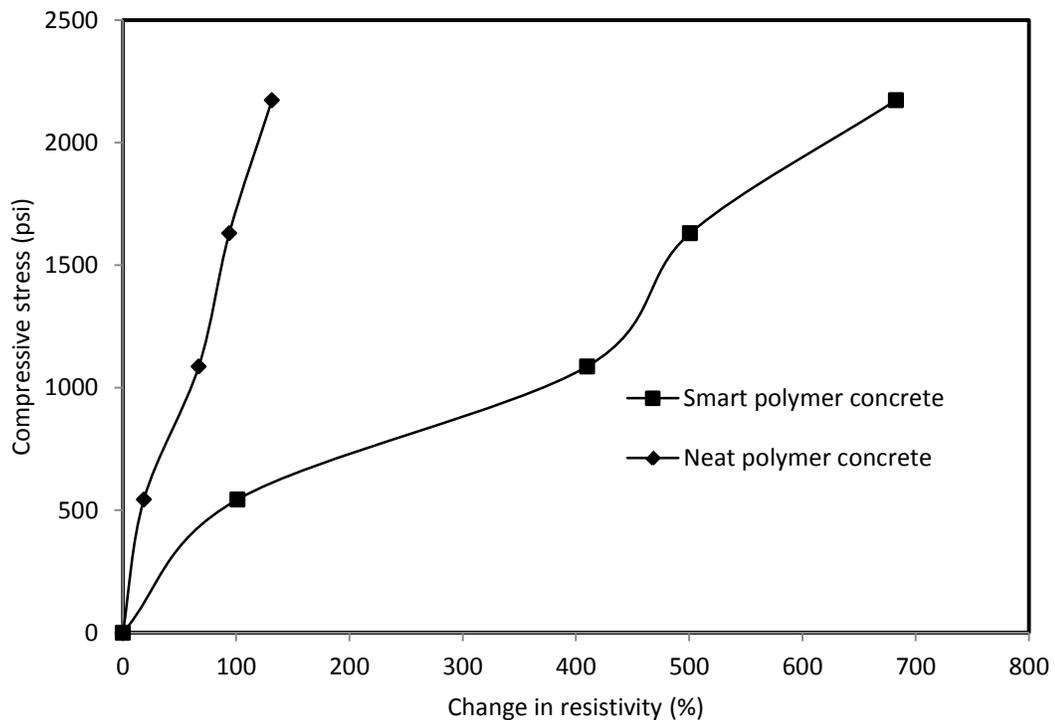
Typical electrical property of the smart polymer concrete compared to the polymer concrete without added conductive fillers (neat polymer concrete) is shown in Figure 4.3. From Figure 4.3, it can be seen that the smart polymer concrete sensing was about 5 times greater than that of neat polymer concrete.

Figure 4.3: Typical piezoresistive behavior of polymer concrete

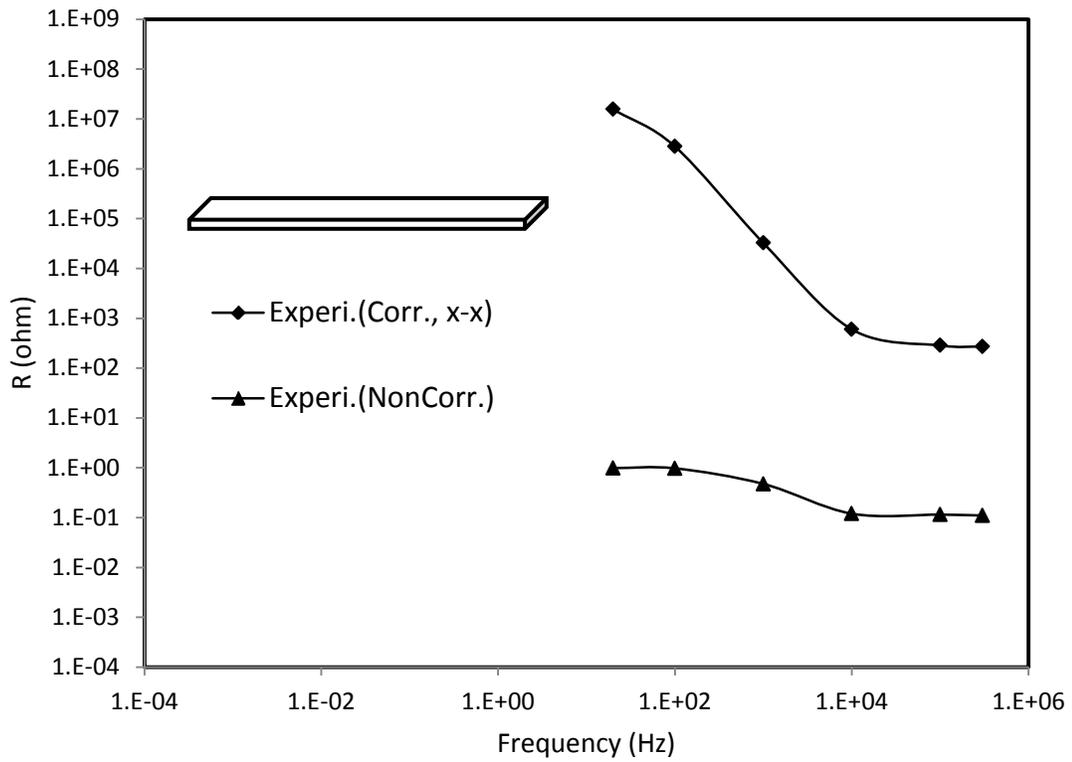
Figure 5.3 Bode plot for steel bars

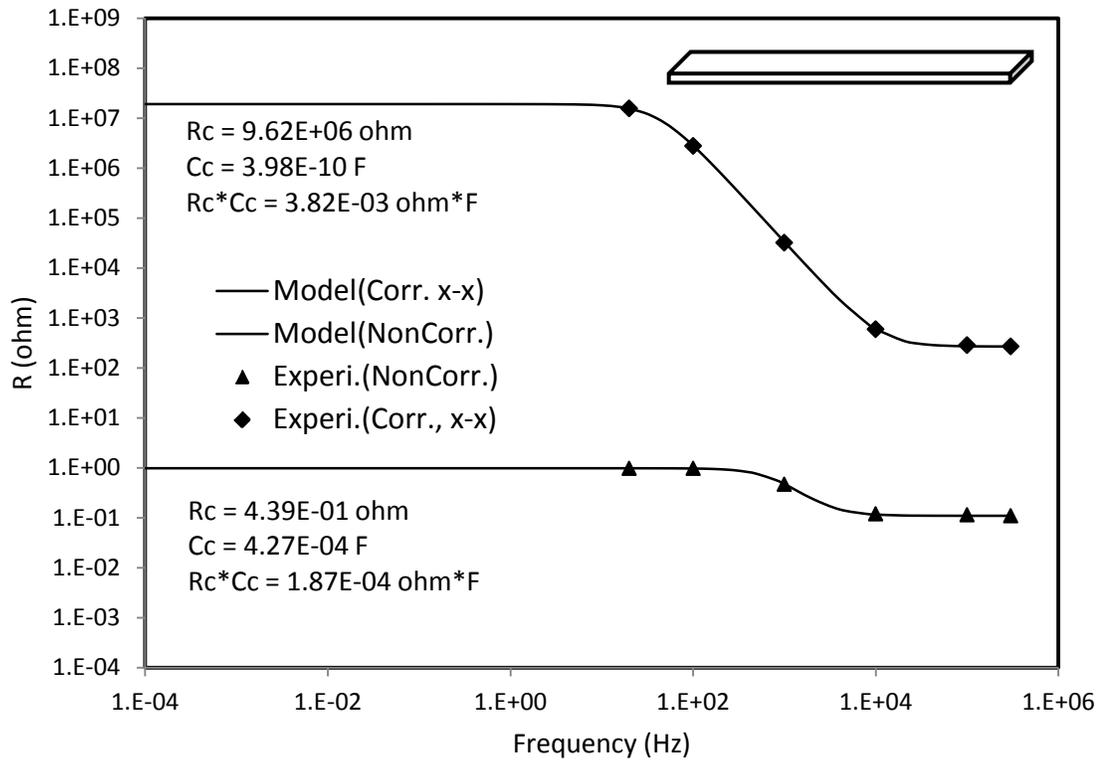
Figure 5.4 Bode plot of for steel bars along the impedance model

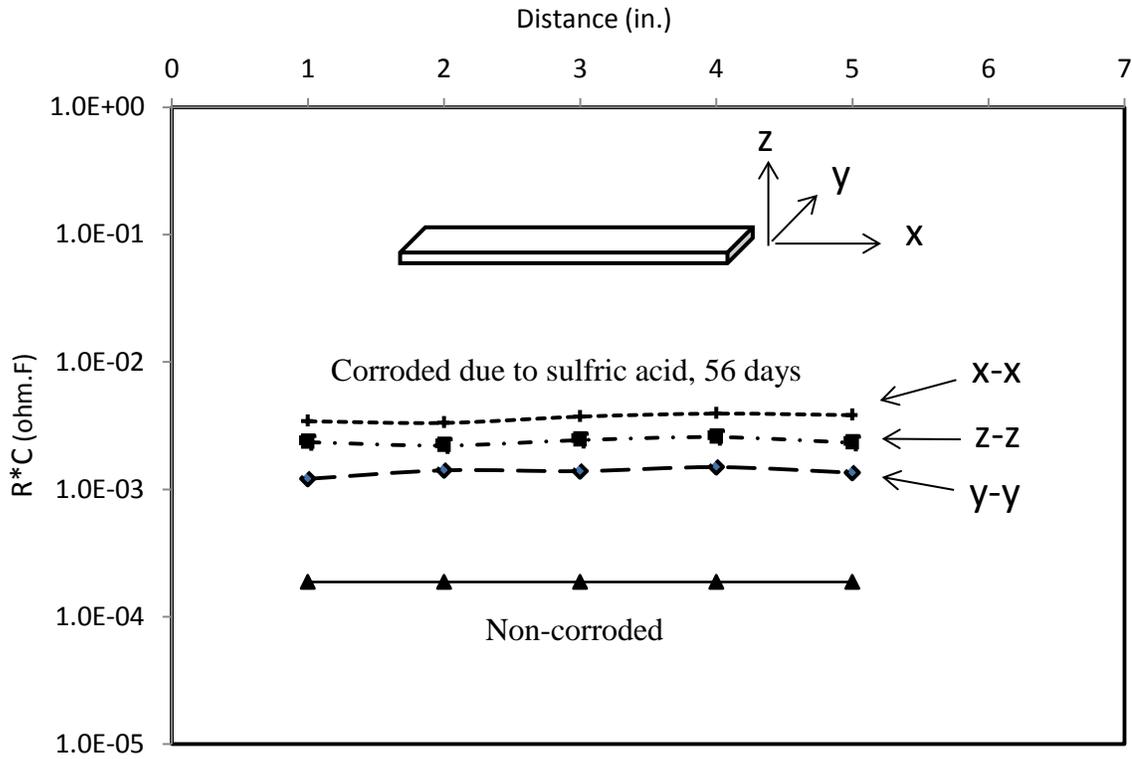
For the corroded steel bar, the impedance measurements that were taken in the three X, Y, and Z directions indicated different impedance values. This could indicate that the formation of the corrosion was direction dependent due to the non-uniformity nature of corrosion. After analyzing the impedance measured data to determine the  $R_c$  and  $C_c$  for each directions, the surface material property  $R_c * C_c$ , were determined and plotted as shown in Figure 5.5.

Figure 5.5  $R_c \cdot C_c$  vs distance for steel bars

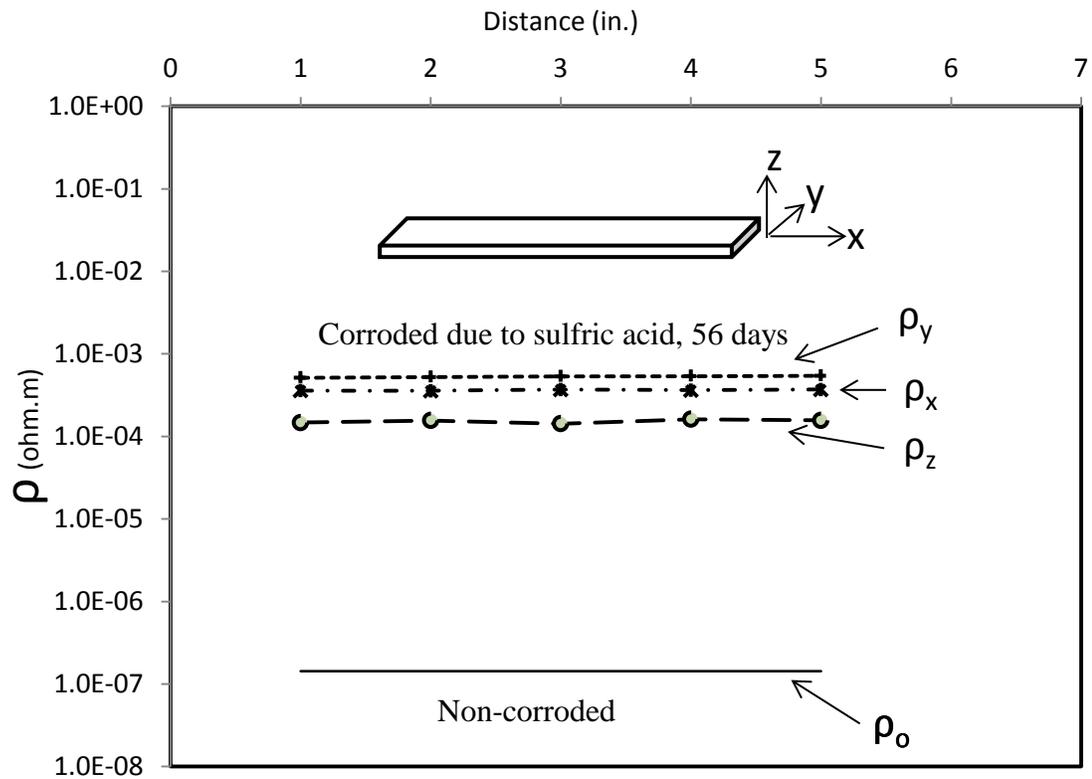
The resistivity for the corroded steel bars were determined in direction of X, Y, and Z and plotted as shown in Figure 5.6. From the Figure 5.6, it can be shown that the corrosion along the y-y direction (along the width of the steel bar) was more corroded than the other directions.

Figure 5.6 Resistivity of the steel bars

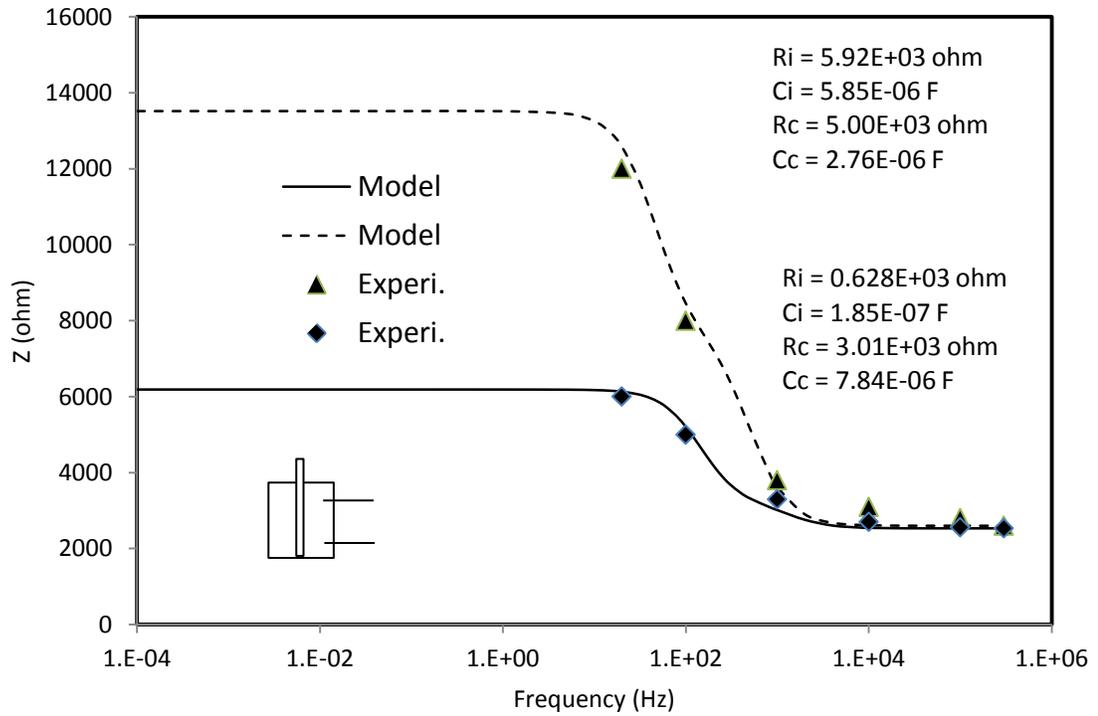
Figure 5.9 Bode plot of cement composites with embedded non-corroded and corroded bar along respective impedance models

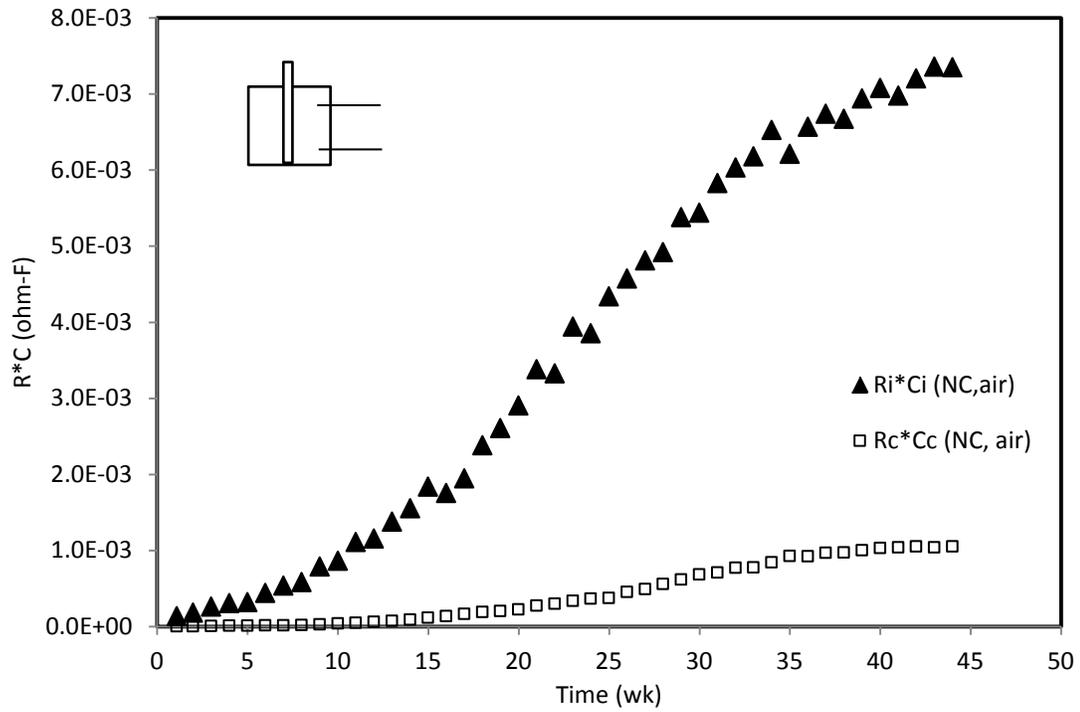
The material property parameter defined as product of resistance and capacitance,  $R \cdot C$ , for the non-corroded bar embedded in the smart cement is shown Figure 5.12. From the Figure 5.12, the interface  $R_i \cdot C_i$  between of the non-corroded bar and the smart cement was greater than the  $R_c \cdot C_c$  at the cement contact for the measuring time period. It can also be observed that both the interface  $R_i \cdot C_i$  and the contact  $R_c \cdot C_c$  were increased with respect to time. Therefore, from Figure 5.10 through Figure 5.12, it could be observed that it was possible to detect and quantify the presence of the corrosion in non-corroded bar embedded in the smart cement.

Figure 5.12  $R^*C$  vs. time of the non-corroded bar embedded in smart cement in air dry condition

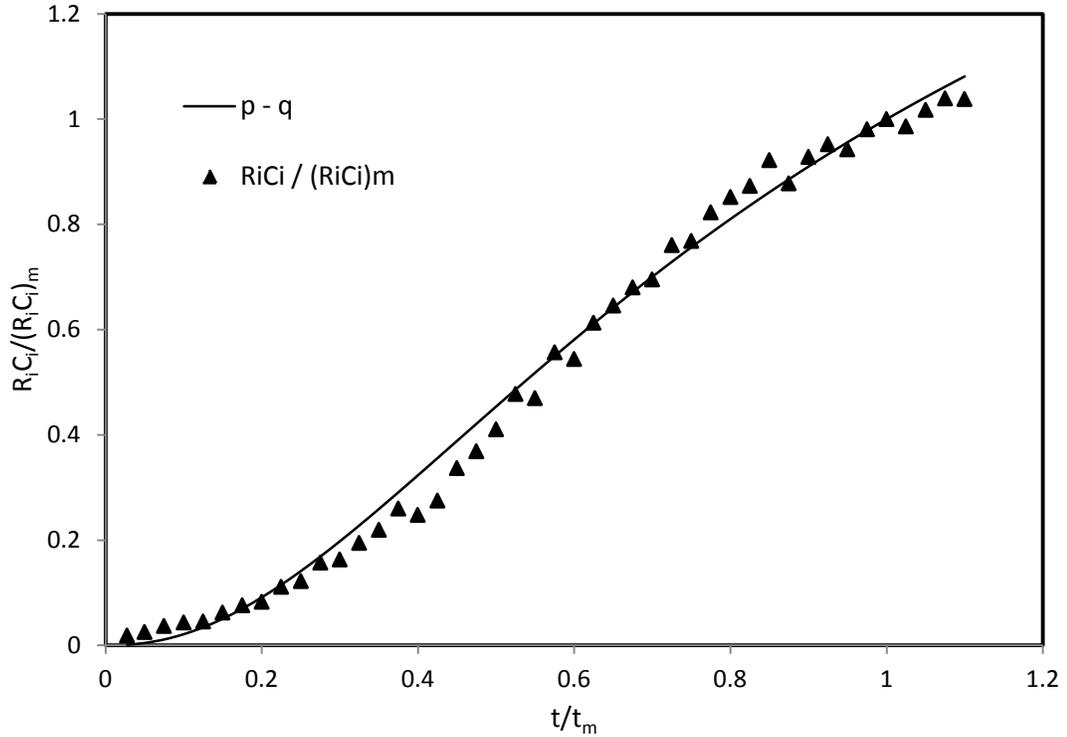
The progression of the interface corrosion with respect to time is modeled using equation (5-10) of p-q model and the plot is shown in Figure 5.13. The model parameters p and q are estimated to be 0.21 and 0.37 respectively. As  $t \rightarrow \infty$ , the corresponding interface corrosion parameter  $R_iC_i$  is estimated to be  $1.69E-02$  ohm-F using equation (5-11).

Figure 5.13 Corrosion-time model for non-corroded cement composite under dry condition

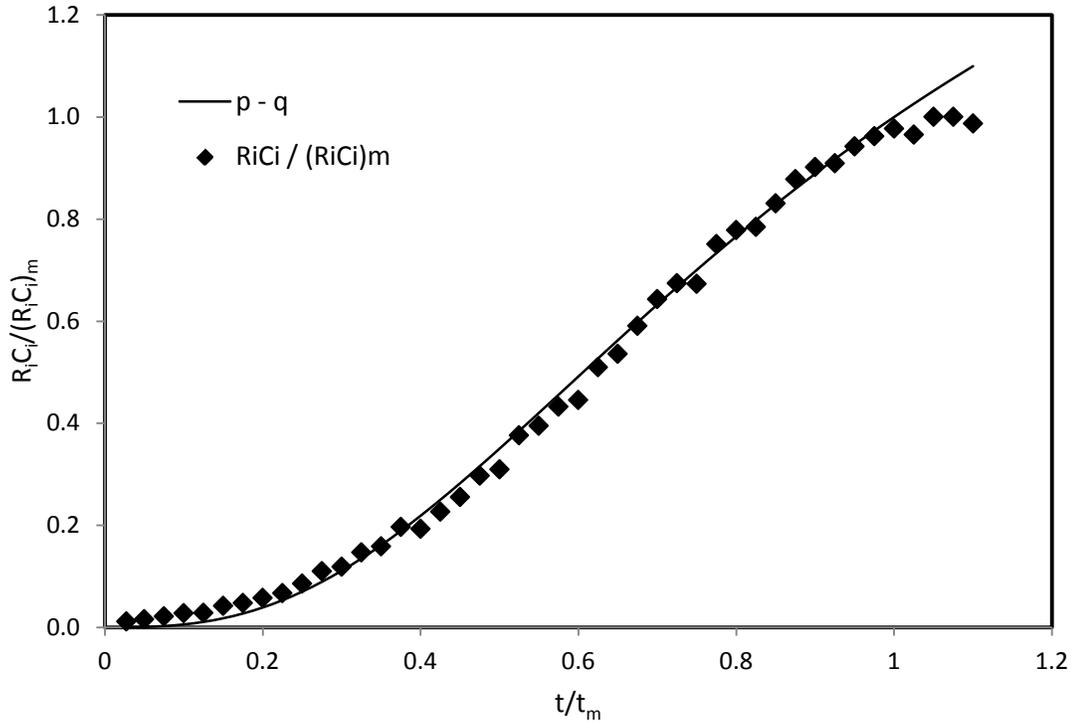
The progression of the interface corrosion with respect to time is modeled using equation (5-10) of p-q model and the plot is shown in Figure 5.17. The model parameters p and q are estimated to be 0.24 and 0.37 respectively. As  $t \rightarrow \infty$ , the corresponding interface corrosion parameter  $R_iC_i$  is estimated to be  $1.35E-01$  ohm-F using equation (5-11).

Figure 5.17 Corrosion-time model for corroded cement composite under dry condition

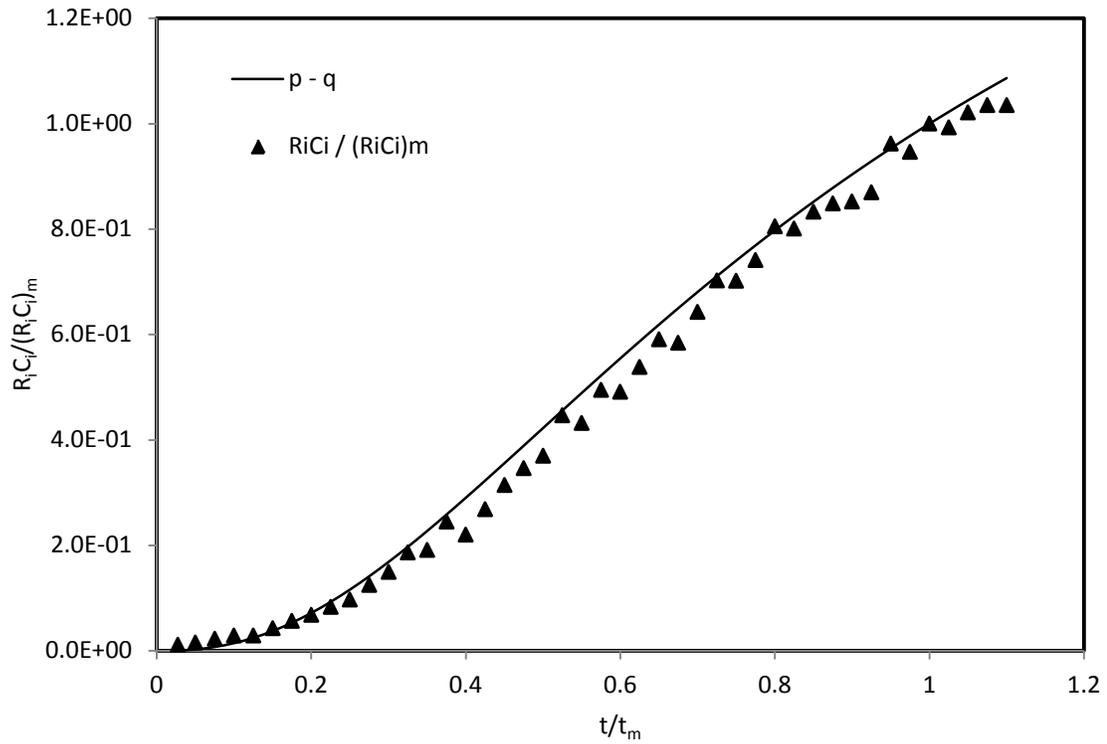
The progression of the interface corrosion with respect to time is modeled using equation (5-10) of p-q model and the plot is shown in Figure 5.24. The model parameters p and q are estimated to be 0.22 and 0.37 respectively. As  $t \rightarrow \infty$ , the corresponding interface corrosion parameter  $R_i C_i$  is estimated to be  $7.91E-03$  ohm-F using equation (5-11).

Figure 5.24 Corrosion-time model for non-corroded cement composite under salt water condition

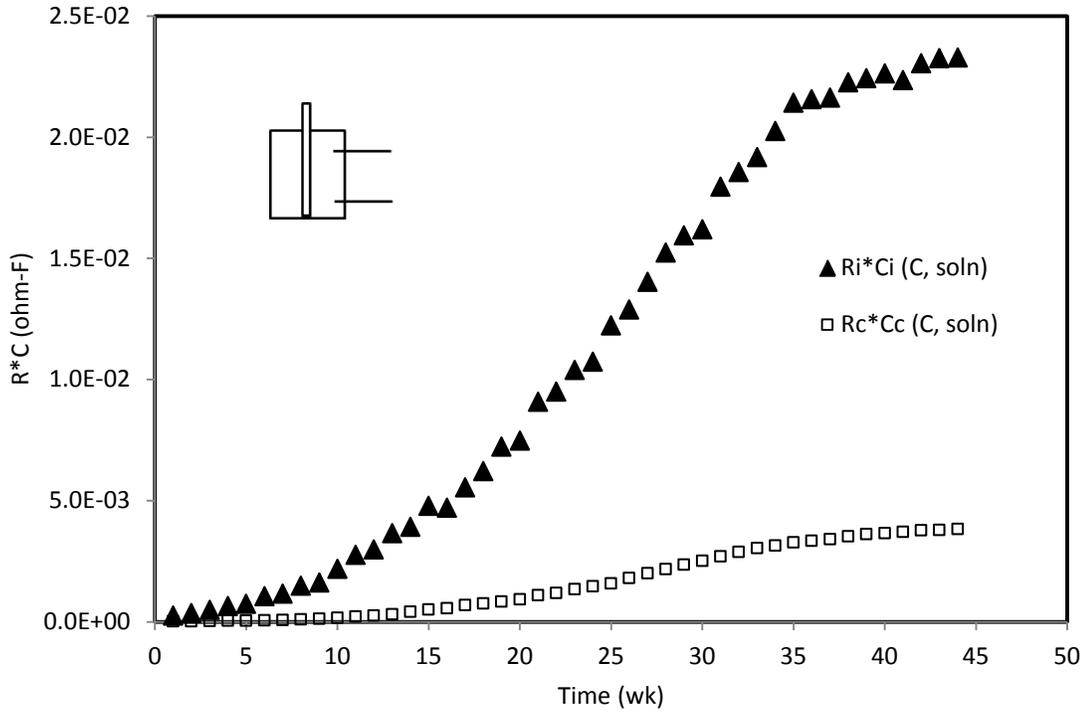
The material property parameter defined as product of resistance and capacitance,  $R \cdot C$ , for the corroded bar embedded in the smart cement specimen immersed in salt water solution is shown Figure 5.27. From the Figure 5.27, the interface  $R_i \cdot C_i$  between of the corroded bar and the smart cement specimen immersed in salt water solution was greater than the  $R_c \cdot C_c$  at the cement contact for the measuring time period. It can also be observed that both the interface  $R_i \cdot C_i$  and the contact  $R_c \cdot C_c$  were increased with respect to time. Therefore, from Figure 5.25 through Figure 5.27, it could be observed that it was possible to detect and quantify the presence of the corrosion in corroded bar embedded in the smart cement specimen immersed in salt water solution.

Figure 5.27 R\*C vs. time of the corroded bar embedded in smart cement specimen under salt water condition

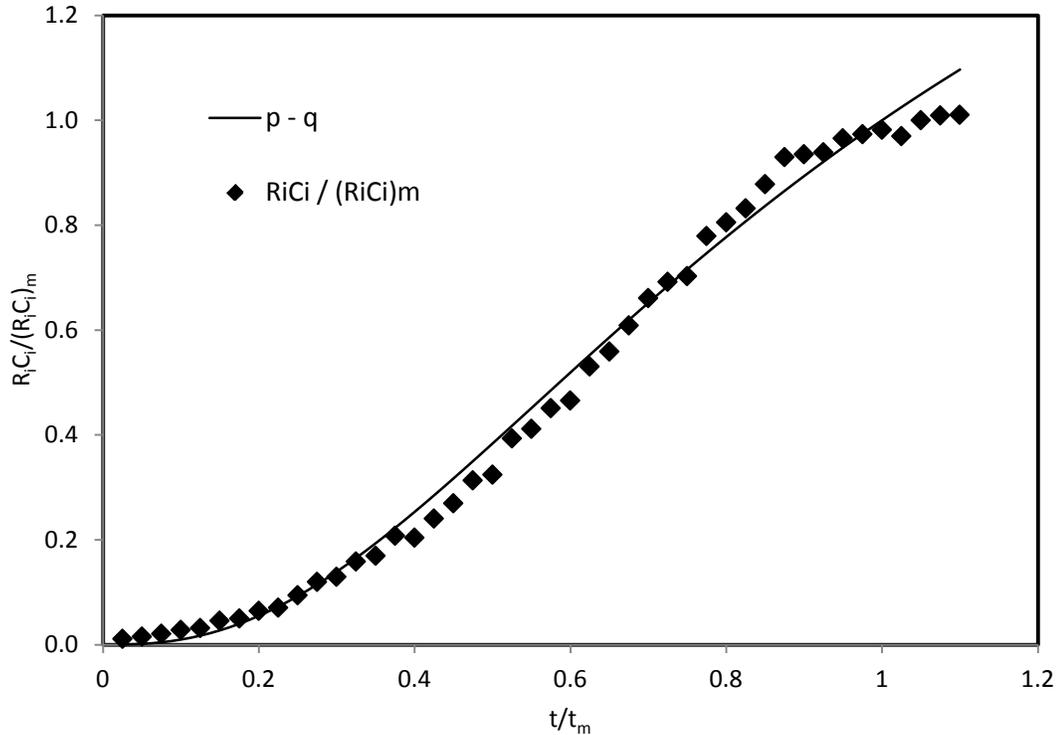
The progression of the interface corrosion with respect to time is modeled using equation (5-10) of p-q model and the plot is shown in Figure 5.28. The model parameters p and q are estimated to be 0.24 and 0.39 respectively. As  $t \rightarrow \infty$ , the corresponding interface corrosion parameter  $R_i C_i$  is estimated to be  $6.12E-02$  ohm-F using equation (5-11).

Figure 5.28 Corrosion-time model for corroded cement composite under salt water condition

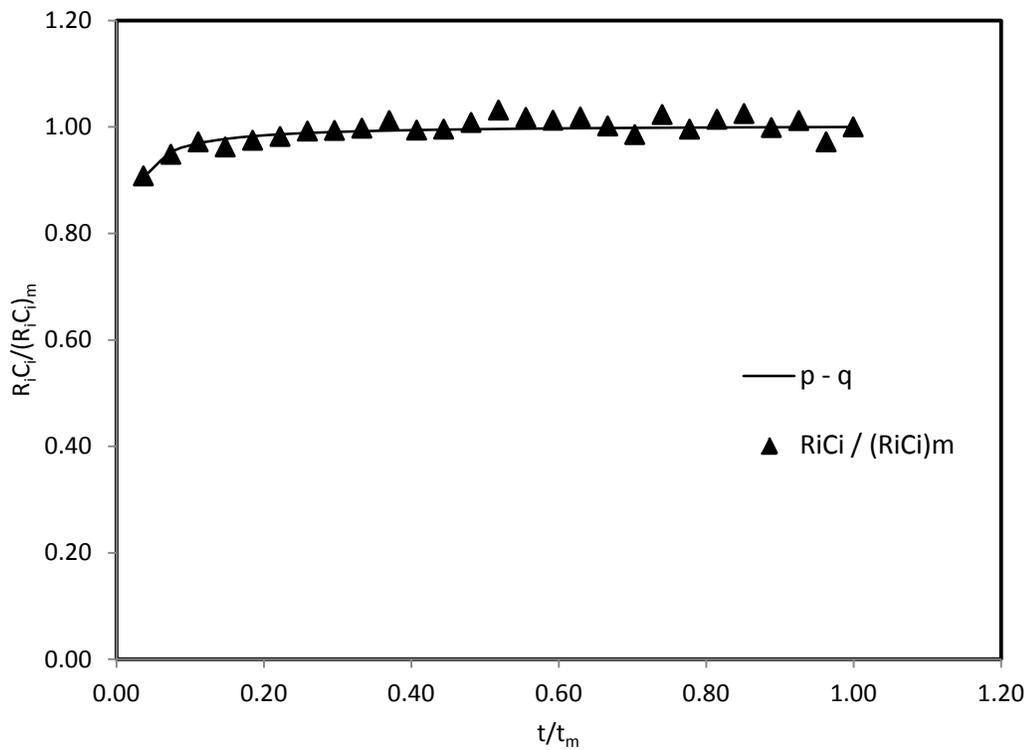
The progression of the interface corrosion with respect to time is modeled using equation (5-10) of p-q model and the plot is shown in Figure 5.35. The model parameters p and q are estimated to be 0.0 and 0.004 respectively. As  $t \rightarrow \infty$ , the corresponding interface corrosion parameter  $R_i C_i$  is estimated to be  $3.54E-04$  ohm-F using equation (5-11). The initial corrosion parameter was  $(R_i C_i)_o$  is  $7.87E-05$  ohm-F.

Figure 5.35 Corrosion-time model for non-corroded polyester composite under dry condition

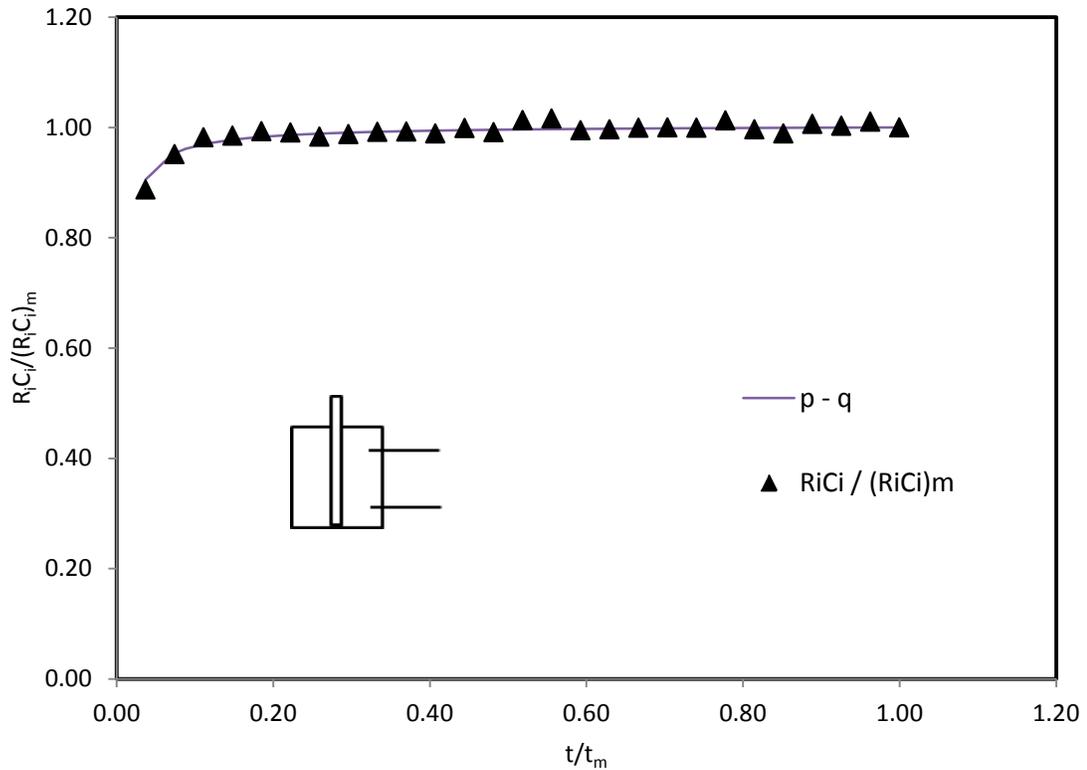
The progression of the interface corrosion with respect to time is modeled using equation (5-10) of p-q model and the plot is shown in Figure 5.39. The model parameters p and q are estimated to be 0.0 and 0.004 respectively. As  $t \rightarrow \infty$ , the corresponding interface corrosion parameter RiCi is estimated to be 5.00E-04 ohm-F using equation (5-11). The initial corrosion parameter was  $(RiCi)_o$  is 1.51E-04 ohm-F.

Figure 5.39 Corrosion-time model for corroded polyester composite under dry condition

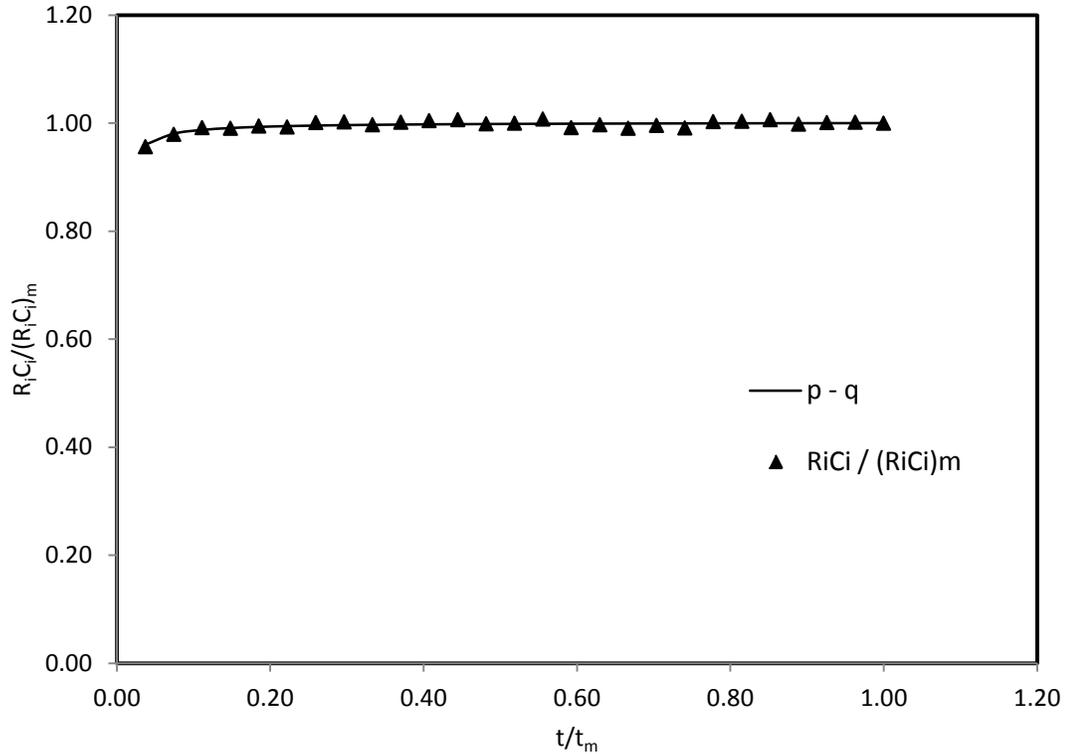
The progression of the interface corrosion with respect to time is modeled using equation (5-10) of p-q model and the plot is shown in Figure 5.46. The model parameters p and q are estimated to be 0.0 and 0.0016 respectively. As  $t \rightarrow \infty$ , the corresponding interface corrosion parameter  $RiCi$  is estimated to be  $3.28E-04$  ohm-F using equation (5-11). The initial corrosion parameter was  $(RiCi)_o$  is  $7.63E-05$  ohm-F.

Figure 5.46 Corrosion-time model for non-corroded polyester composite under salt-water condition

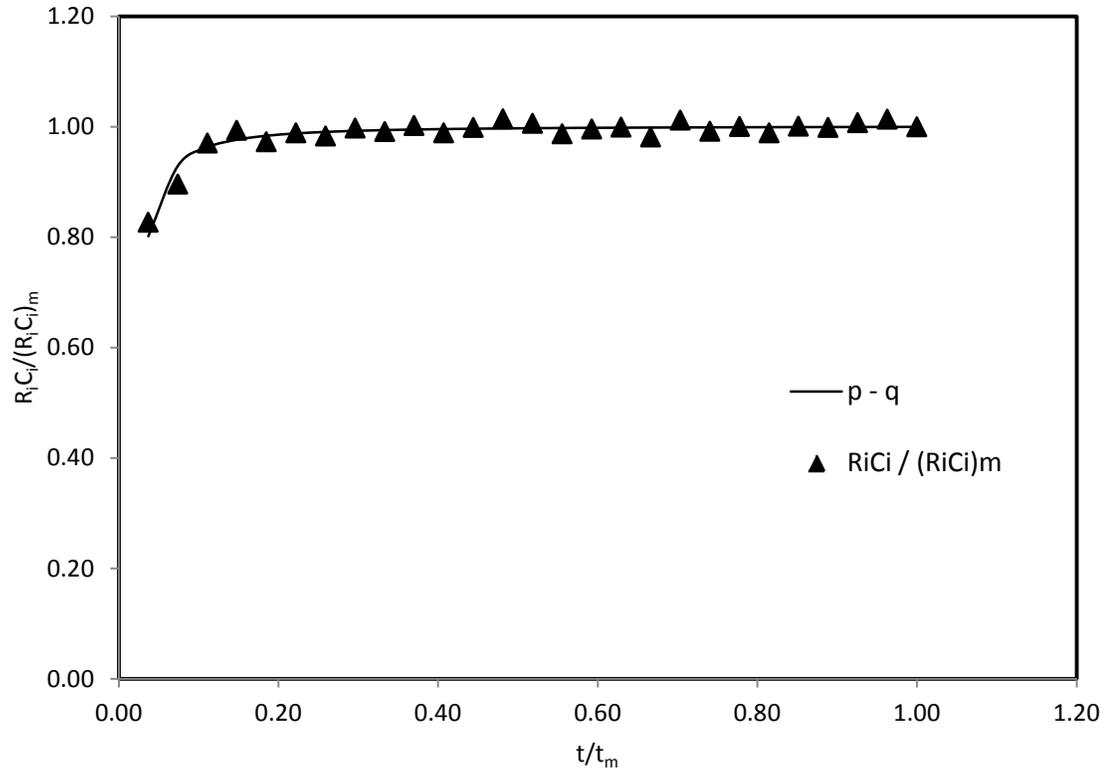
The progression of the interface corrosion with respect to time is modeled using equation (5-10) of p-q model and the plot is shown in Figure 5.50. The model parameters p and q are estimated to be 0.00054 and 0.0012 respectively. As  $t \rightarrow \infty$ , the corresponding interface corrosion parameter  $RiCi$  is estimated to be  $5.28E-04$  ohm-F using equation (5-11). The initial corrosion parameter was  $(RiCi)_0$  is  $1.54E-04$  ohm-F.

Figure 5.50 Corrosion-time model for corroded polyester composite under salt-water condition

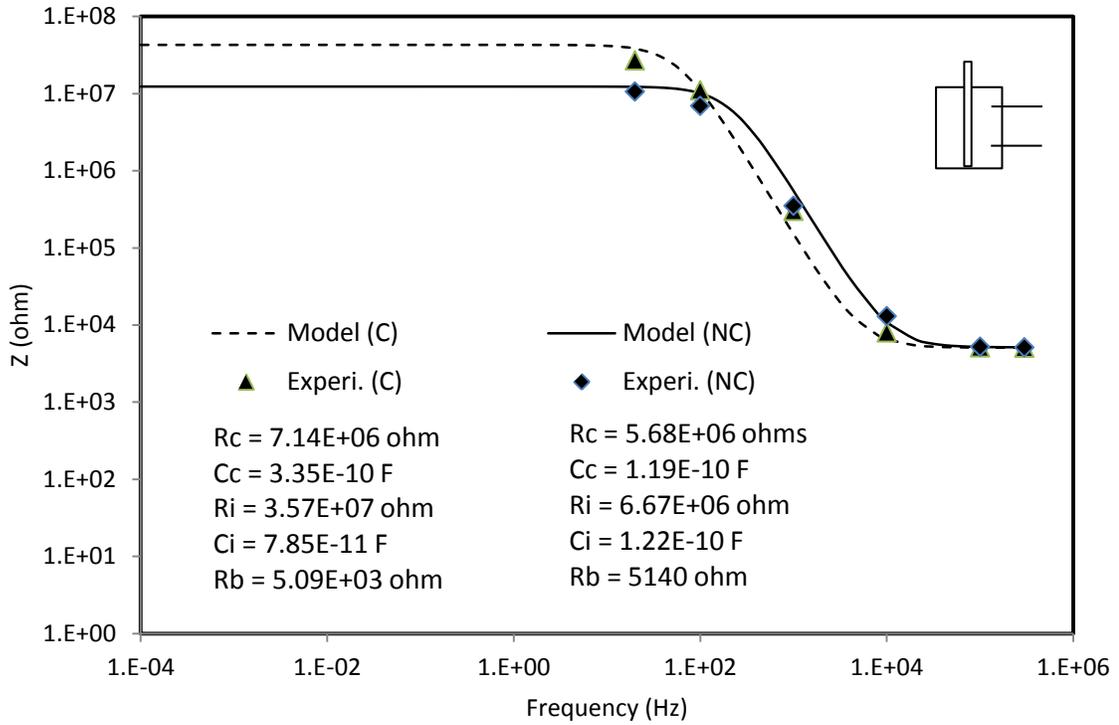
Figure 5.53 Bode plot of polymer concrete composites with embedded non-corroded and corroded bar along respective impedance models

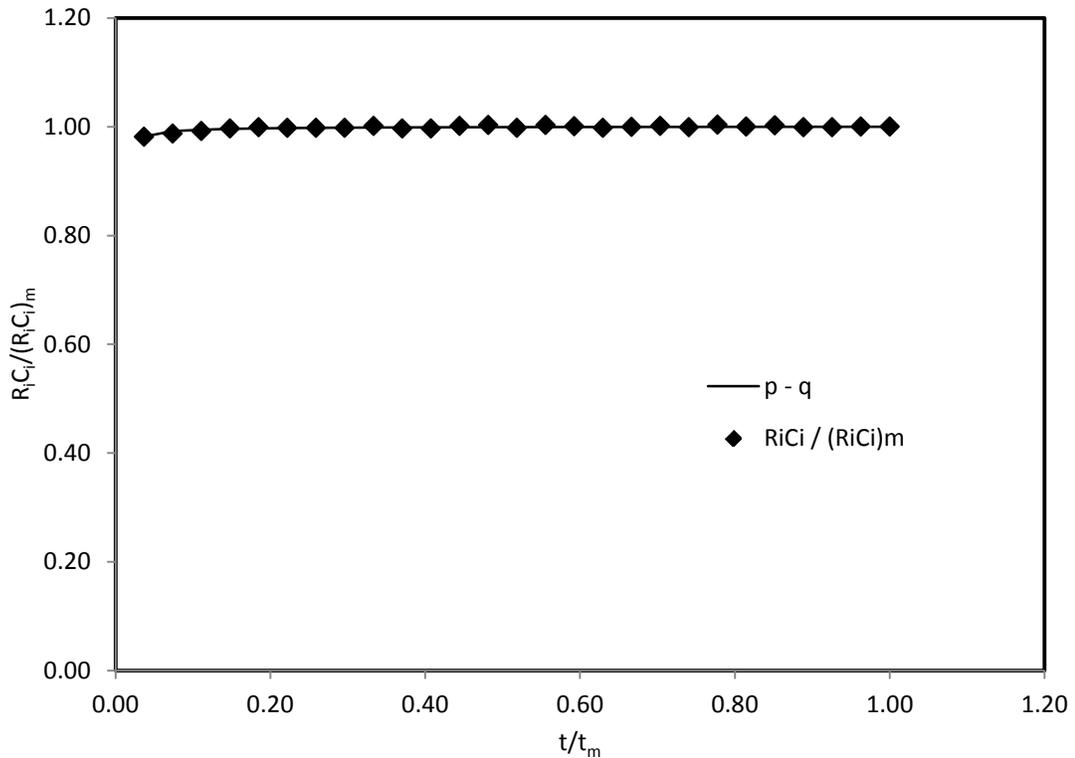
Figure 5.57 Corrosion-time model for non-corroded polymer concrete composite under dry condition

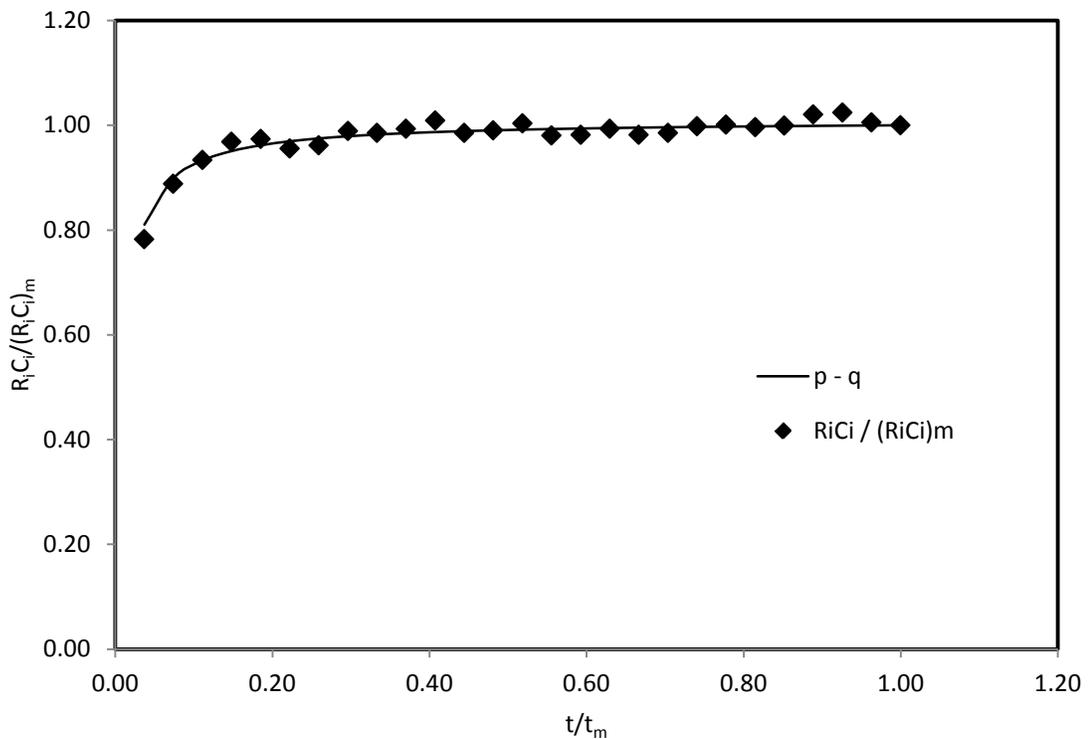
Figure 5.61 Corrosion-time model for corroded polymer concrete composite under dry condition

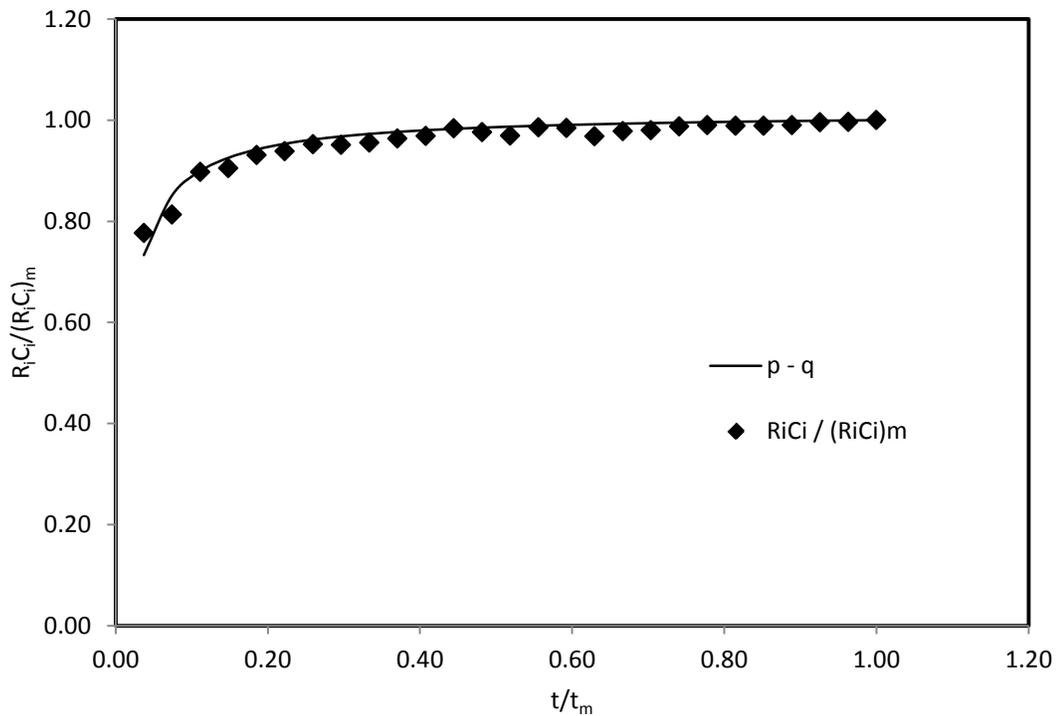
Figure 5.68 Corrosion-time model for non-corroded polymer concrete composite under salt-water condition

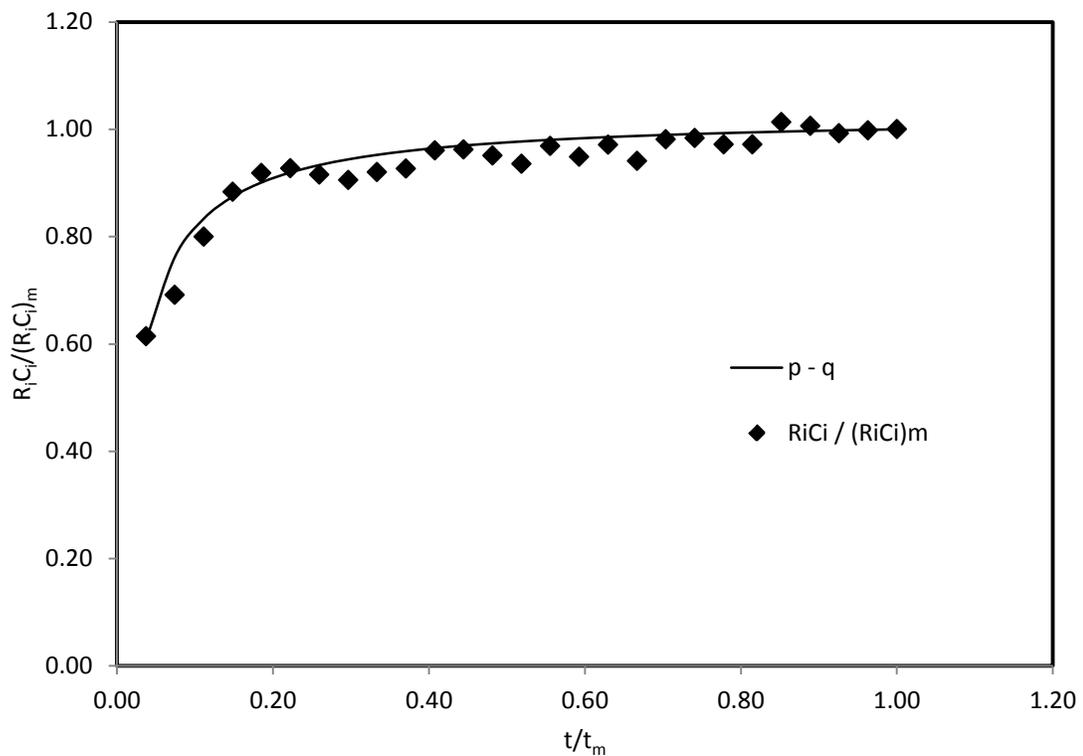
Figure 5.72 Corrosion-time model for corroded polymer concrete composite under salt-water condition

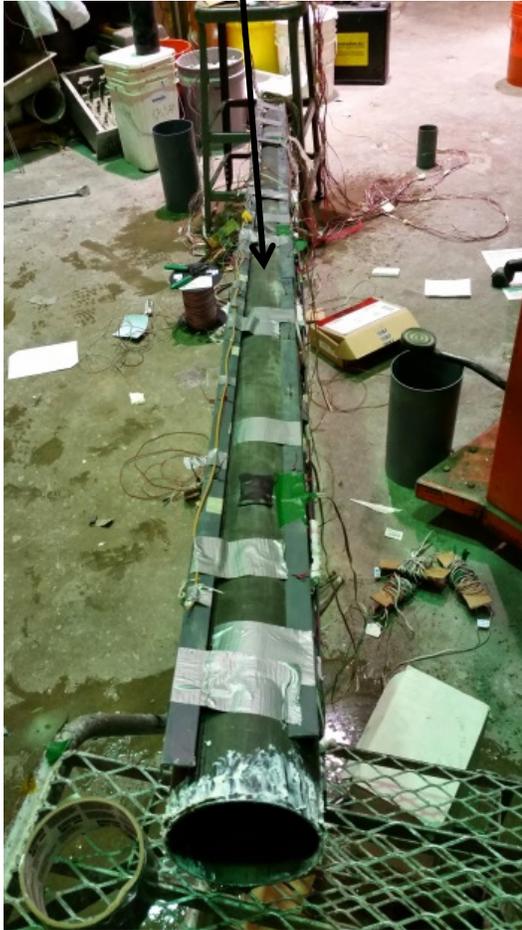
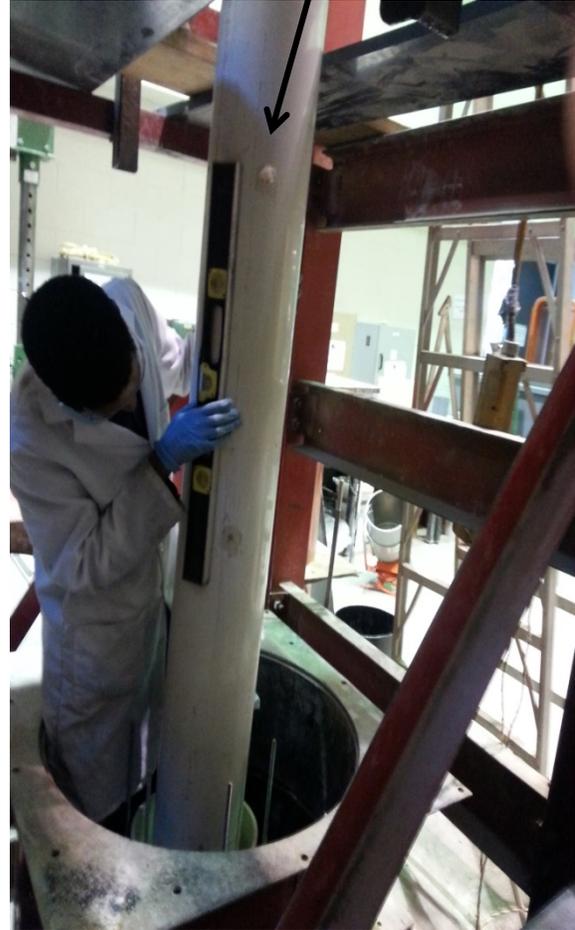
Figure 6.1 Steel casing pipe embedded in the PVC pipe

a. Steel casing pipe with instrumentation

b. Casing embedded in PVC pipe

A large scale cement well (composite specimen) was prepared in the material laboratory of Civil and Environmental Engineering department and was under continuous tests and monitoring procedures for its electrical properties. The model composed of steel casing pipe of 8 feet in length and 4 inches in diameter. The steel case was placed in the PVC pipe, simulating the borehole, whose length was 8 feet and inside diameter was 8 inches as shown in Figure 6.1. The gap between the steel casing and the PVC pipe was filled with smart cement slurry. The water-to-cement ratio used was 0.4. The cemented sheath was instrumented with probes spaced at distance of 6 inches and placed at four different directions along the entire length to monitor and test the bulk material (cement slurry).

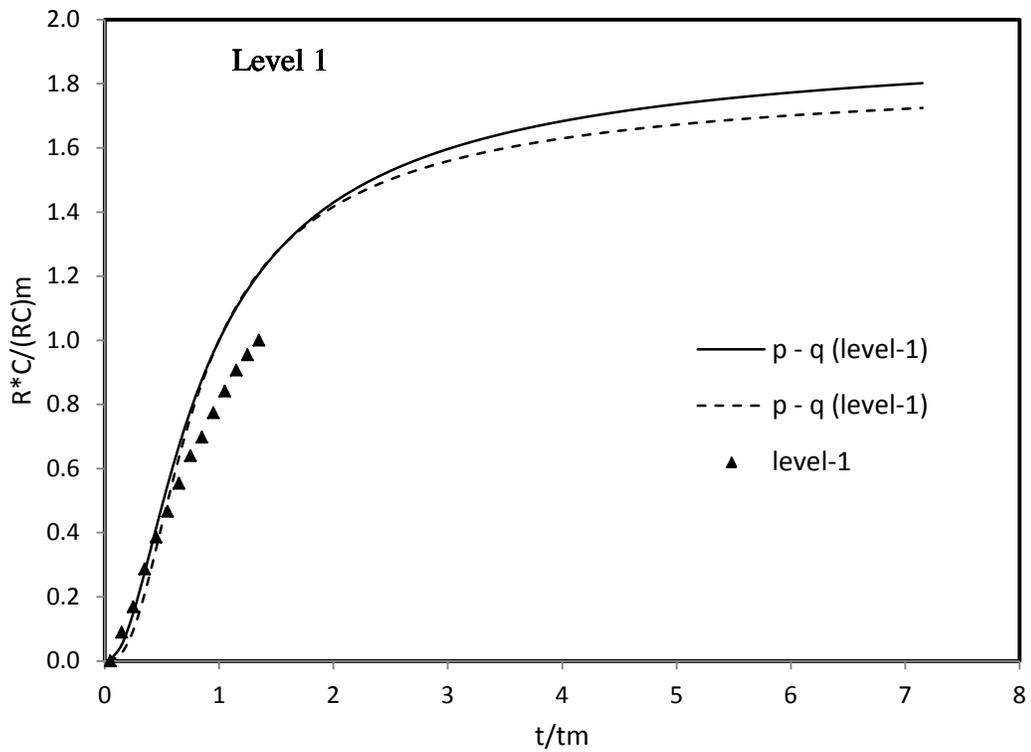
Figure 6.47 Corrosion-time model for the casing at level-1

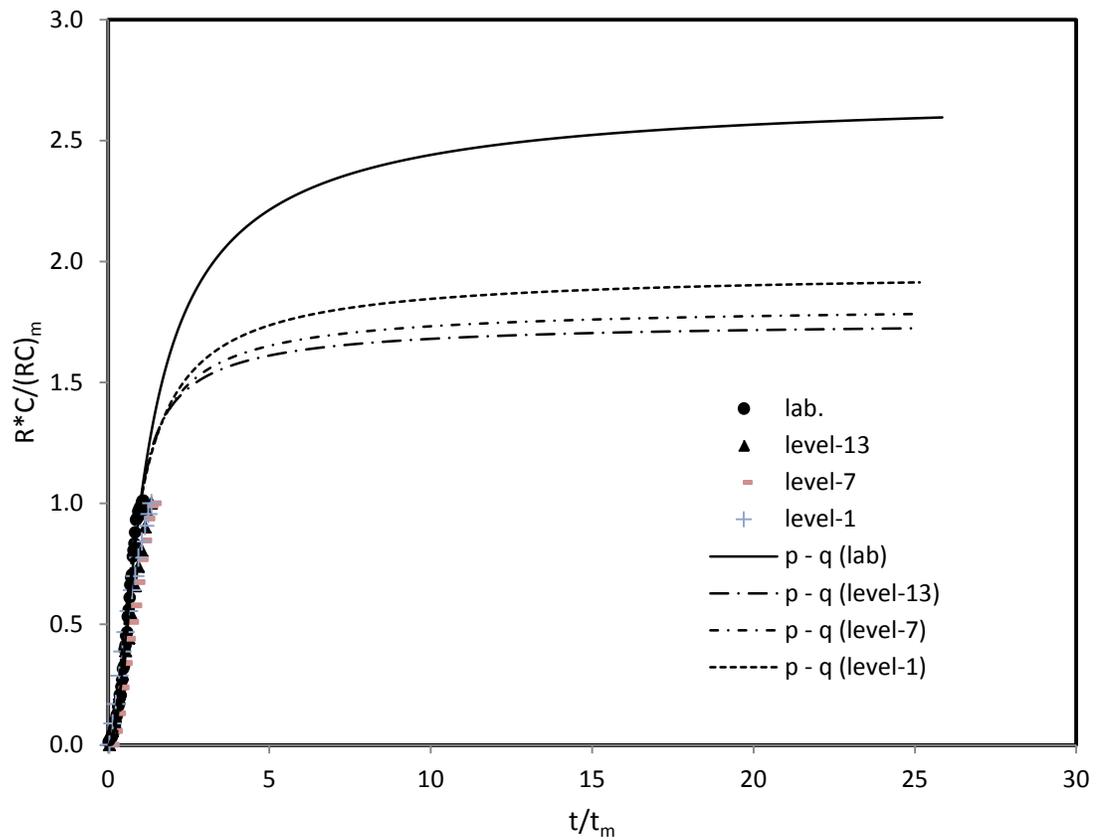
Figure 6.50 Corrosion-time model for corroded cement composite and field casing
