AN EXPERIMENTAL STUDY ON REPAIR OF STEEL BRIDGE PILES USING  
GFRP CONCRETE-FILLED JACKET

Presented to the Faculty of the  
Department of Civil and Environmental Engineering  
University of Houston

In Partial Fulfillment of the  
Requirements for the Degree Master of Science in  
Civil Engineering

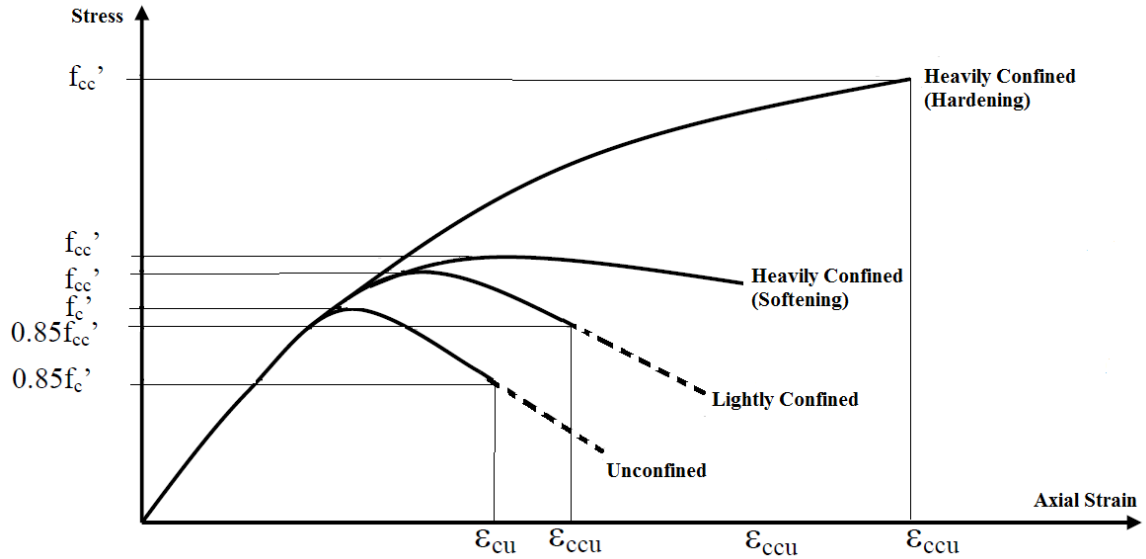
Figure 1.1. Stress- Strain Curve of Concrete with Different Levels of Confinement

While FRP jacketing of concrete piles is a well-established technique, there has been substantially less research conducted to investigate the effectiveness of this method to retrofit steel compression members as compared to flexural strengthening of concrete columns. GFRP may be preferable in cost-sensitive applications where the higher strength and stiffness of carbon fibers are not required to provide satisfactory structural performance. Replacing corroded or damaged steel piles or columns typically requires major replacement of substantial portions of the rest of the structure which may not otherwise require replacement. As reviewed below, researchers have investigated the use of GFRP laminates to strengthen and repair steel piles. The GFRP jacket provides a confining stress while the concrete is expanding. Researchers also have worked on strength, modulus of elasticity, and density of FRP required for strengthening applications. FRP jacketing minimizes the environmental effects and therefore the rate of environmental degradation of the pile is reduced. Additionally, the strength and ductility of the system is increased due to FRP confinement. The axial capacity of confined concrete is higher than that of an unconfined member; the stress-strain curve on the level of confinement is shown in Figure 1.1. However, the shape of the cross section influences the effectiveness of the confinement. Confining circular columns is more effective than

confining rectangular piles with FRP jackets. Therefore, in strengthening steel piles using FRP jackets, a circular section is preferred.

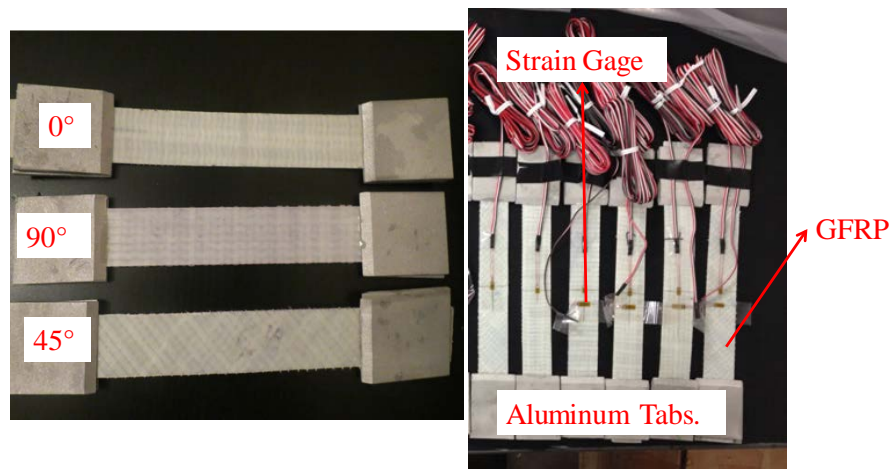
Figure 3.3. GFRP Coupons

Two thin flat strips of GFRP were tested to measure the modulus of elasticity in longitudinal ( $0^\circ$ ) and transverse ( $90^\circ$ ) directions. In addition, GFRP was tested in  $45^\circ$  direction to measure the shear modulus. Width and thickness of the GFRP coupons was measured at three locations to determine the cross sectional area. The GFRP coupons were nominally 5.8 inches long, 1 inch wide and 0.026 inches thick. Strain gauges were bonded on the face of the GFRP at the center of the coupons to measure longitudinal and transverse strains. Figure 3.3 shows the GFRP tension coupons. GFRP coupons were tested using a 110 kips servo-hydraulic MTS load frame. Table 3.5 presents the measured properties of GFRP.

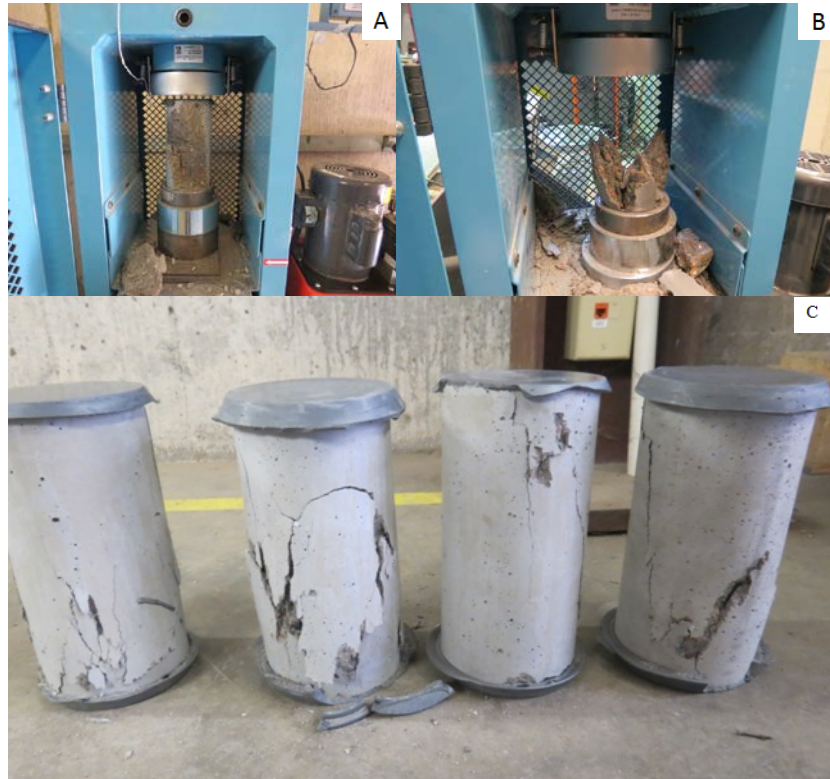
Figure 3.4. Failure of Cylinders A) Group #4, B) Group #3, C) Group #1 and #2

Four batches of concrete were cast in the this study. To evaluate the compressive strength of the concrete,  $4 \times 8$  inch cylinders were cast and cured with the test piles. The cylinders were tested following ASTM C39/C39M 03 (2003) in a 500-kip capacity Forney cylinder test frame. Loading was applied without shock. The cylinders that were tested on 8/5/2014, 8/9/2014, 8/1/2014 and 8/4/2014 were capped with sulfur while the other cylinders were tested with Neoprene rubber pads inserted in steel end caps. The cylinder test results are summarized in Table 3.8 and representative failed cylinders from each group are shown in Figure 3.4.

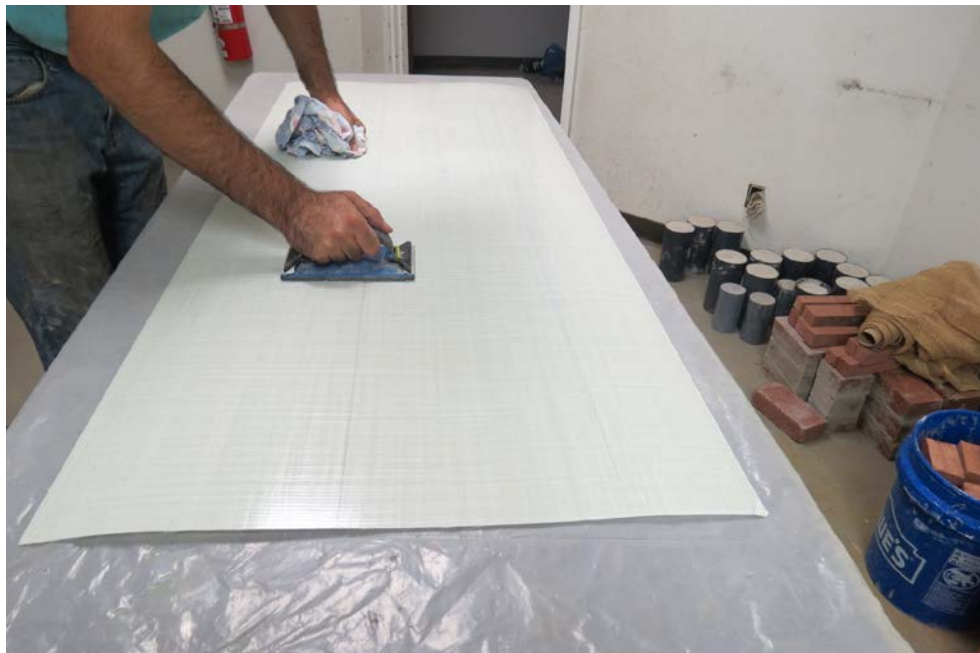
Figure 3.7. Sanding of the GFRP Laminates Using Sandpaper

(4) The GFRP laminates were sanded on both sides in one direction using a grade 220 sand paper to improve the bonding of the laminate layers (see Figure 3.7). Epoxy was prepared according to the product data-sheet. Table 3.9 shows the amounts used in mixing the two parts of the epoxy. The two parts were mixed with a low speed (400-600 rpm) mixing paddle for three minutes until a uniform color was achieved. After mixing, the epoxy was applied to the entire surface of one side of the GFRP laminates using a spatula. Special care was given to keep the epoxy thickness around 0.04 inches. The steel piles were wrapped with flexible GFRP laminates in two and three layers with an overlap

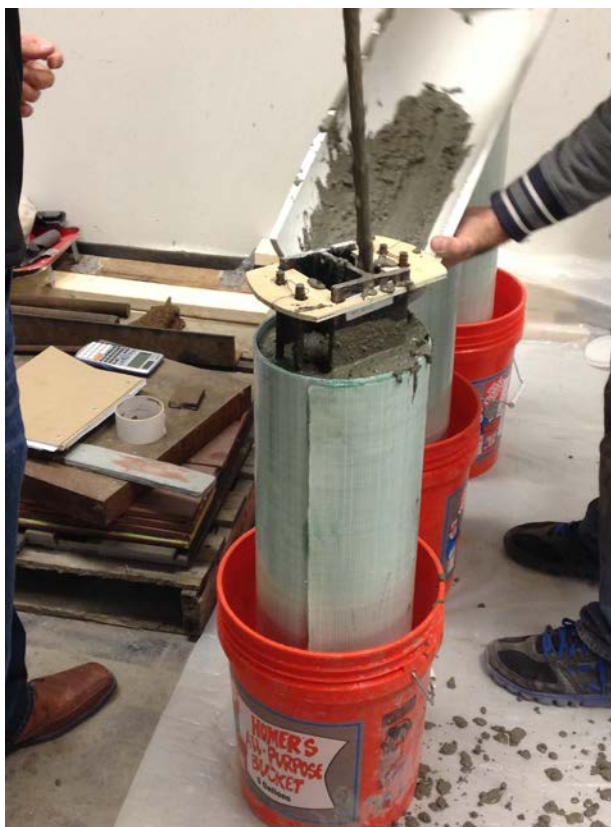
Figure 3.10. Casting Concrete

(6) The last step was casting the grout into the GFRP jacket. Because of the limitations of the concrete mixer, specimens were divided into four groups. Table 3.10 shows the mixture proportions for each group and the number of 4x8 inch cylinders prepared for compression testing. Groups #2 and #3 were cast inside the laboratory while Groups #1 and #4 were cast outside. The concrete was mixed using a gravity-based mixer and cast into the GFRP jackets (see Figure 3.10). The following steps were followed in casting the specimens: mix the concrete and gravel until the particles are uniformly distributed, pour water slowly and mix the concrete for three minutes, quickly transport the mixed material to the casting area, pour the mixed material into the specimens in three phases by fill one-third of the GFRP jacket and tamping 25 times with a tamping rod and repeating for the remainder two-thirds in two steps, and fill 4x8 inch plastic cylinder molds with the mixed material for compression testing.

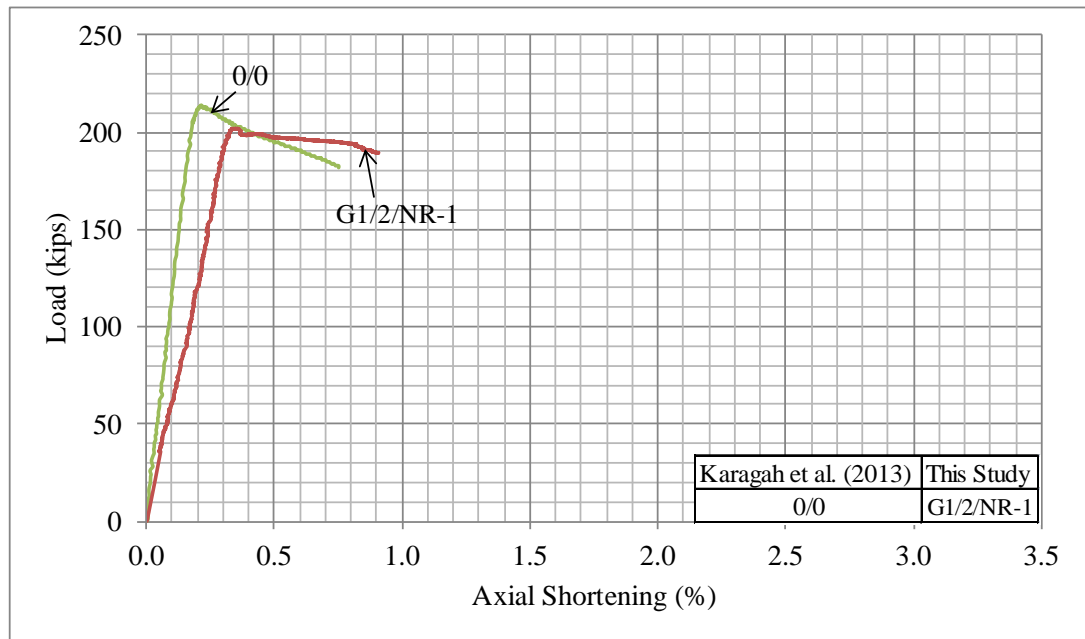
Figure 4.3. Load versus Axial Shortening of G1/2/NR-1

Pile G1/2/NR-1 failed at a load level of 202 kips due to buckling of the pile and rupture of the GFRP as illustrated in Figure 4.2. Prior to the repair, the control pile failed by global buckling at a load level of 215 kips. The capacity of the repaired pile was 94% of the capacity of the undamaged control pile. Figure 4.3 compares the axial load-shortening responses of the control pile (prior to repair) and the repaired buckled pile (after installation of the jacket).

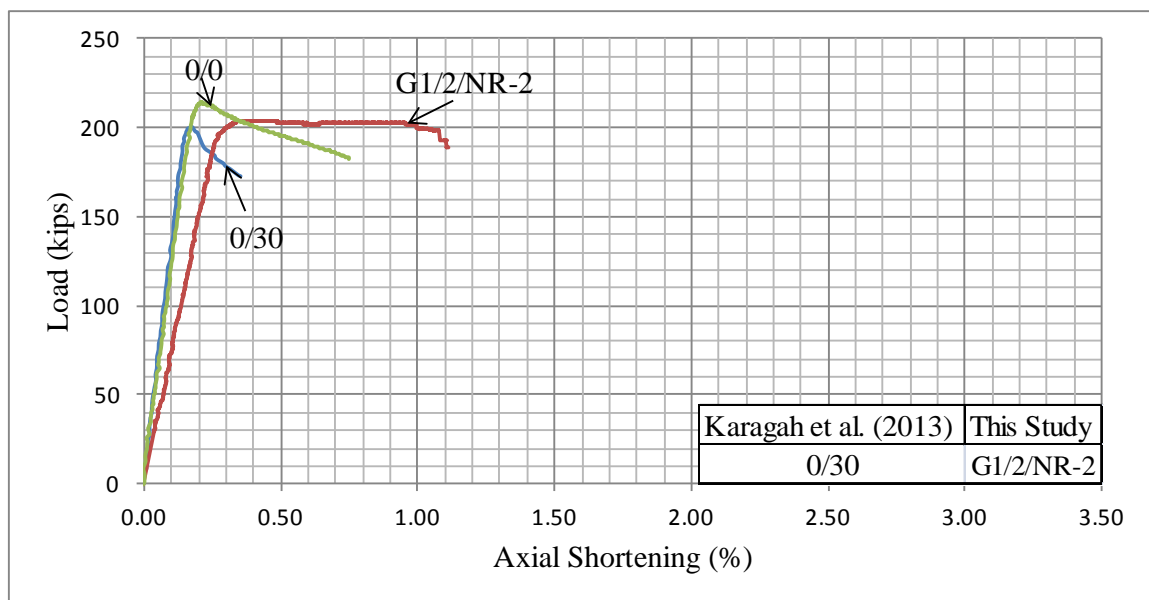
Figure 4.5. Load versus Axial Shortening of G1/2/NR-2

Pile G1/2/NR-2 failed at a load level of 204 kips due to buckling of the pile and rupture of GFRP as illustrated in Figure 4.4. Prior to the repair, the column failed by global buckling at a load level of 201 kips. The capacity of the repaired pile was approximately the same as the capacity of the damaged pile and 95% of the capacity of the undamaged control pile. Figure 4.5 compares the axial load-shortening responses of the corroded pile

(prior to repair) and the repaired buckled pile (after installation of the jacket) to the response of the undamaged control pile.

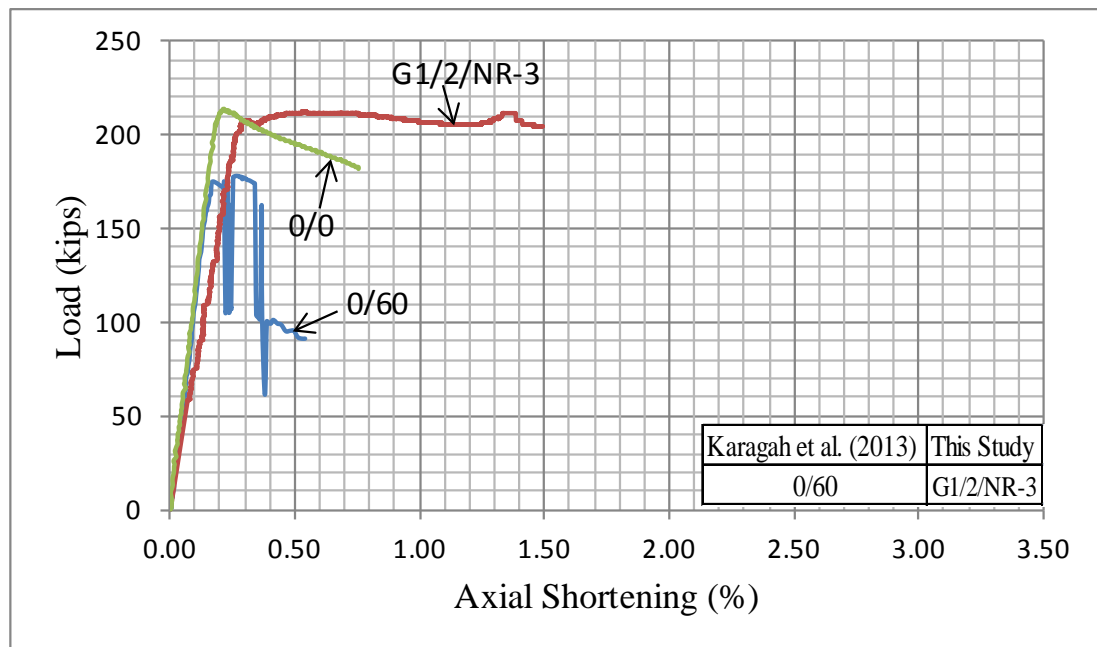
Figure 4.7. Load versus Axial Shortening of G1/2/NR-3

Pile G1/2/NR-3 failed at a load level of 212 kips due to GFRP rupture as illustrated in Figure 4.6. Prior to the repair, the pile failed by global buckling at a load level of 178 kips. After the peak load, the specimen continued to deform extensively and rupture of the GFRP was observed. The capacity of the repaired pile was 1.2 times the capacity of the damaged pile and 99% of the capacity of the undamaged control pile. Figure 4.7 compares the axial load-shortening responses of the corroded pile (prior the repair) and the retrofitted buckled pile (after installation of the jacket) to the response of the undamaged control pile. The irregular response of pile 0/60 during prior testing was attributed to the electro-magnetic interference and is not believed to represent the actual response of the pile.

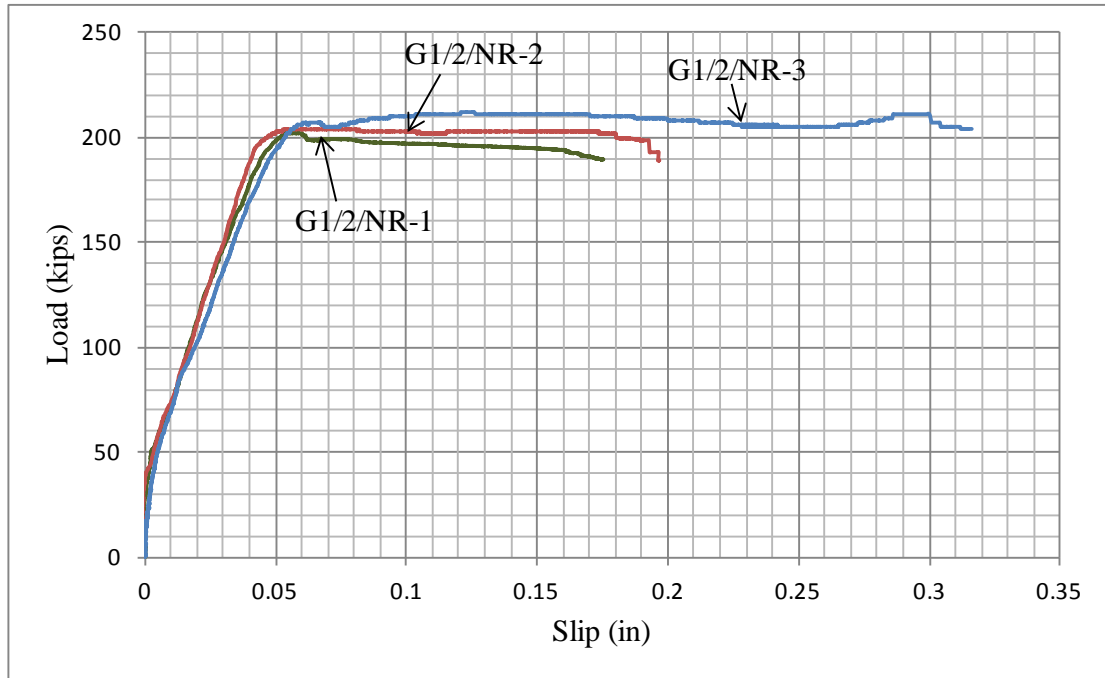
Figure 4.8. Load versus Slip Responses of G1/2/NR-1, G1/2/NR-2, and G1/2/NR-3

Figure 4.8 presents the slip behavior for specimens G1/2/NR-1, G1/2/NR-2, and G1/2/NR-3. In addition, the entire first group specimens are compared in Figure 4.9 before and after repair.

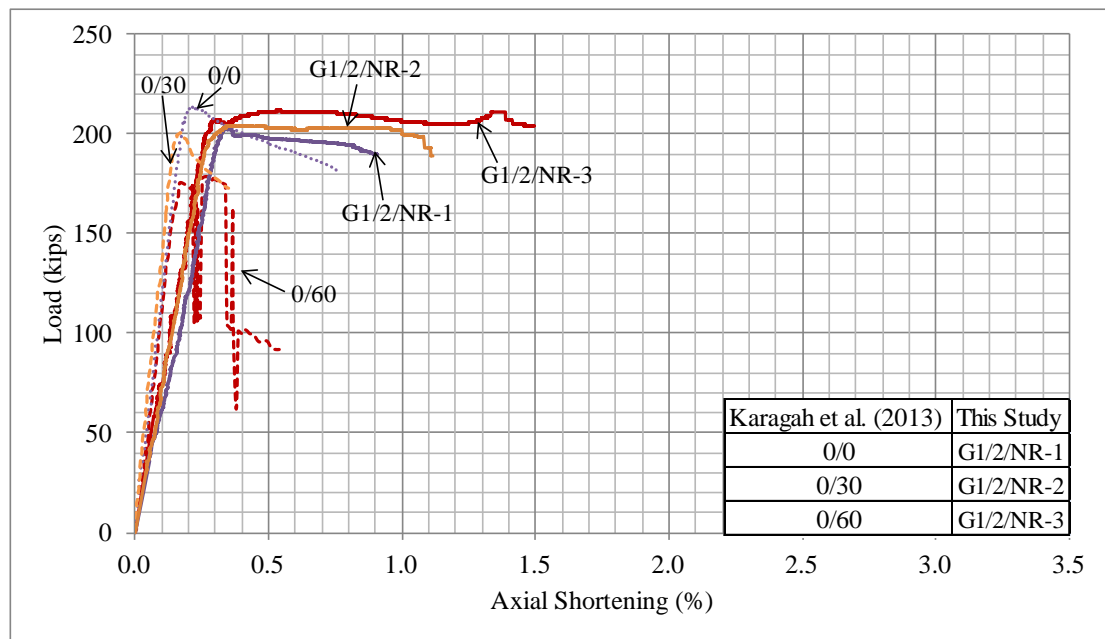
Figure 4.9. A) Load versus Shortening of All First Group Specimens

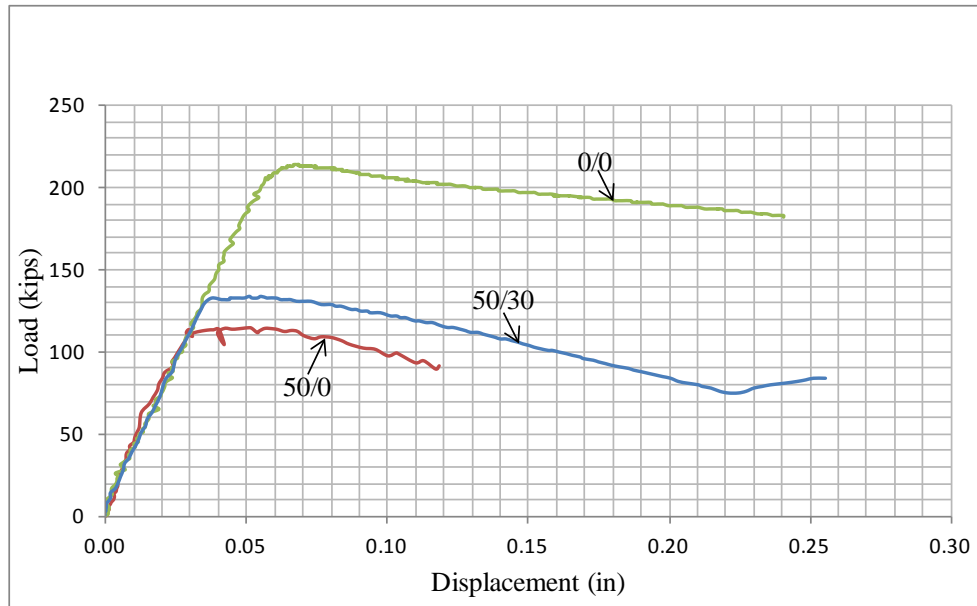
Figure 4.10. The Axial Load versus Displacement Relationships of the Damaged Piles in Group #2

Prior to repair, the pile 50/0 failed by flange local buckling and pile 50/30 failed by flange and web local buckling at load levels of 117 and 130 kips, respectively. After reaching their peak loads, loading of the piles continued until the load decreased to 92 and 84 kips, respectively for piles 50/0 and 50/30. Figure 4.10 presents the axial load-displacement relationships of the damaged piles prior to repair with the GFRP-based system.

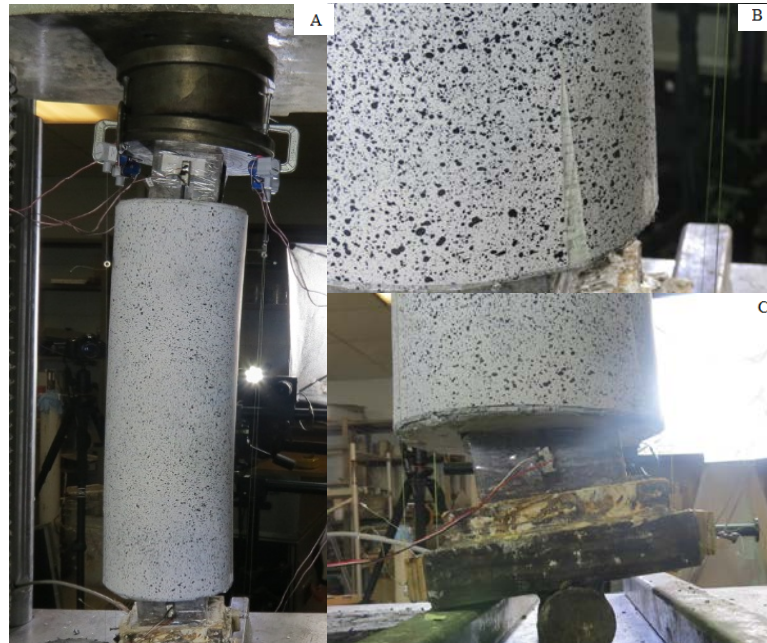
Figure 4.11. Failure of G2/3/NR-1

Pile G2/3/NR-1 failed at a load level of 216 kips due to buckling of the pile and rupture of GFRP as illustrated in Figure 4.11. Prior to the repair, the pile failed by flange local buckling at a load level of 117 kips. The capacity of repaired pile was 1.8 times the capacity of the damaged pile and approximately equal to the capacity of the undamaged control pile. Figure 4.12 compares the axial load-shortening responses of the corroded

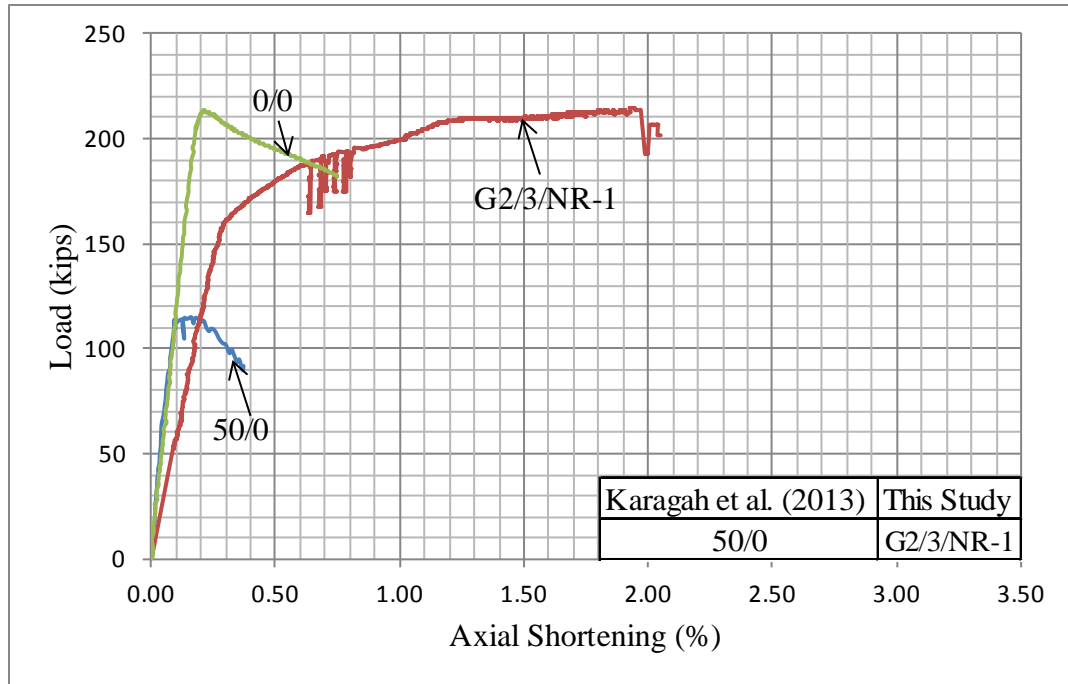
Figure 4.12. Load versus Axial Shortening of G2/3/NR-1

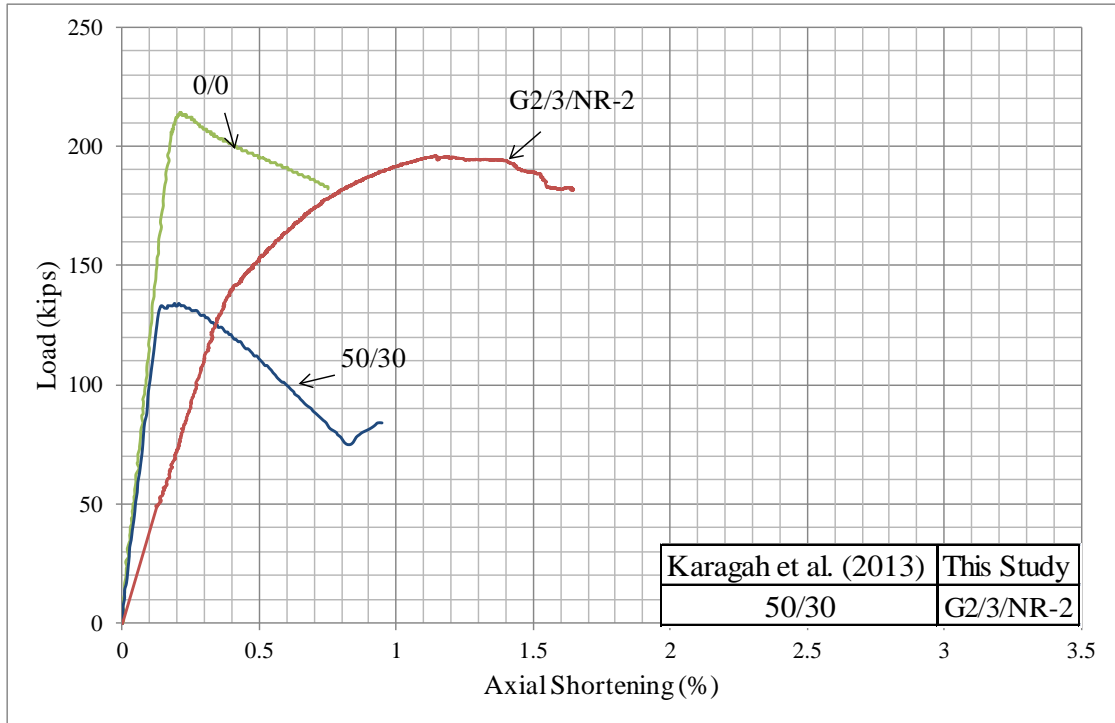
Figure 4.14. Load versus Axial Shortening of G2/3/NR-2

Pile G2/3/NR-2 failed at a load level of 197 kips due to buckling of the pile and rupture of GFRP as illustrated in Figure 4.13. Prior to the repair, the pile failed by flange and web local buckling at a load level of 130 kips. The capacity of the repaired pile was 1.5 times the capacity of the damaged pile and 92% of the capacity of the undamaged control pile. Figure 4.14 compares the axial load-shortening responses of the corroded pile (prior to repair) and the repaired buckled pile (after installation of the jacket) to the response of the undamaged control pile.

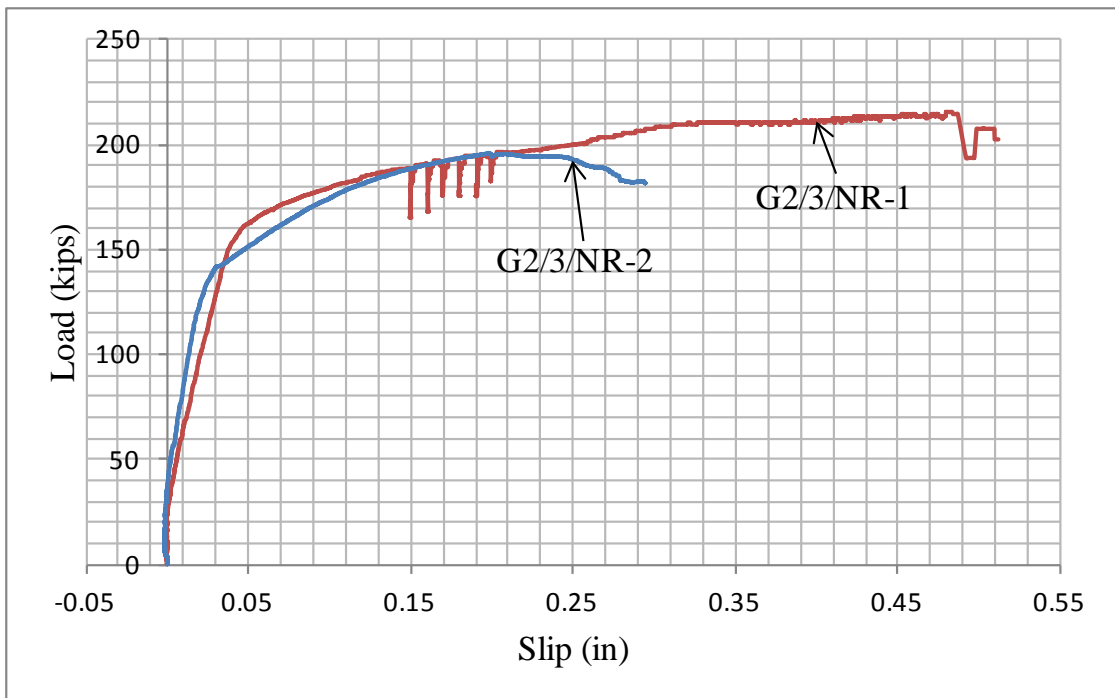
Figure 4.15. Load versus Slip Responses of G2/3/NR-1 and G2/3/NR-2

The slip between steel and concrete for G2/3/NR-1 and G2/3/NR-2 is shown in Figure 4.15. The slip was not equal to zero because the steel piles were damaged already and the shortening of the piles was larger than the shortening of the jacket. The loads versus shortening responses of all the specimens Group#2 are presented in Figure 4.16.

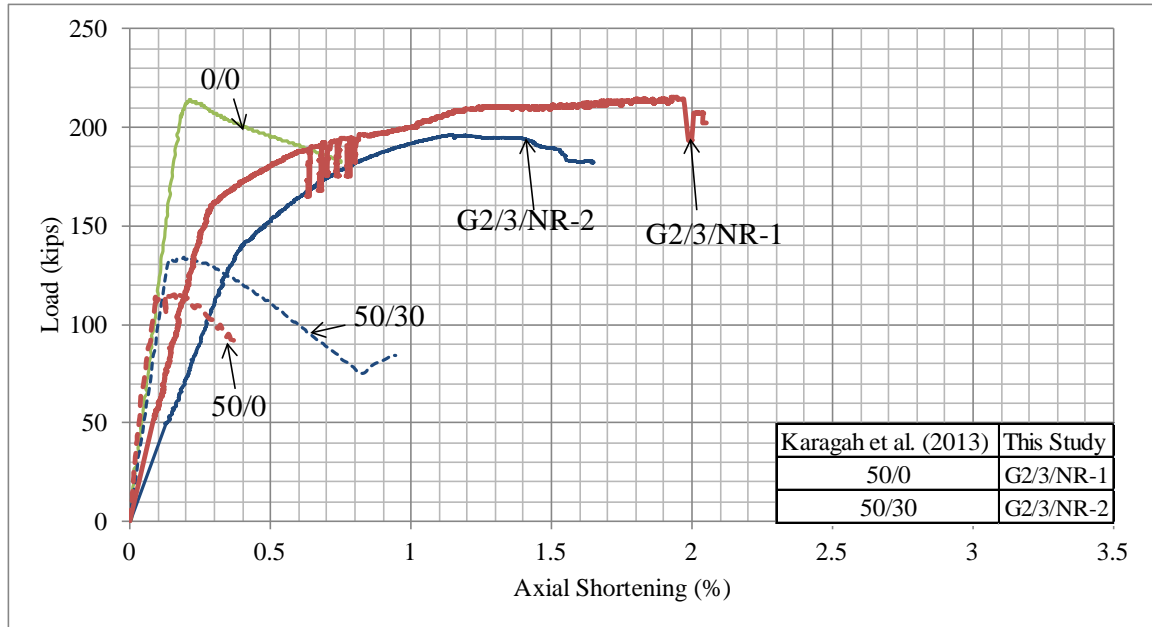
Figure 4.16. Load versus Shortening of Specimens in Group#2

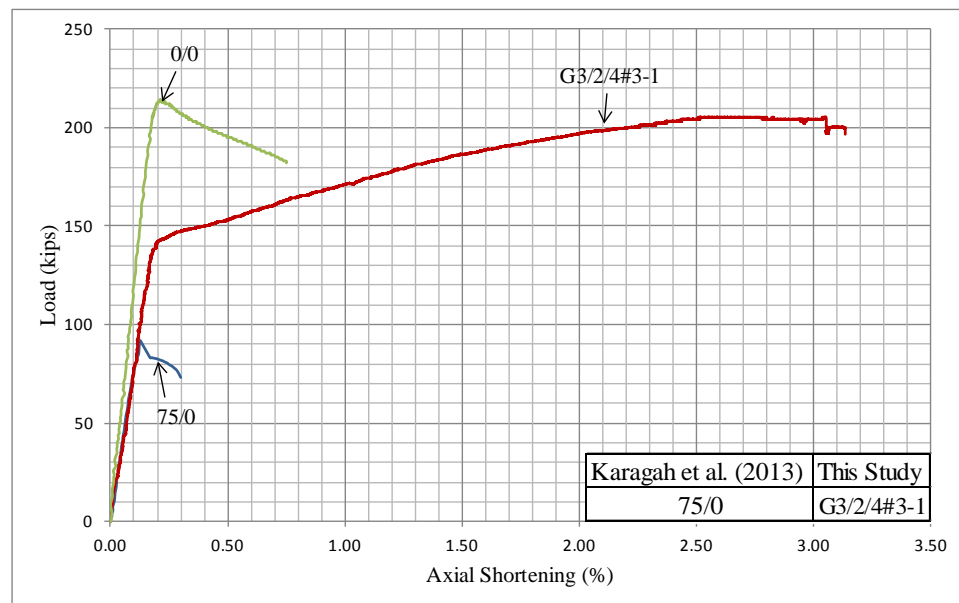
Figure 4.19. Load versus Axial Shortening of G3/2/4#3-1

Pile G3/2/4#3-1 failed at a load level of 205 kips due to GFRP rupture as illustrated in Figure 4.18. Prior to the repair, the pile failed by flange local buckling a load level of 92 kips. After the repair, failure mode was GFRP rupture near the mid-height of the pile. The capacity of the repaired pile was 2.2 times the capacity of the damaged pile and 95% of the capacity of the undamaged control pile. Figure 4.19 compares the axial load-shortening responses of the corroded pile (prior to repair) and the repaired buckled pile (after installation of the jacket) to the response of the undamaged control pile.

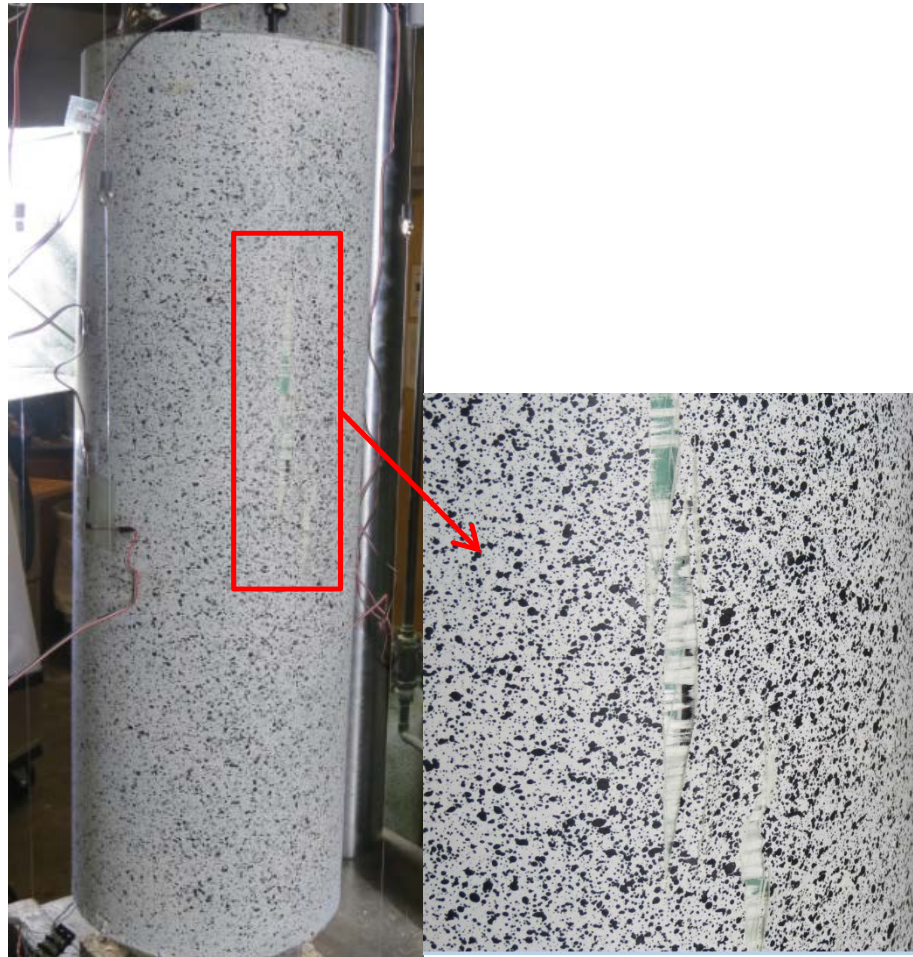
Figure 4.27. Failure of G4/2/NR

Pile G4/2/NR failed at a load level of 149 kips due to GFRP rupture as illustrated in Figure 4.27. Prior to the repair, the pile failed by flange local buckling at a load level of 40 kips. The capacity of the repaired pile was 3.7 times the capacity of the damaged pile and 70% of the capacity of the undamaged control pile. Figure 4.28 compares the axial load-shortening responses of the corroded pile (prior to repair) and the repaired buckled pile (after installation of the jacket) to the response of the undamaged control pile.

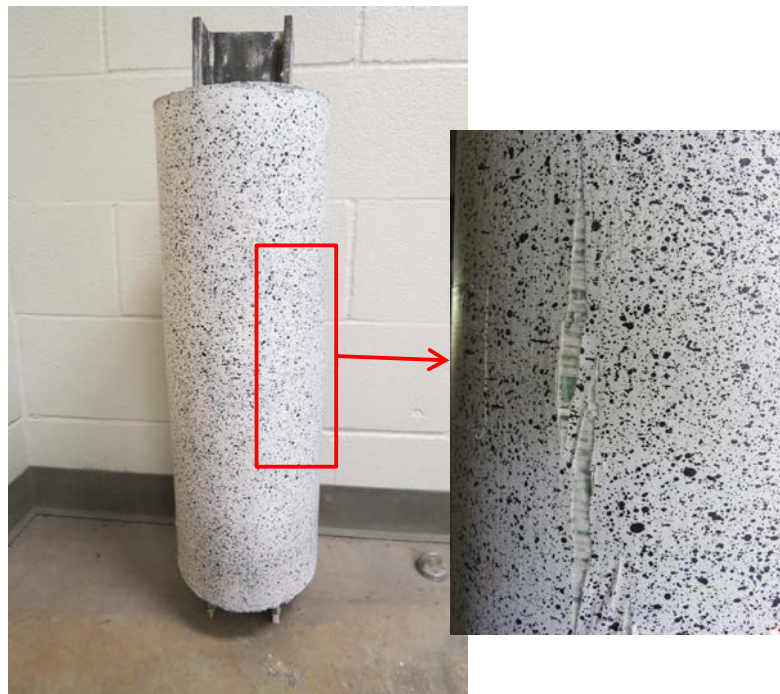
Figure 4.31. Failure of G4/3/NR

Pile G4/3/NR failed at a load level of 189 kips due to GFRP rupture as illustrated in Figure 4.31. Prior to the repair, the pile failed by flange local buckling at a load level of 40 kips. The capacity of the repaired pile was 4.7 times the capacity of the damaged pile and 88% of the capacity of the undamaged control pile. Figure 4.32 compares the axial load-shortening responses of the corroded pile (prior to repair) and the repaired buckled pile (after installation of the jacket) to the response of the undamaged control pile.
